123 Sample St - Maintenance report

15/01/2026

Inspector Name: Sam Taylor

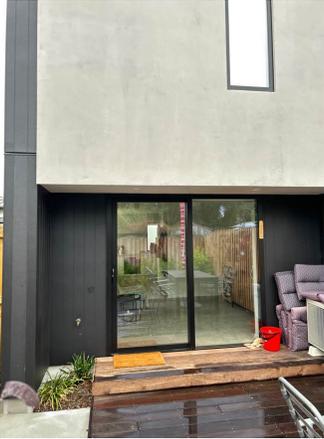
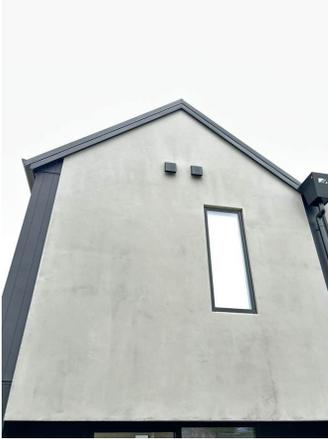
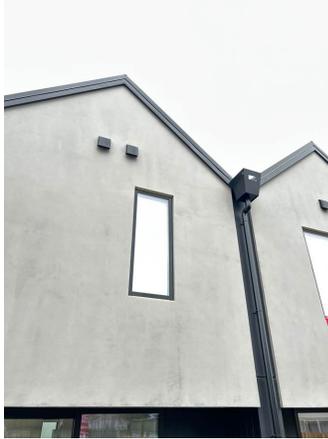
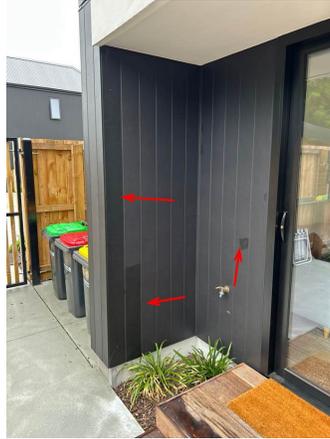
Good with the exception of a small area of mismatched paint near ranch slider and missing paint as per photos

Mismatched paint

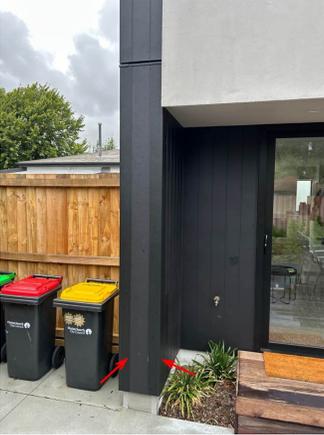
Mismatched paint

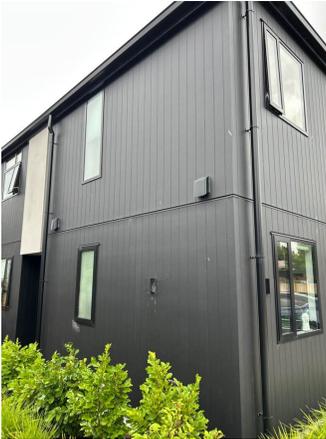
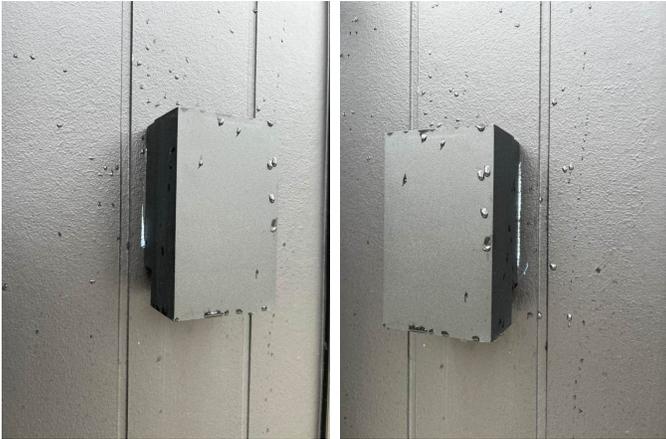
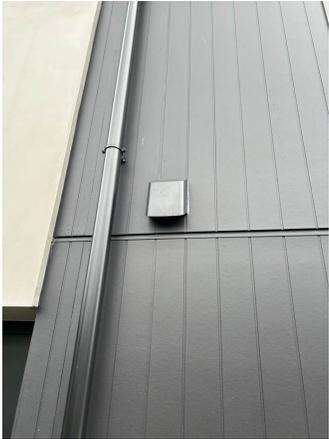
Missing paint around light next to kitchen window

Missing paint around grille

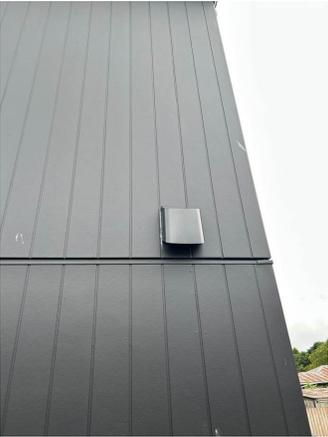
Missing paint around grille

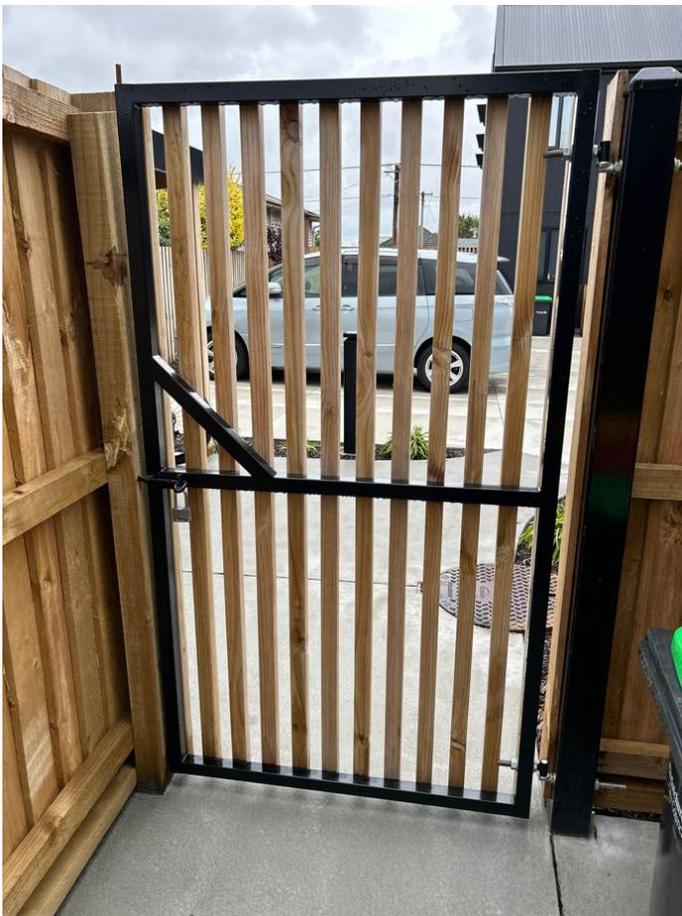
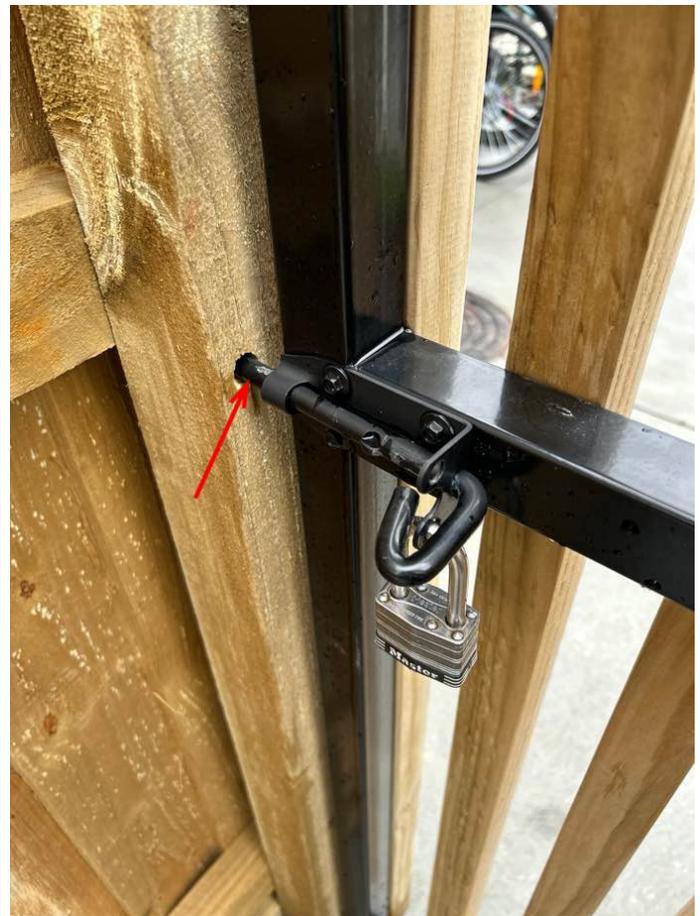
Gate latch is very difficult to operate, recommend enlarging hole

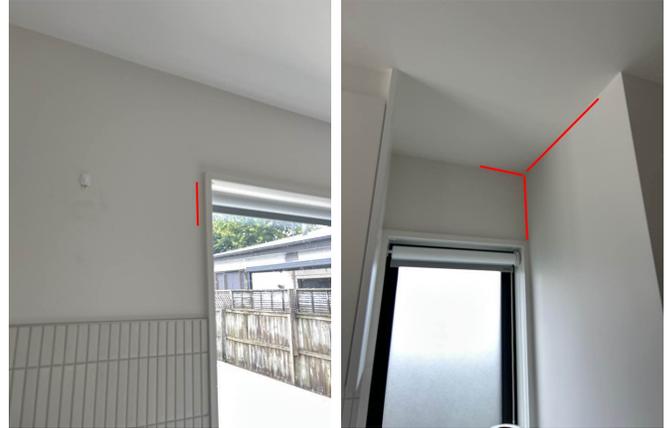
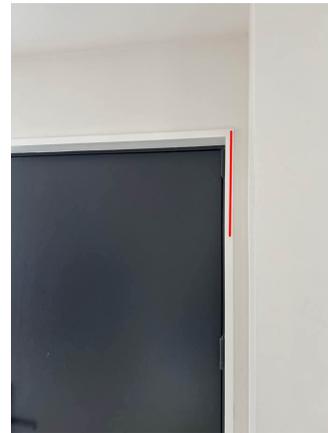
Paint split as per photos

Maintenance Recommended

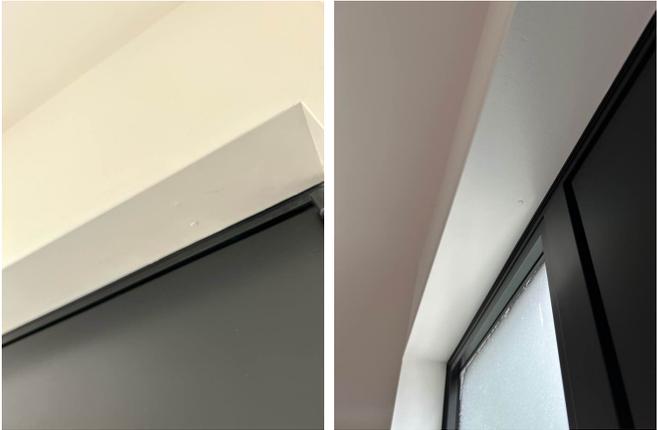
Exposed fixings in reveal

Maintenance Recommended

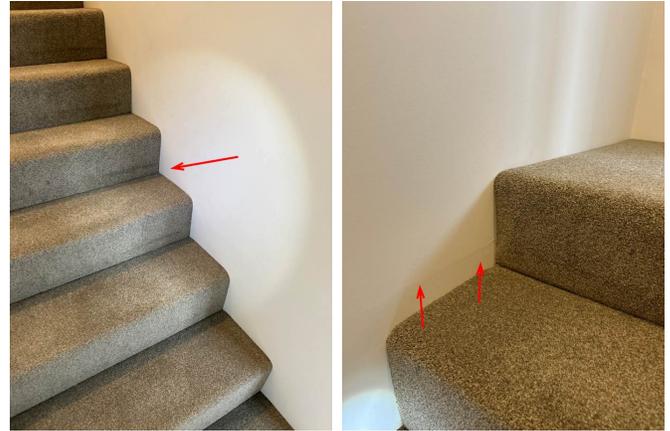
Popped screw and small crease as per photos

Maintenance Recommended

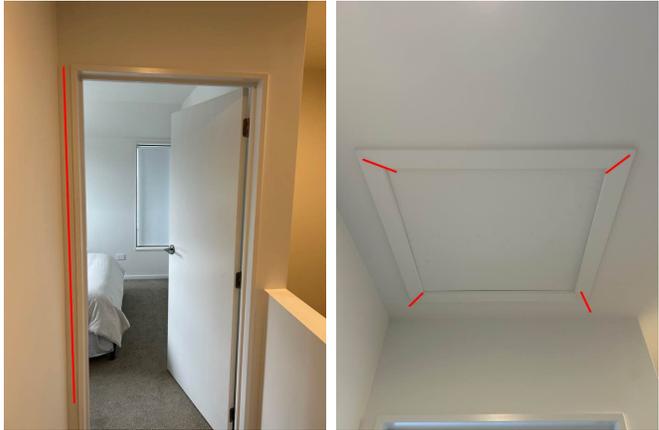
Paint split down side of door and to mitres on manhole architrave

Maintenance Recommended

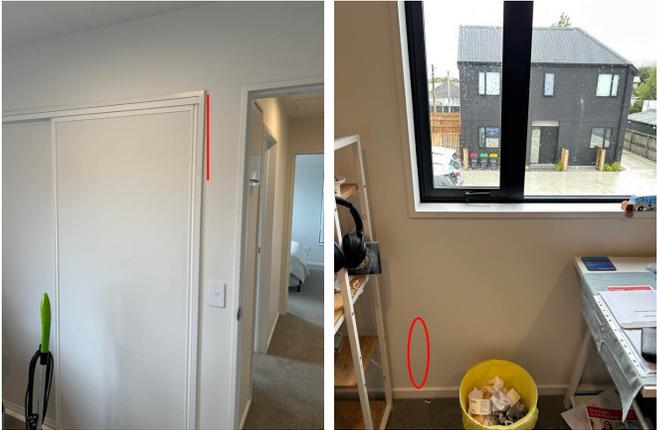
Minor paint splits and exposed fixings as per photos

Popped fixings

Maintenance Recommended

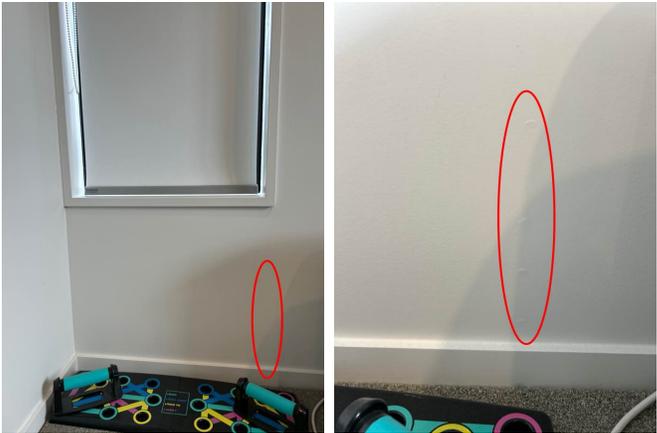
Popped fixings

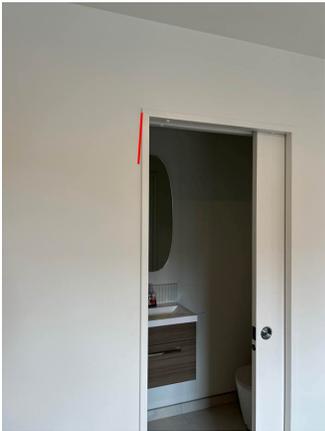
Small split

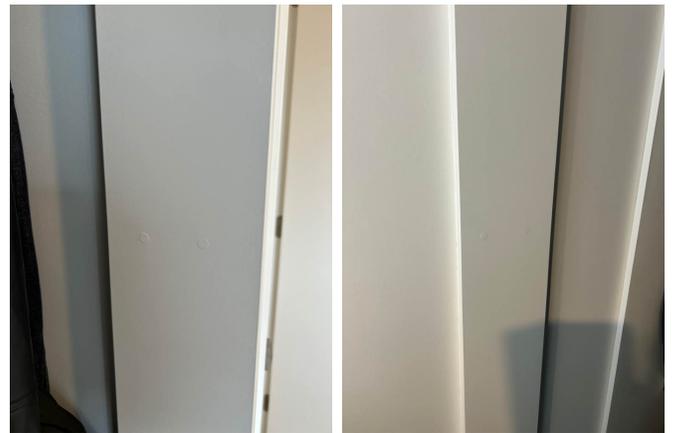
Exposed fixings on wardrobe reveals (all fixings)

Maintenance Recommended

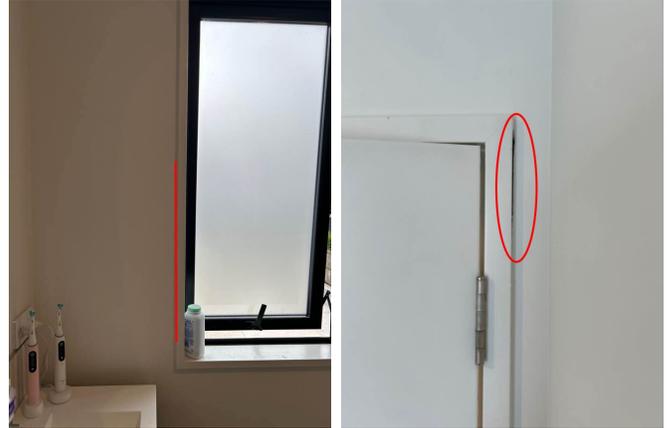
Small paint split as per photos

Maintenance Recommended

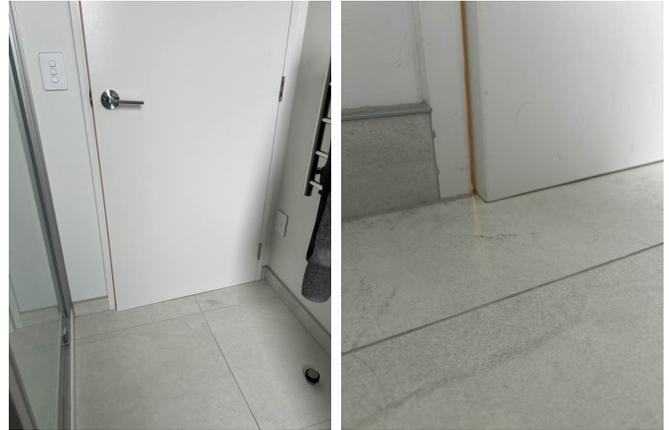
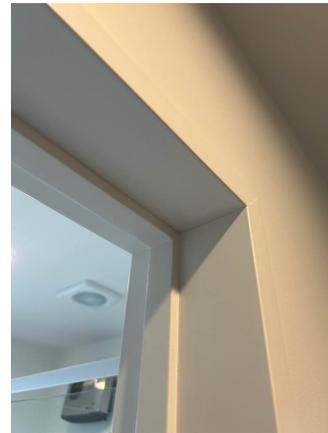
Door is catching on tiles - ease required. Paint split to mitre

Maintenance Recommended

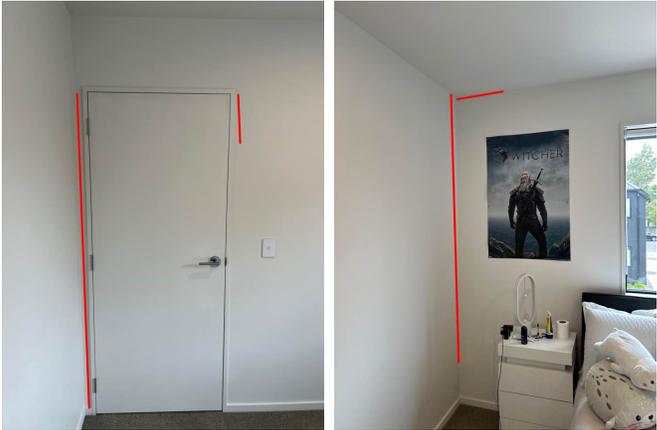
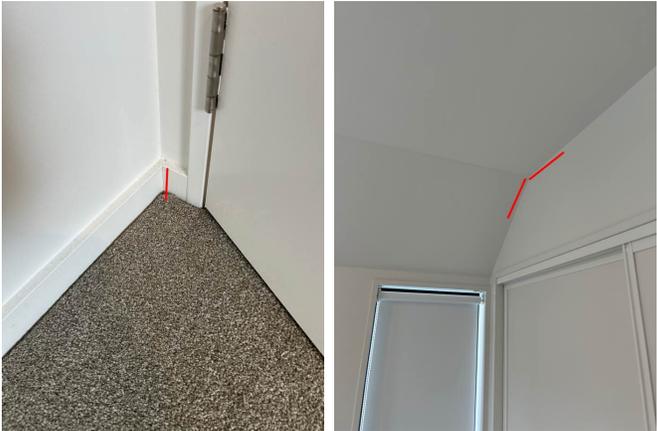
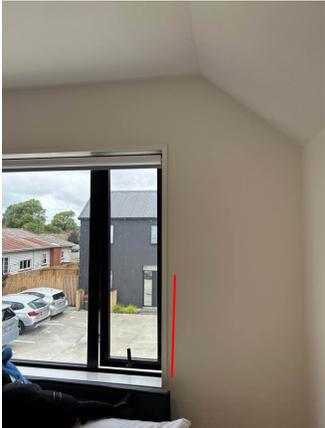
Paint splits as per photos

Maintenance Recommended

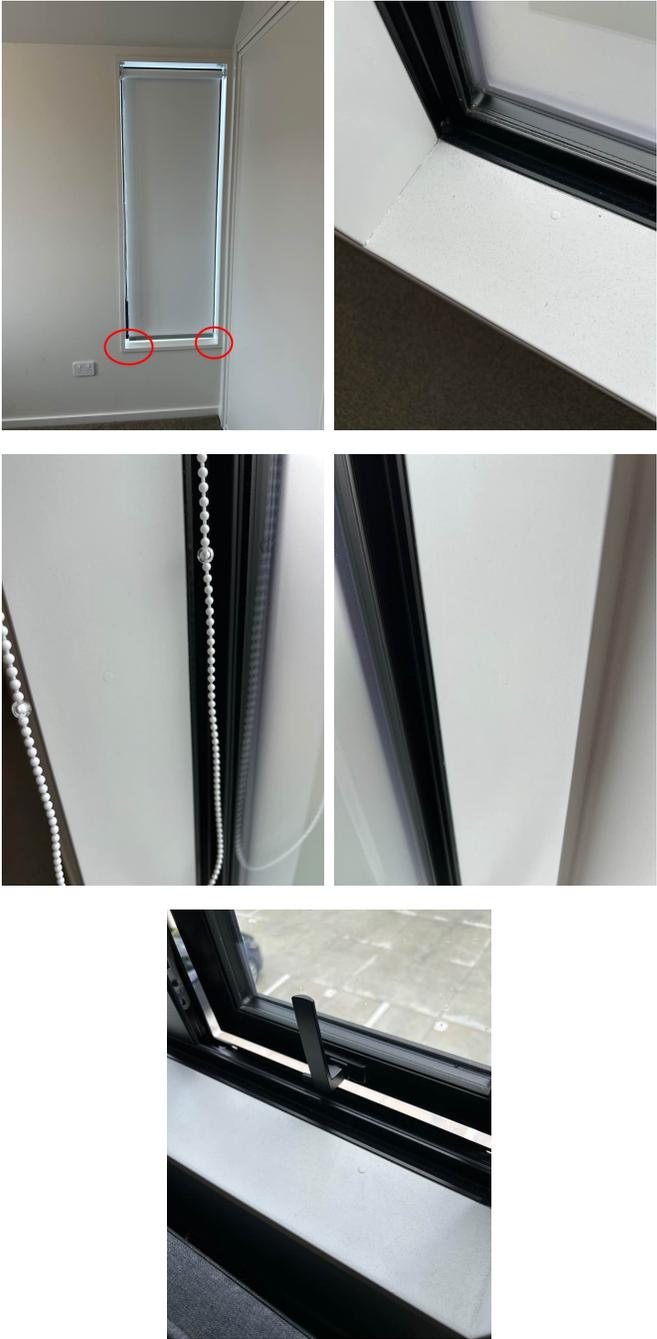
Exposed fixings and paint split to mitres

Maintenance Recommended

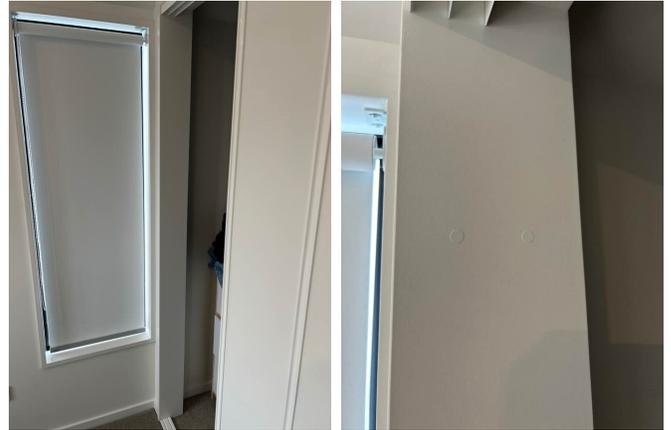
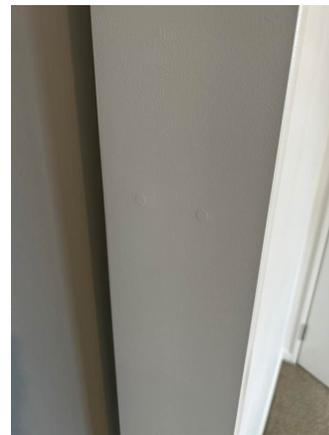
Exposed fixings on wardrobe reveals (all fixings)

Maintenance Recommended
