123 Sample St - Multi storey

20/01/2026

Inspector Name: Sam Taylor

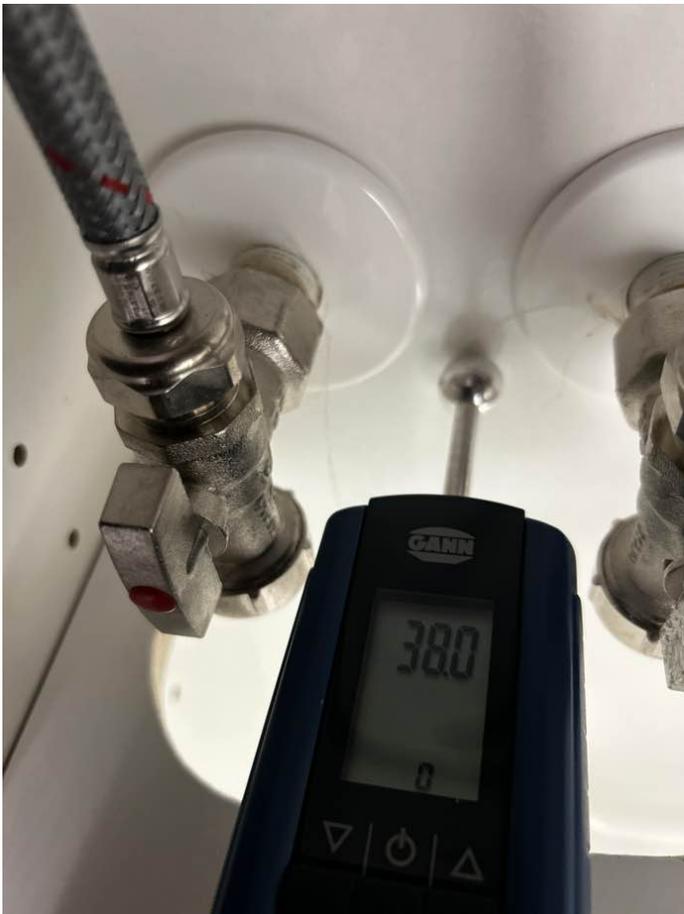
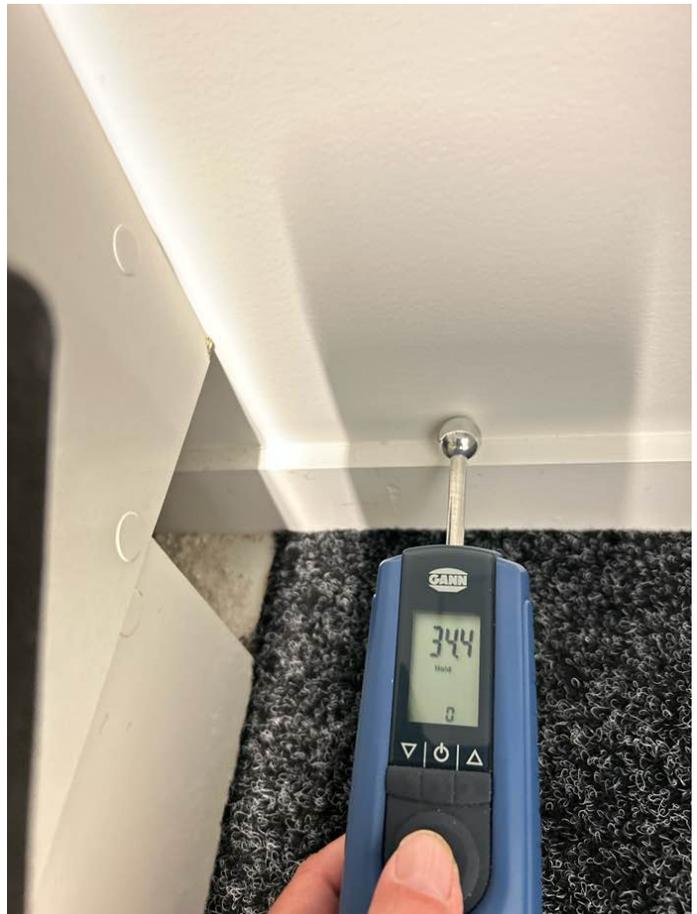
Room:
Laundry

Moisture Reading
20-40 digits - Dry

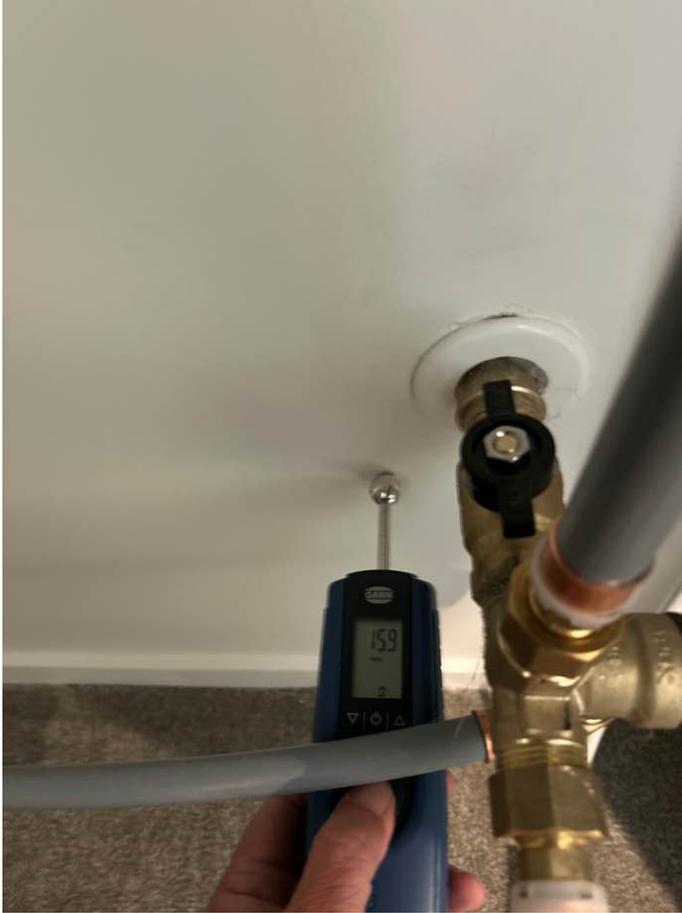
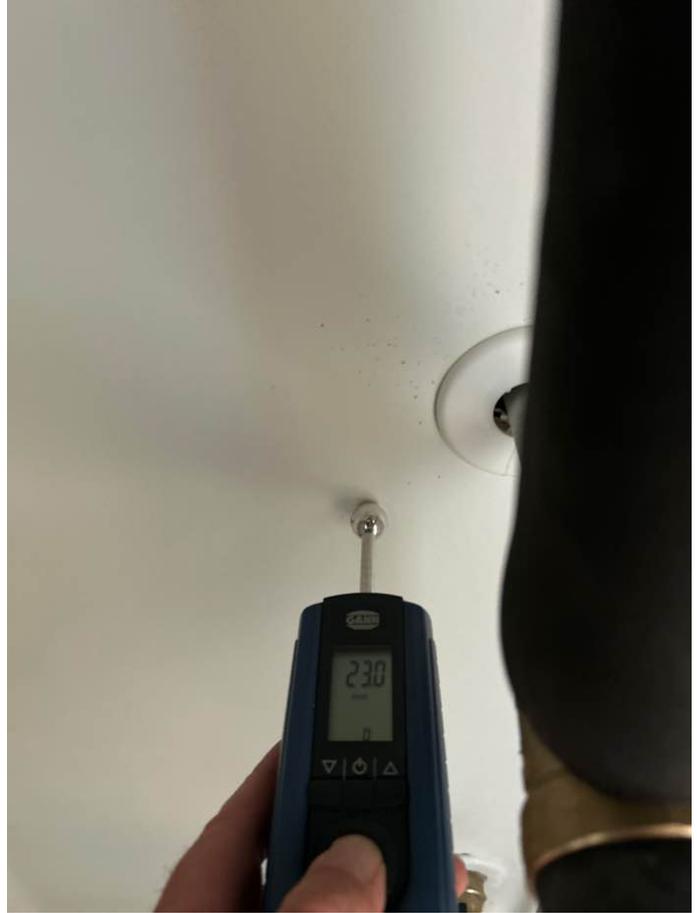
Room:
HWC

Moisture Reading
20-40 digits - Dry

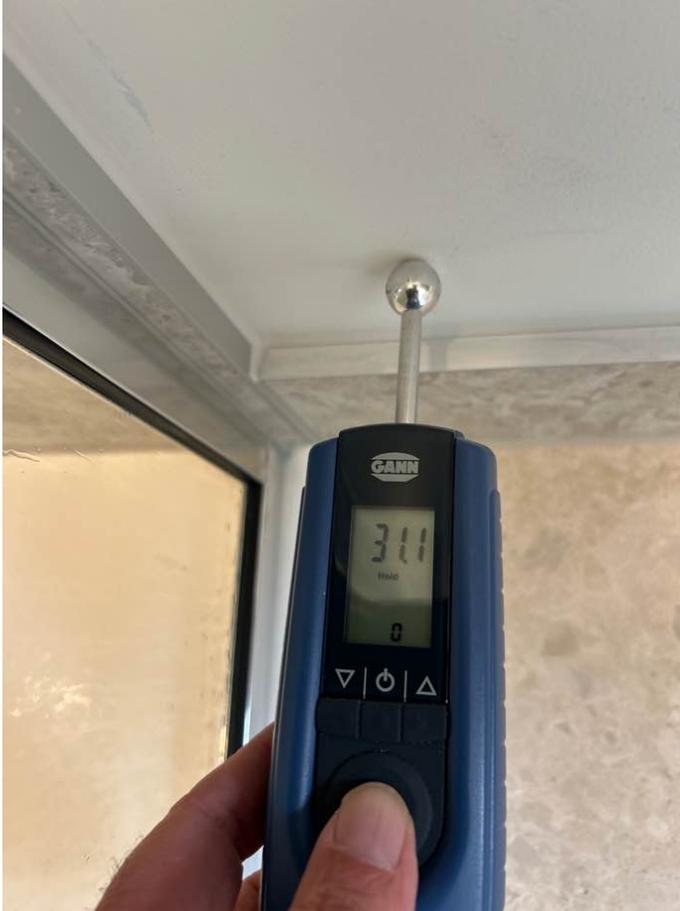
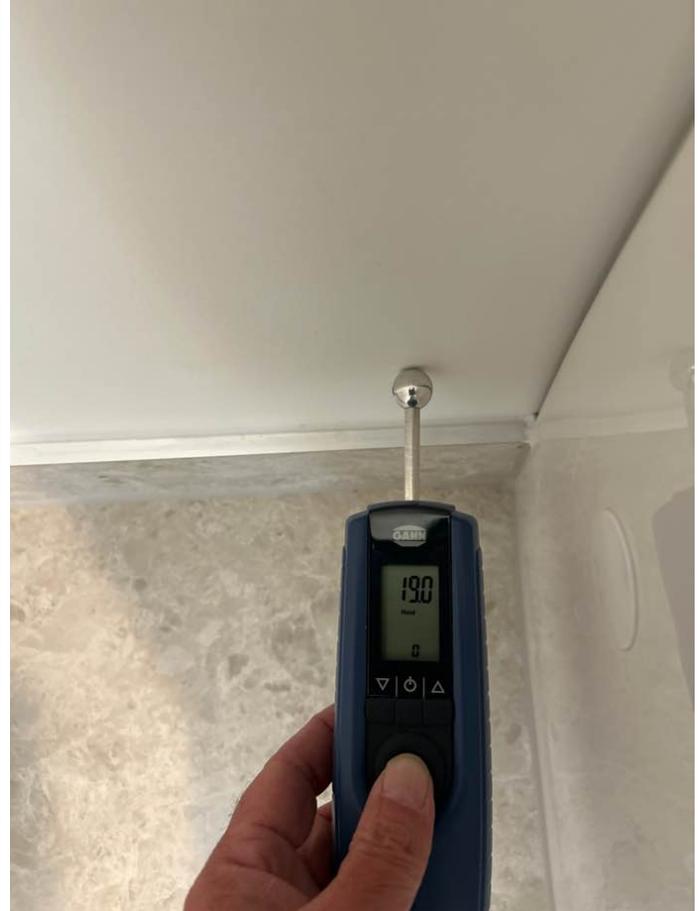
Room:
Ensuite 1

Moisture Reading
20-40 digits - Dry

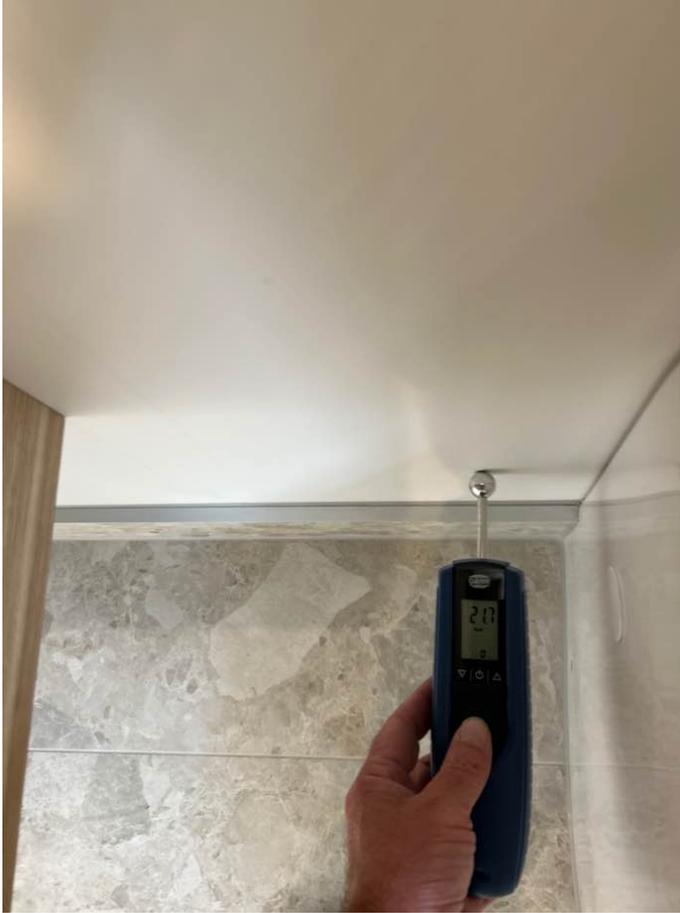
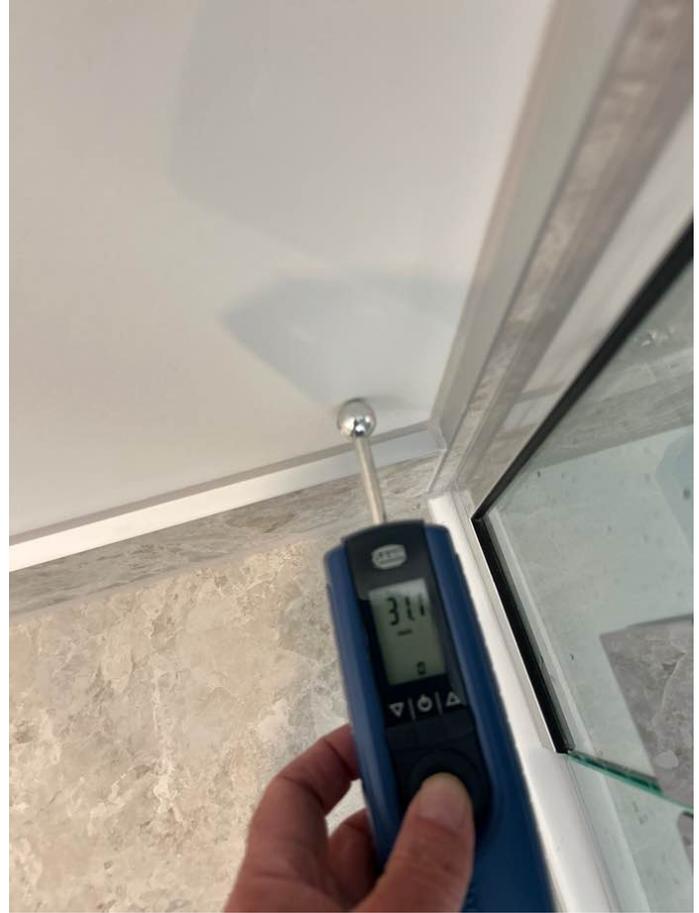
Room:
Bathroom 1

Moisture Reading
20-40 digits - Dry

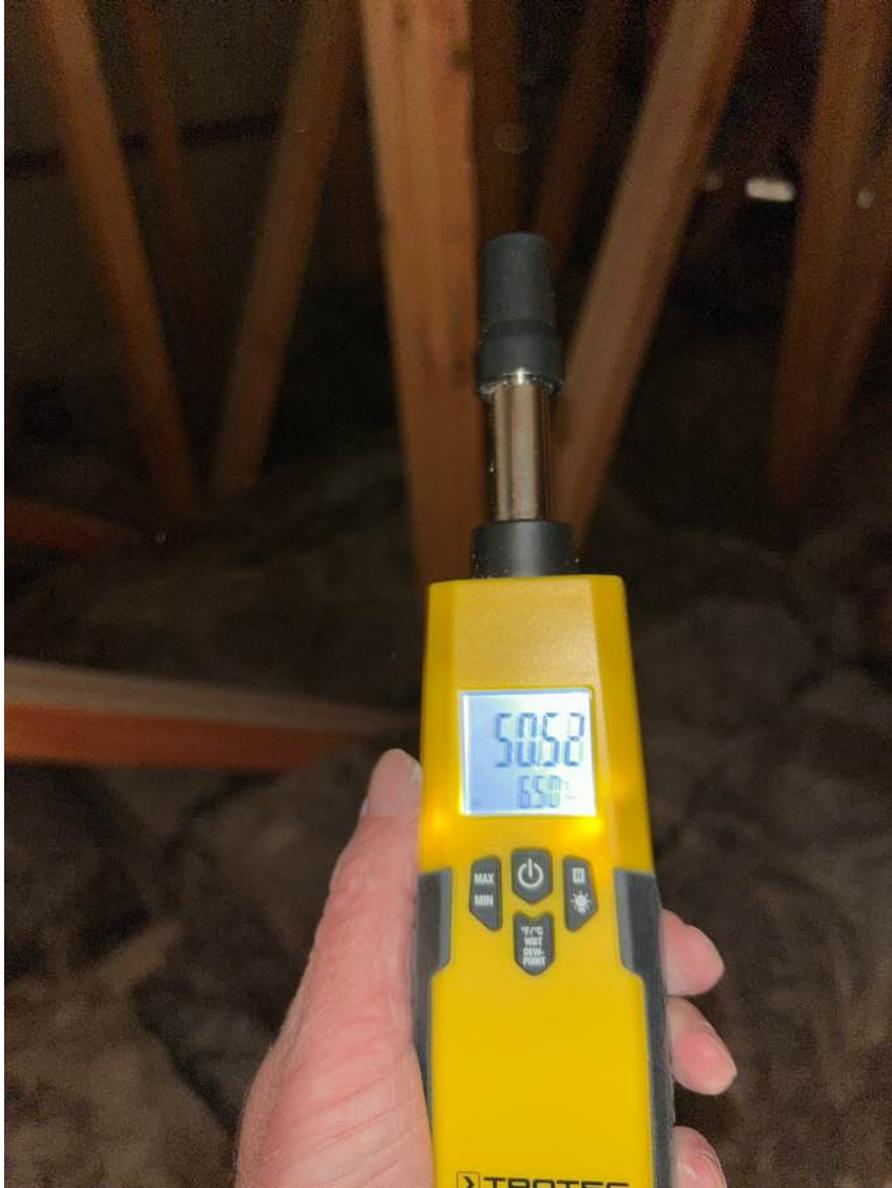
Room:
Humidity Reading - Roof space

Roof space - 50.5%

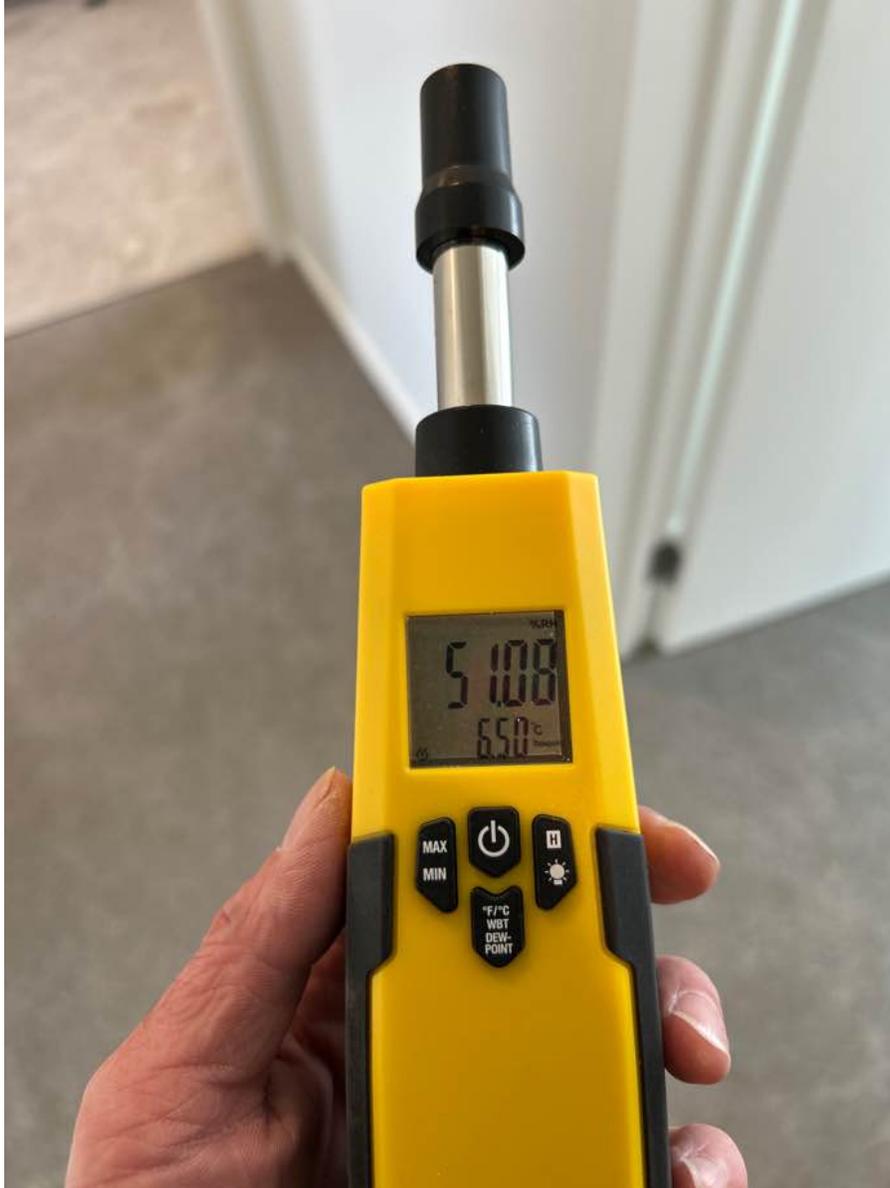
Room:
Humidity Reading - First floor

First floor - 51%

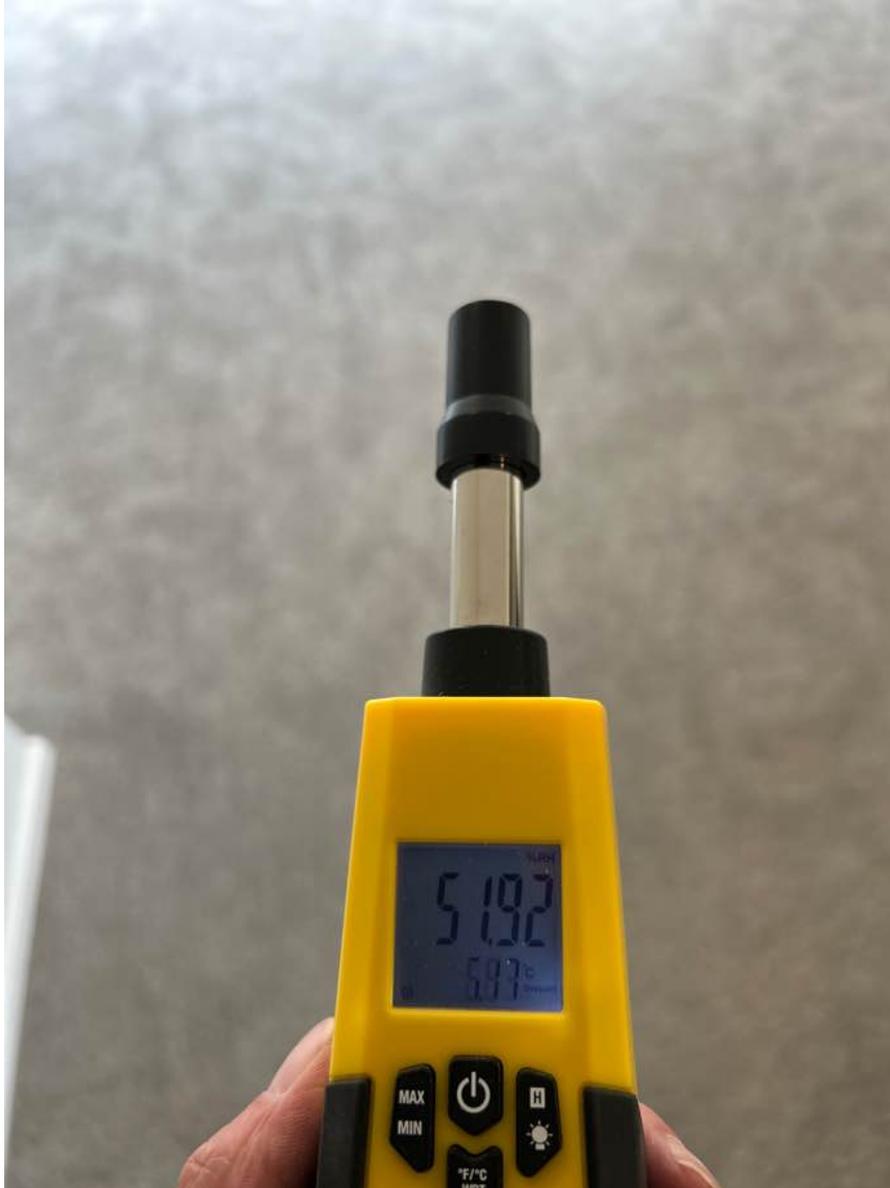
Humidity Reading - Ground floor

Ground floor - 51.9%

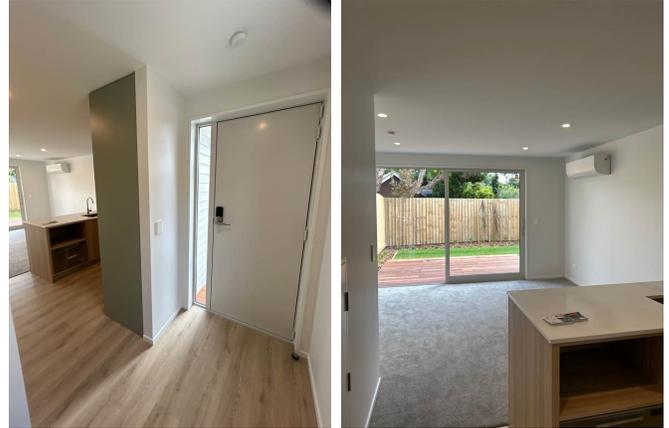
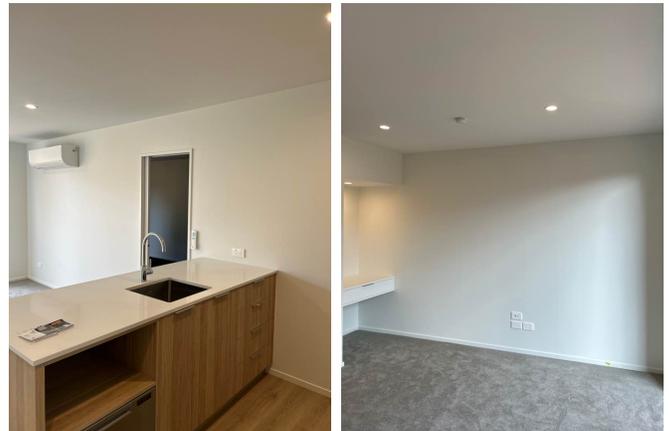
Gib walls and ceiling with paint finish - minor imperfections and marking as marked with green tape

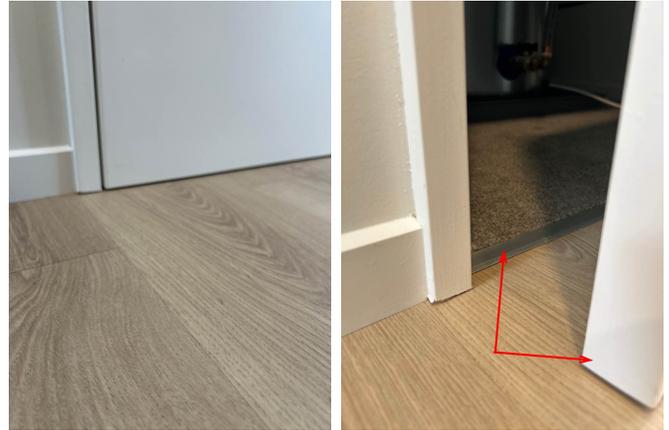
HWC timber door is catching on floor

Catching on trim

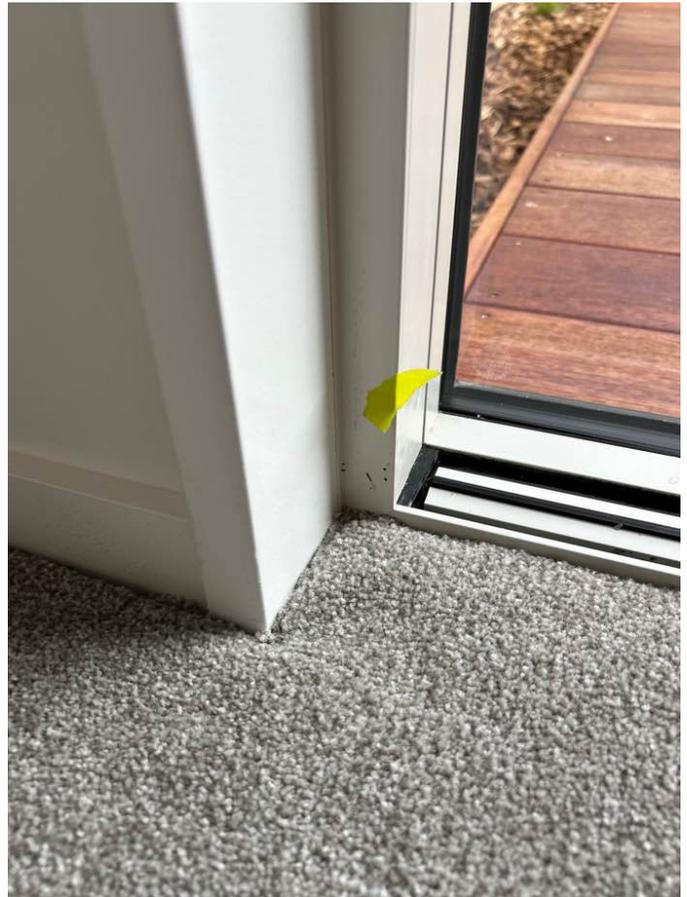
Small mark on ranch slider

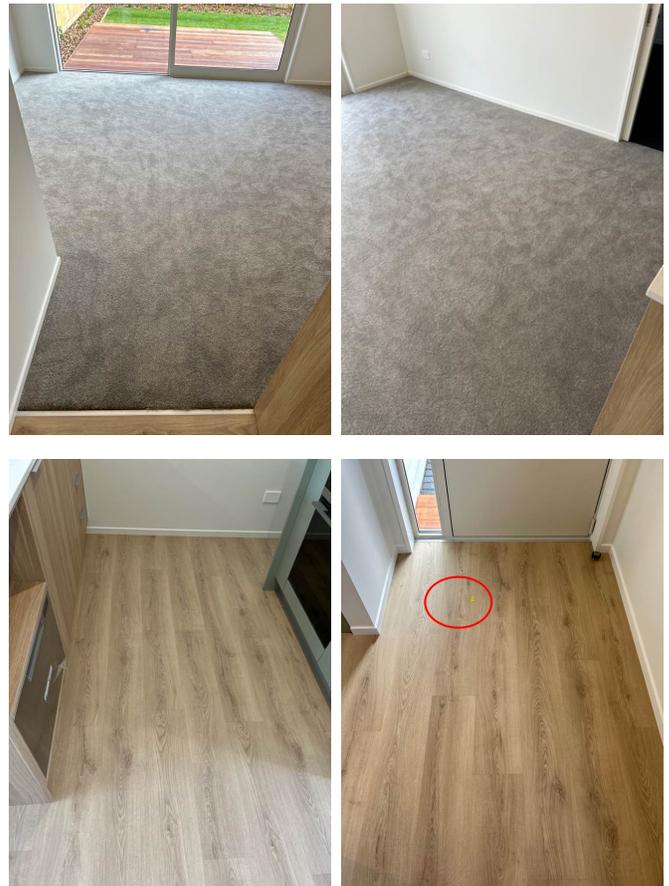
Laminate flooring and carpet - small Kwila stain mark on floor at entry

Kwila stain

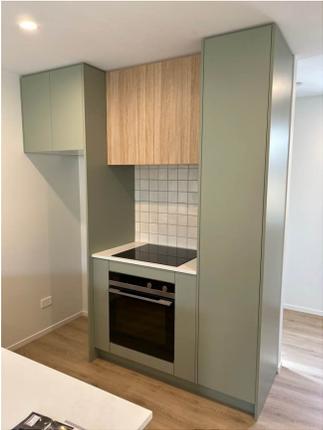
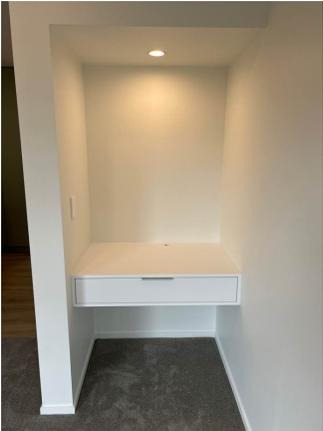
Melamine joinery with stone bench tops and tile splashback - 2nd drawer down is catching on top drawer

Drawer catching on drawer above

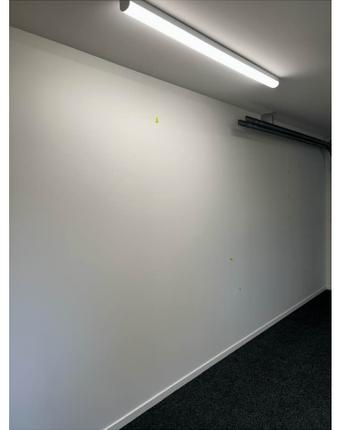
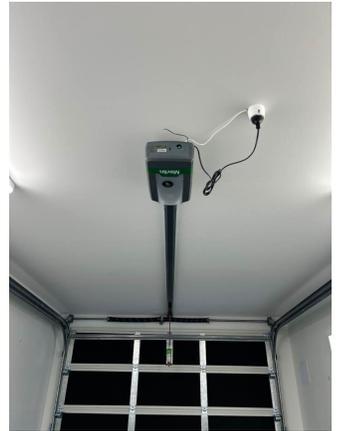
Gib walls and ceiling with paint finish - minor imperfections and marking as marked with green tape

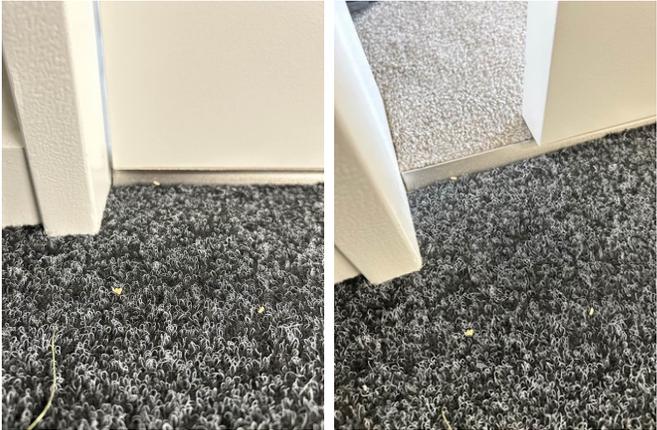
Slider requires adjustment to clear carpet

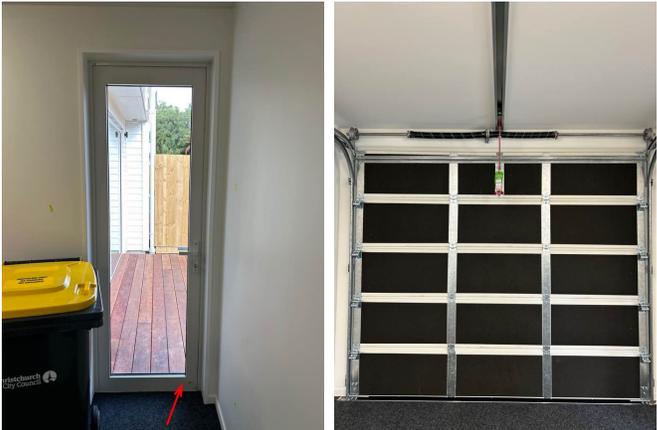
Small mark on door

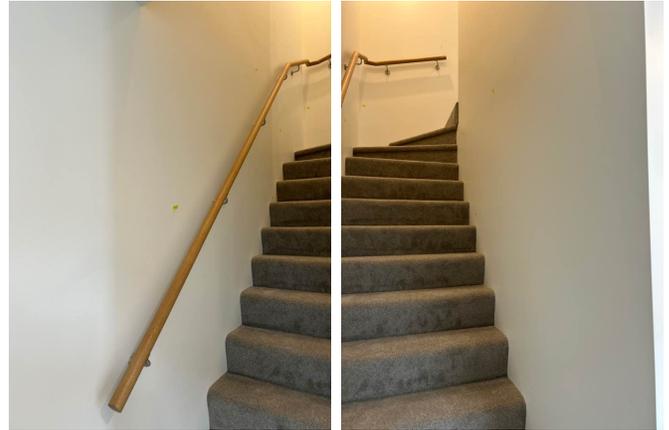
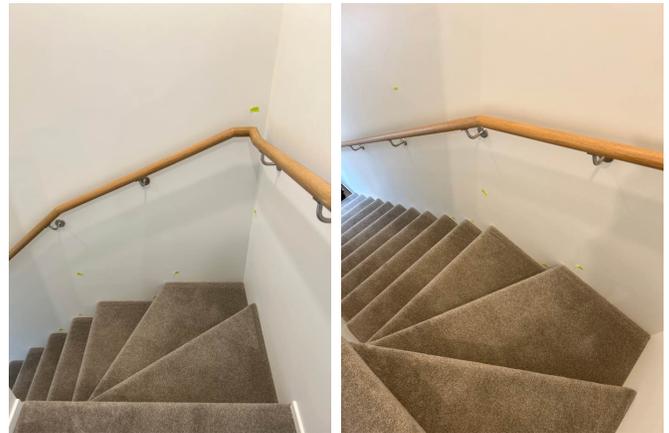
Gib walls and ceiling with paint finish - minor imperfections and marking as marked with green tape

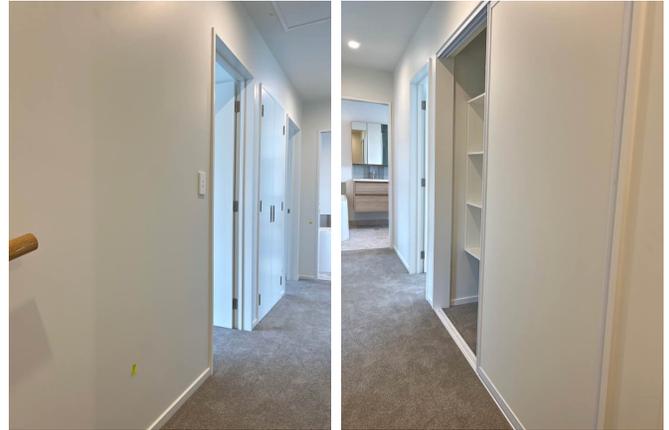
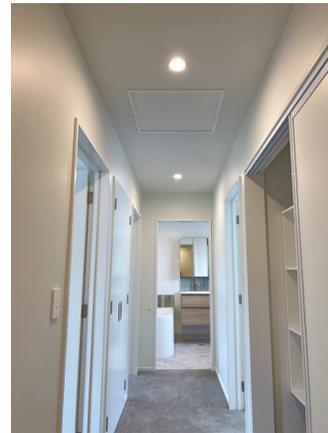
Gib walls and ceiling with paint finish - minor imperfections and marking as marked with green tape

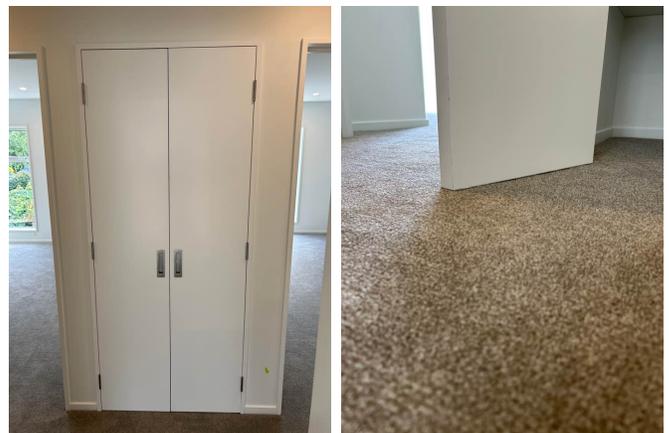
Hallway cupboard doors require easing to clear carpet

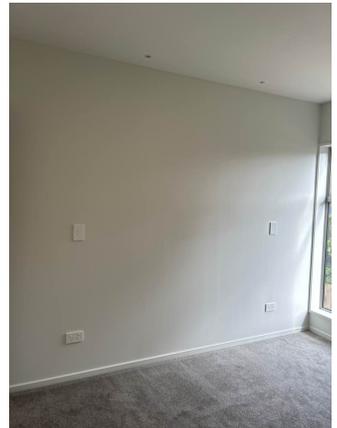
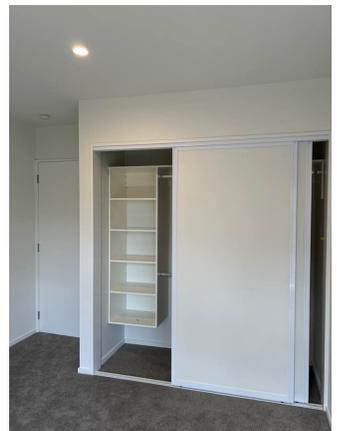
Gib walls and ceiling with paint finish - minor imperfections and marking as marked with green tape

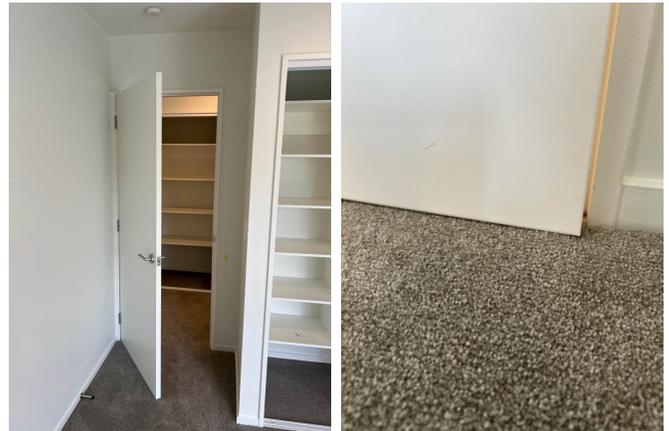
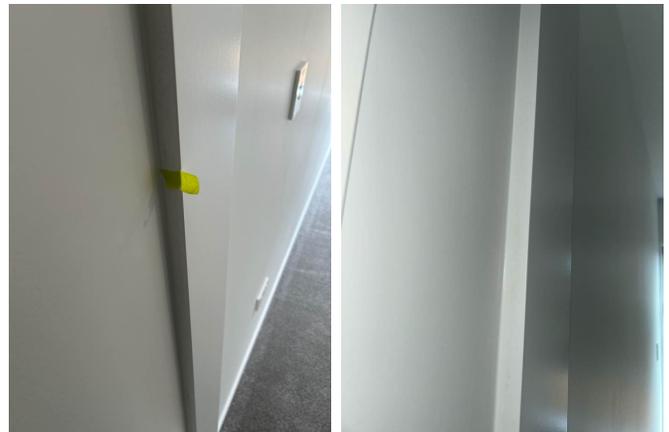
Door requires easing to clear carpet. Incomplete paint on inside of wardrobe reveal

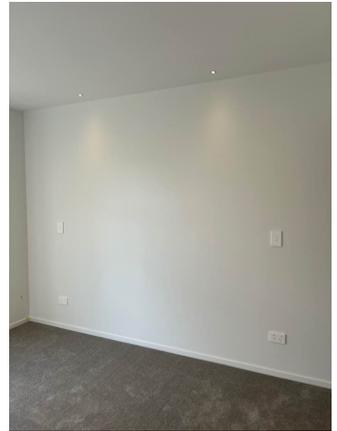
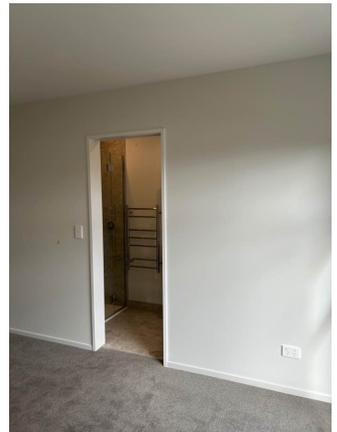
Gib walls and ceiling with paint finish - minor imperfections and marking as marked with green tape

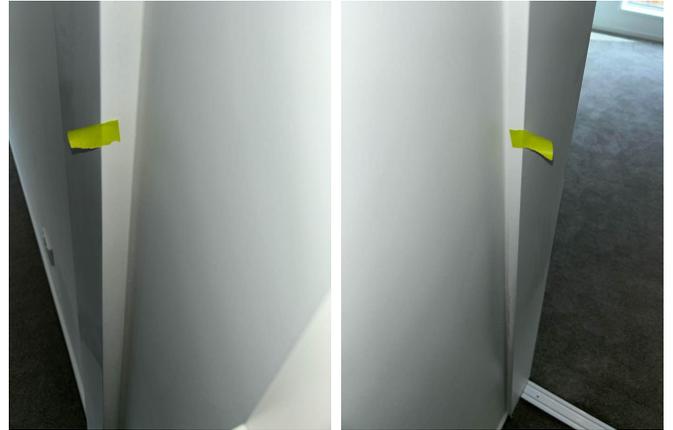
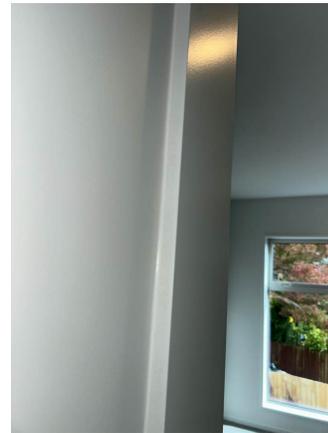
Incomplete paint on inside of wardrobe reveals

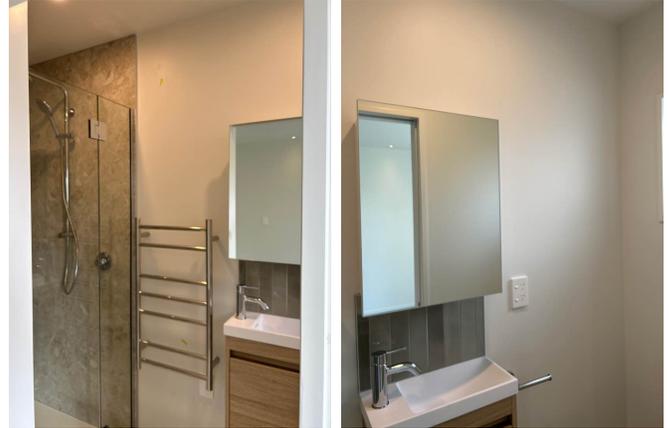
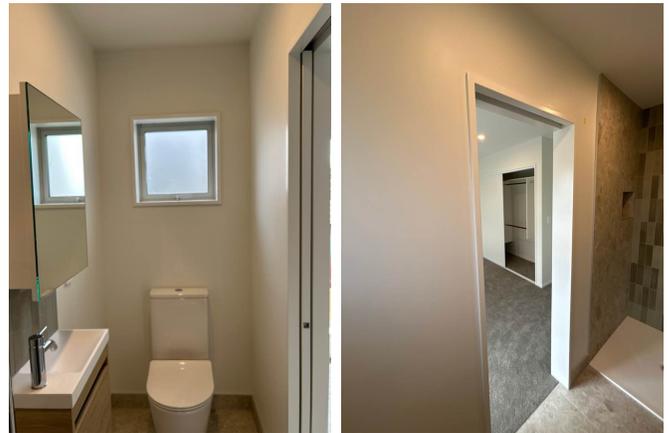
Gib walls and ceiling with paint finish - minor imperfections and marking as marked with green tape

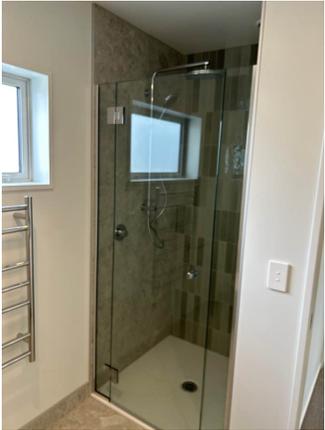
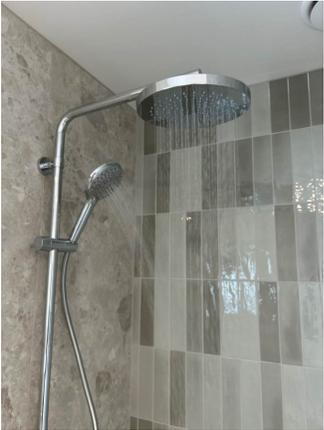
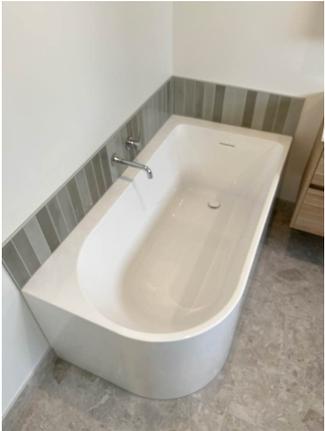
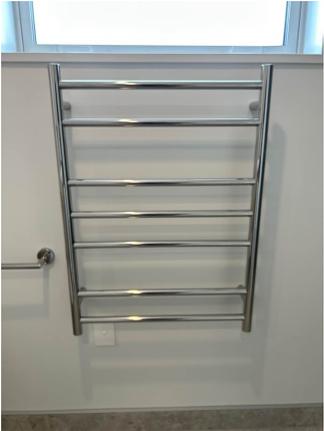
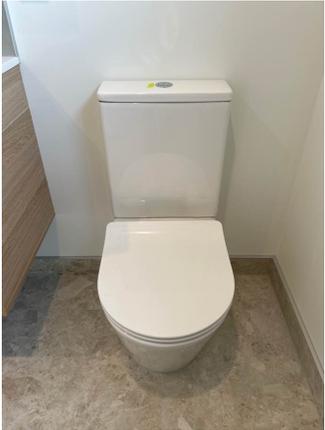
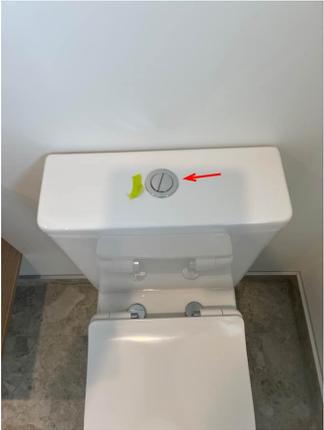
Tile shower with acrylic base, acrylic bathtub, heated towel rail, porcelain toilet - toilet flusher is misaligned

Flusher misaligned

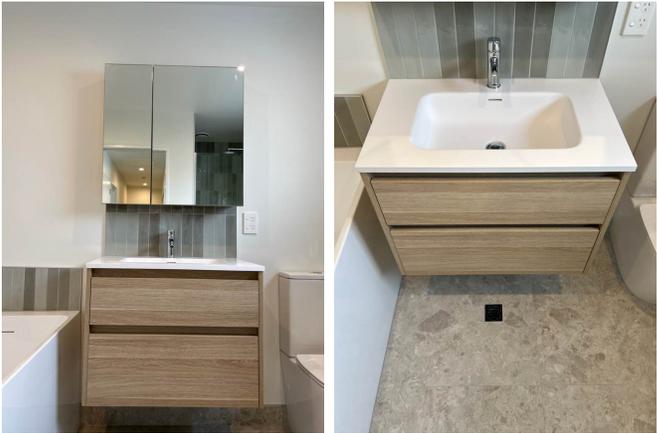
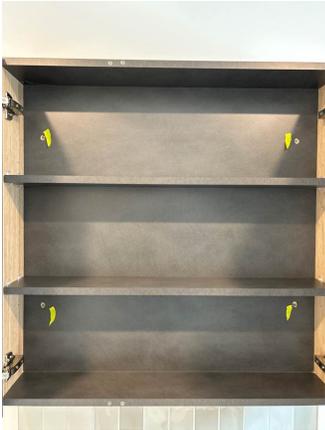
Melamine vanity and cupboard - recommend concealing angled screws in cupboard

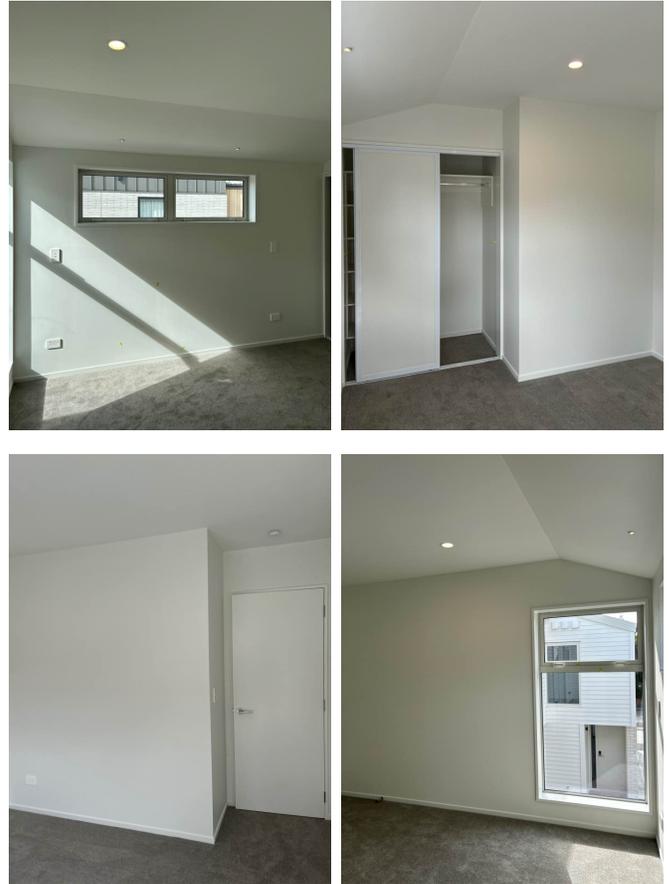
Gib walls and ceiling with paint finish - minor imperfections and marking as marked with green tape

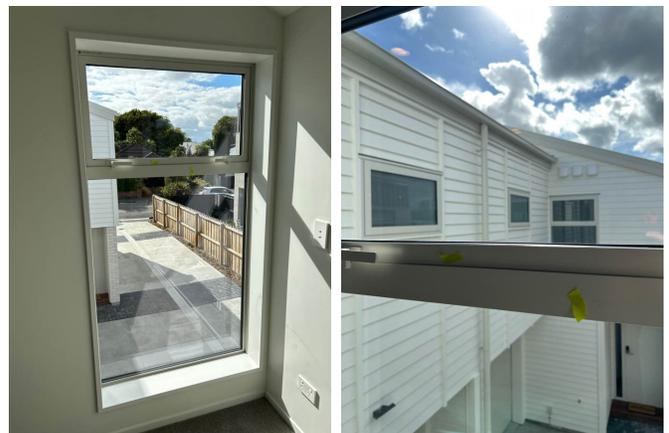
Double glazed aluminium window x2 - minor marking on window
