123 Sample St

26/01/2026

This is a new build property in good condition with just a small few minor finishing imperfections in the process of being completed

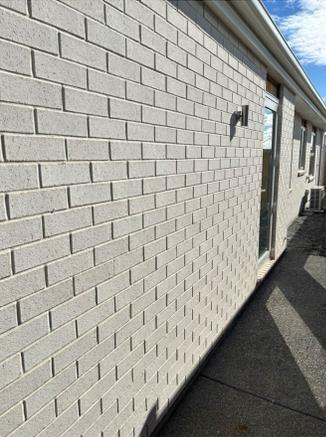
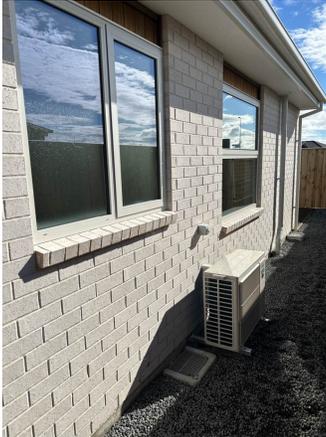
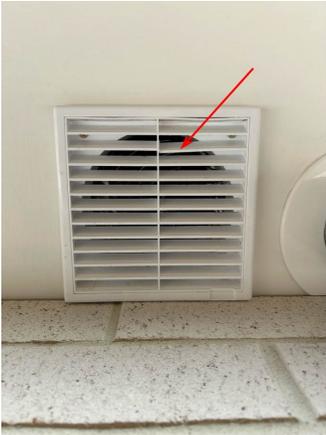
Ensuite grille has a broken louvre

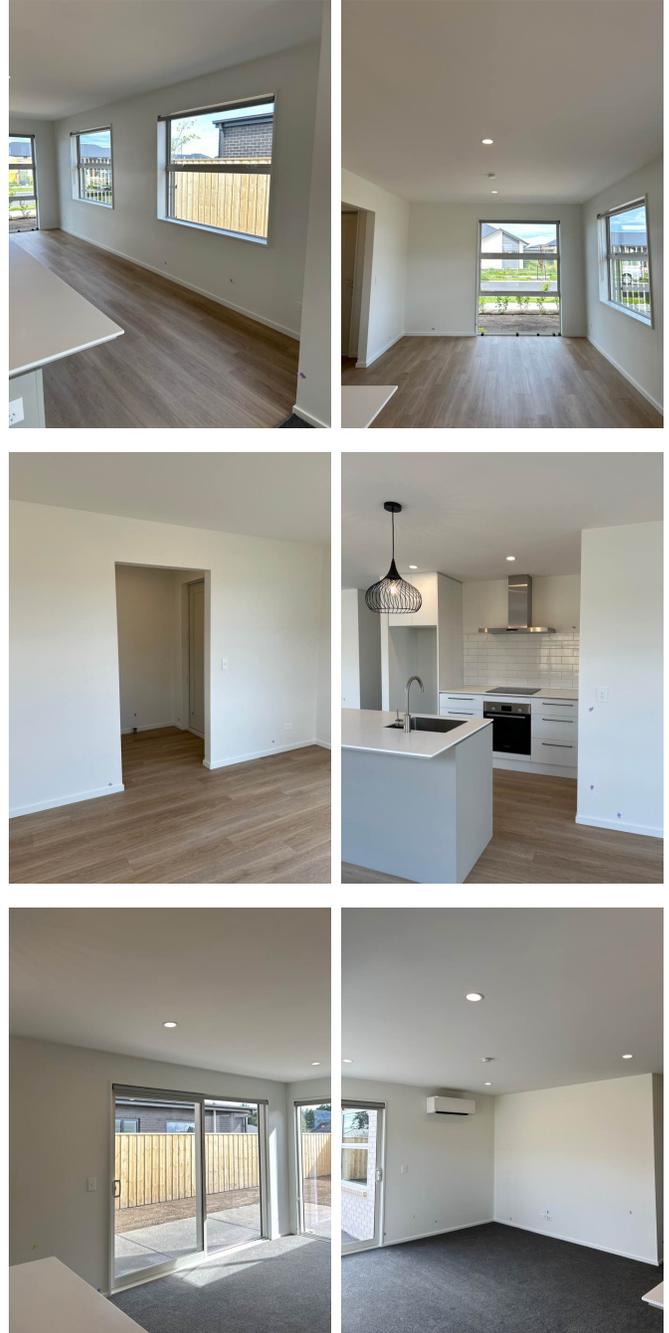
Gib walls and ceiling with paint finish - minor imperfections as marked with tape

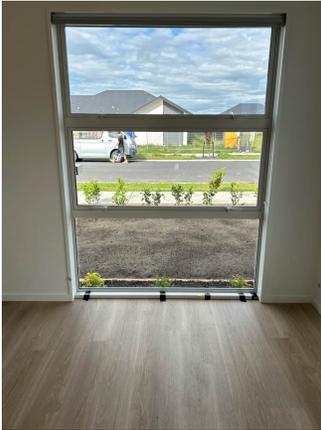
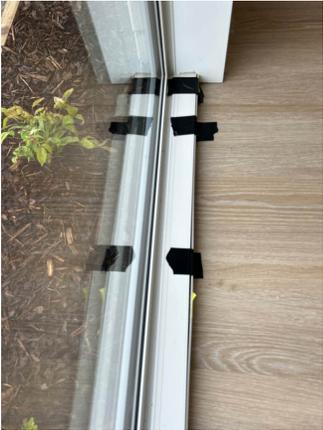
Aluminium trim adhesive has failed, removing and reglueing may be necessary

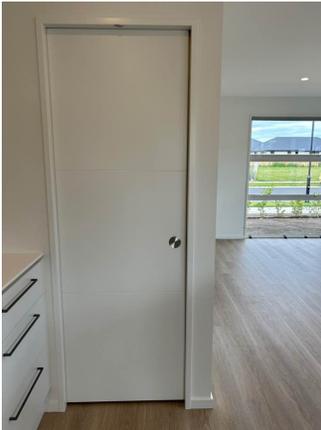
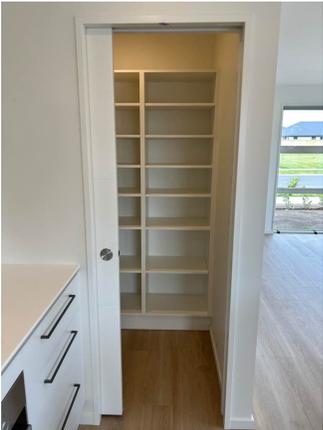
Cavity slider has not been hung plumb and won't stay inside cavity. Adjustment required to plumb

Resting position of door due to not being plumb

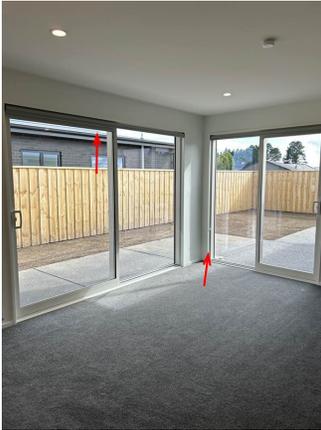
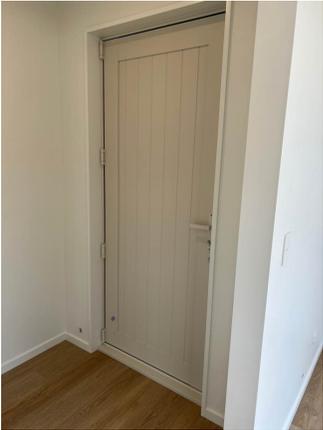
Aluminium front door and 2 ranch sliders - minor imperfections as per photos

Small paint marks on door

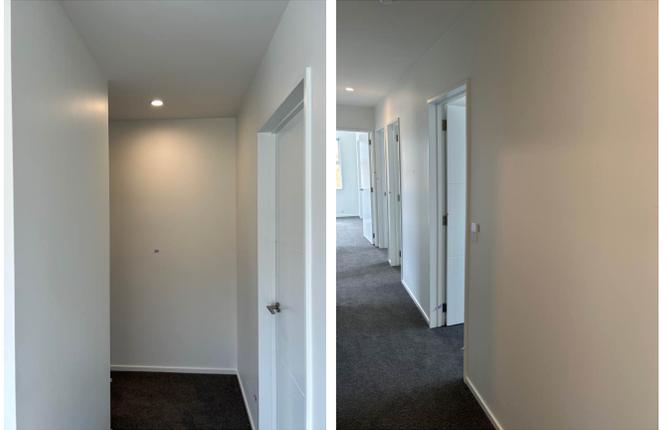
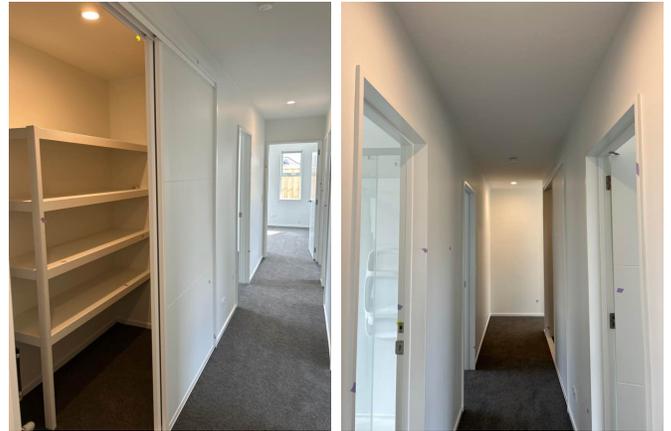
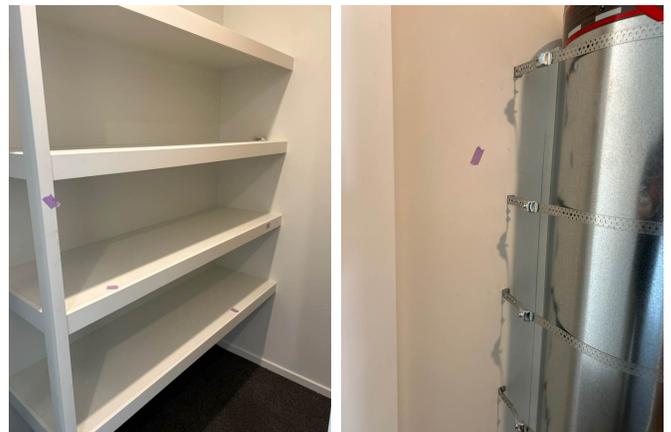
Gib walls and ceiling with paint finish - minor imperfections as marked with tape

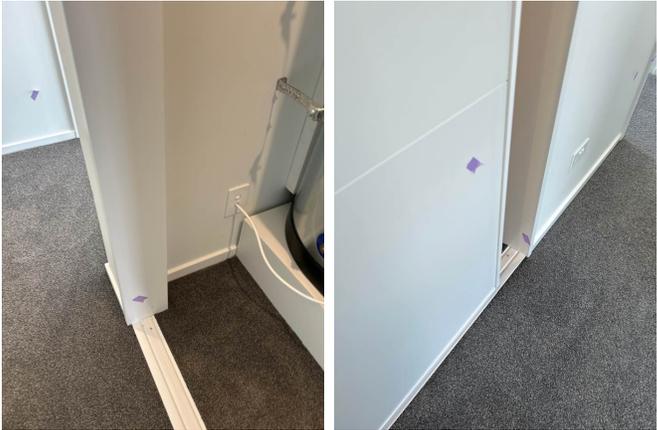
Small mark on HWC reveal

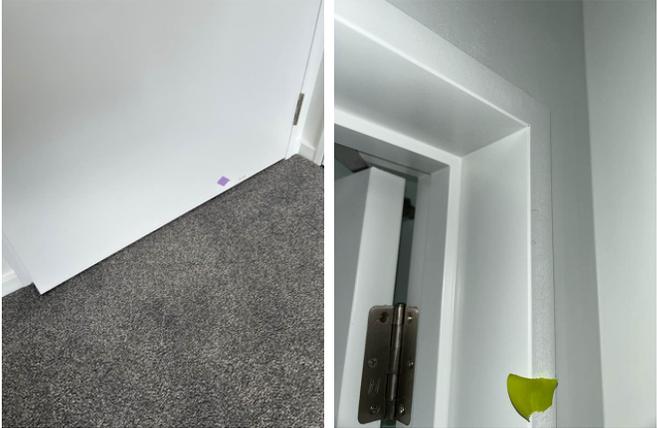
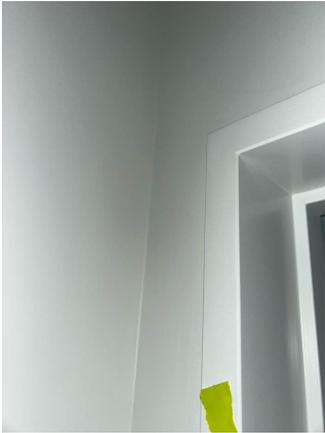
Small mark on main door. Inside of reveal has only received top coat to eye level, the entire reveal requires painting (including above eye level)

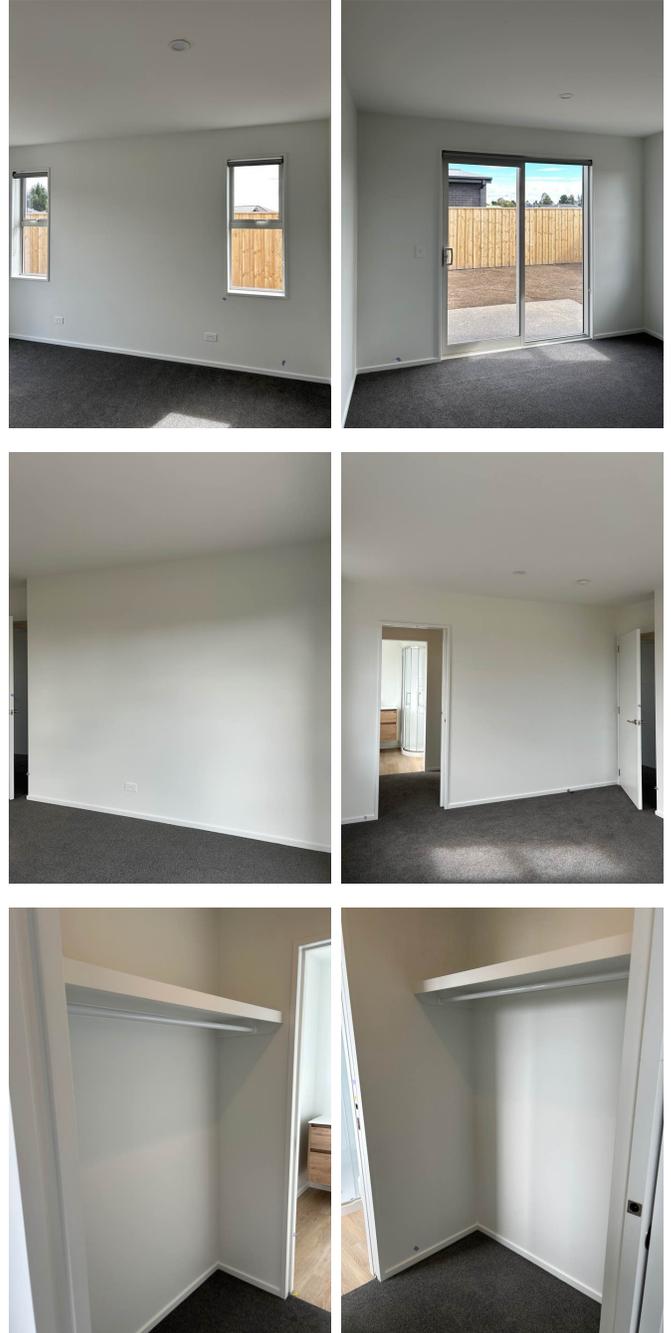
Gib walls and ceiling with paint finish - minor imperfections as marked with tape

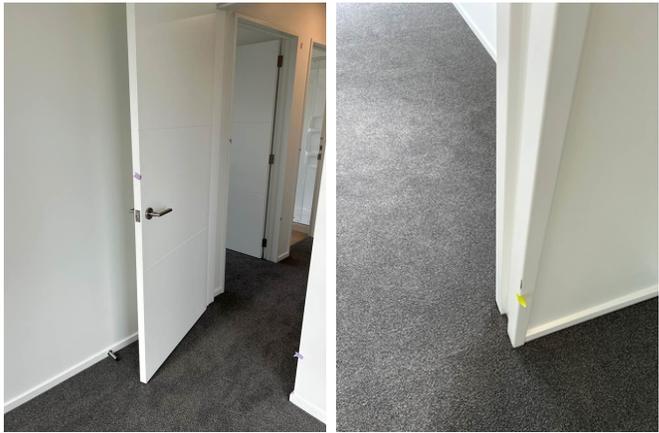
Minor marks on main door and cavity slider reveal

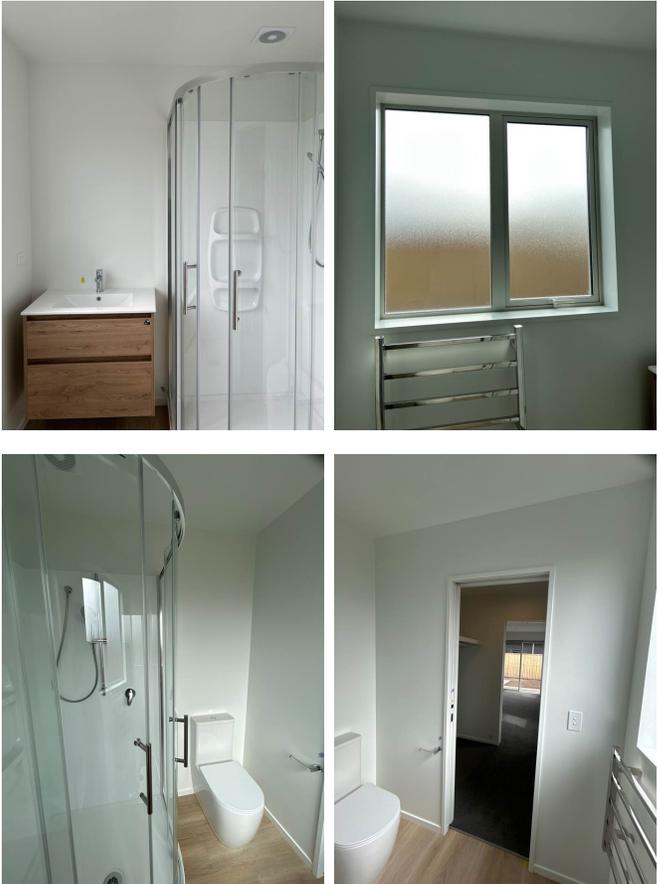
Gib walls and ceiling with paint finish - minor imperfections as marked with tape

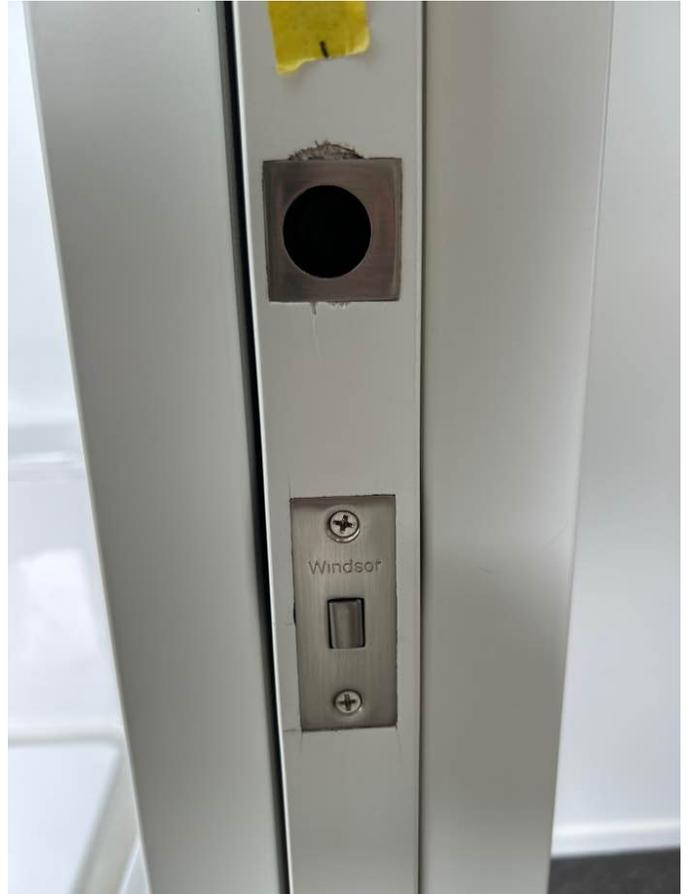
Imperfections around cavity slider handle

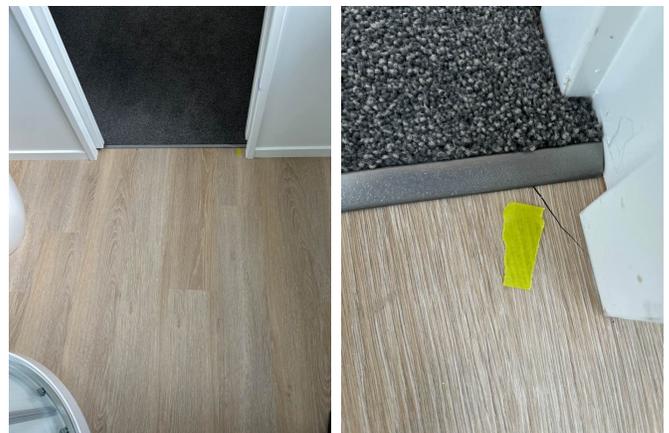
Vinyl flooring - piece of vinyl has split at carpet/vinyl junction

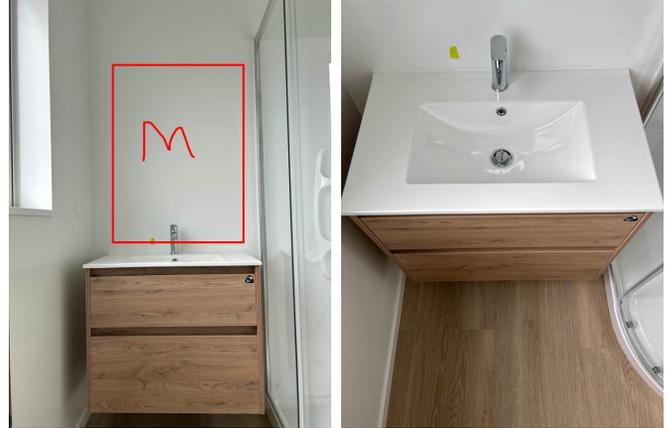
Melamine vanity - mirror to be fitted

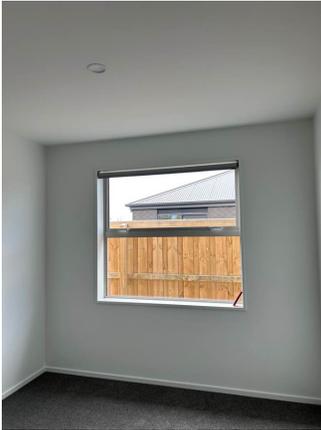
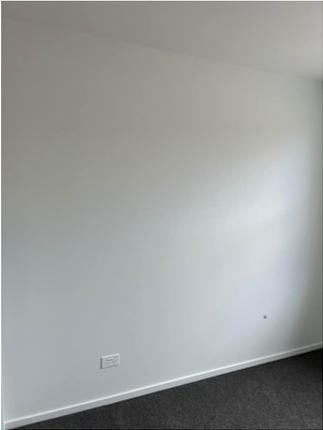
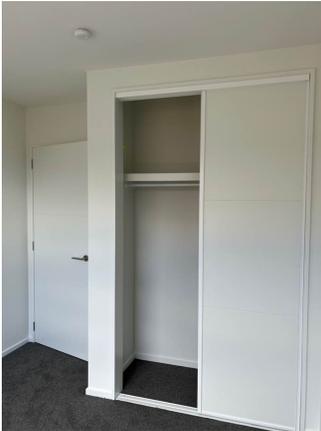
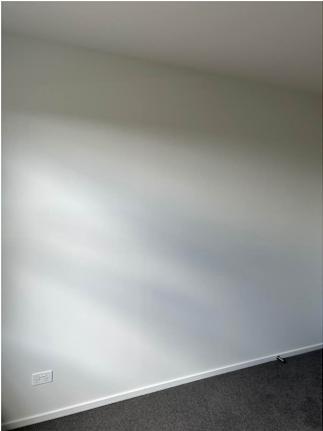
Gib walls and ceiling with paint finish - minor imperfections as marked with tape

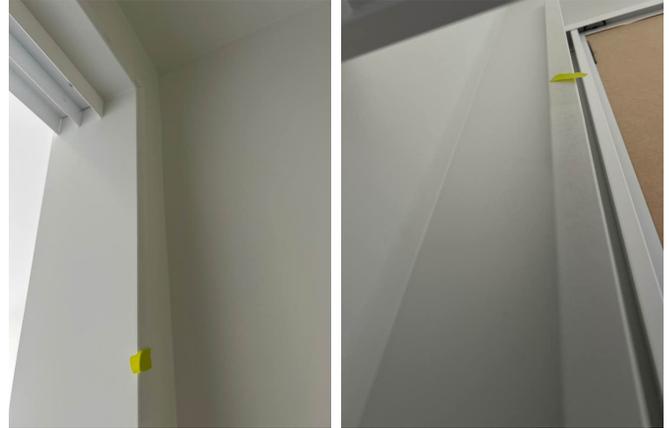
Incomplete top coat on inside of wardrobe reveal, currently only painted to eye level with primer above

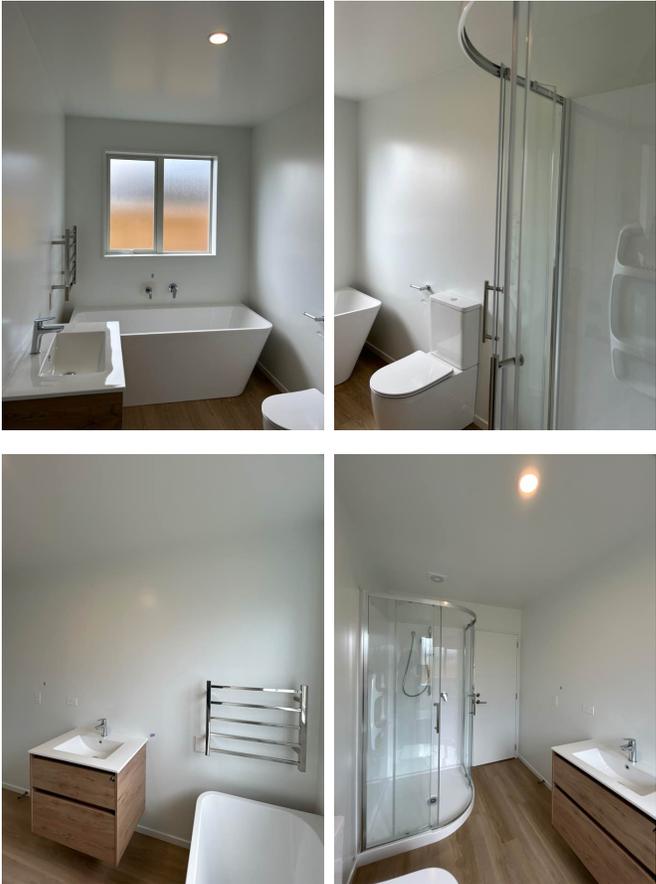
Gib walls and ceiling with paint finish - minor imperfections as marked with tape

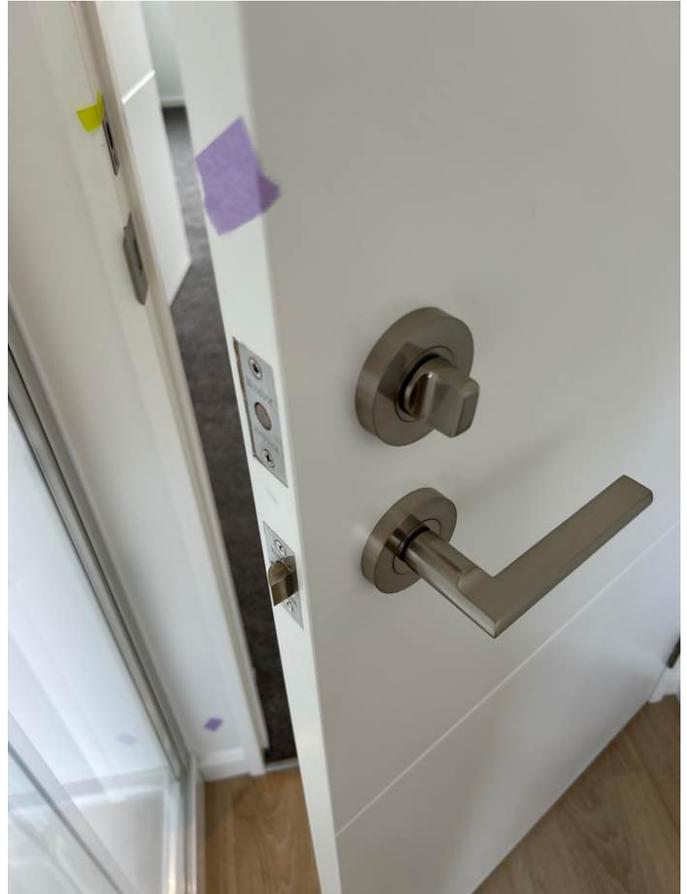
Minor imperfections to door. Locking mechanism is excessively firm to operate, adjustment required

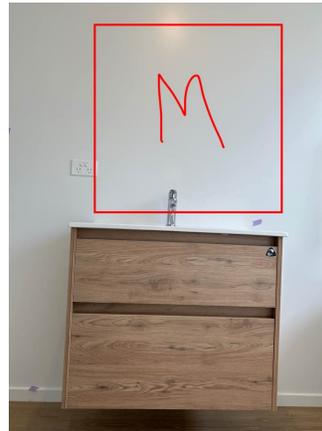
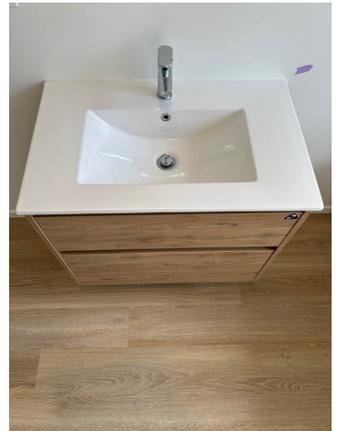
Melamine vanity - mirror to be fitted

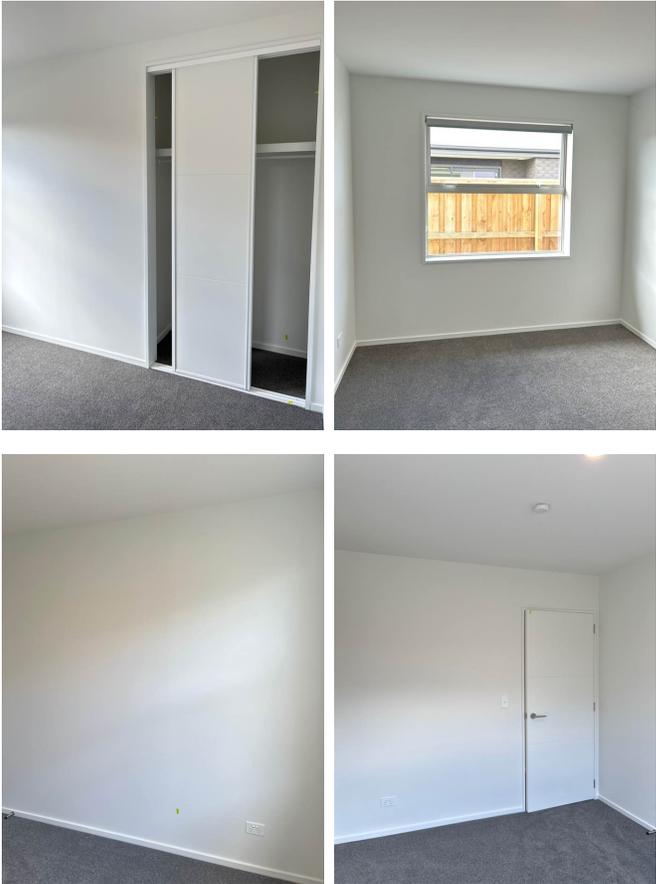
Gib walls and ceiling with paint finish - minor imperfections as marked with tape

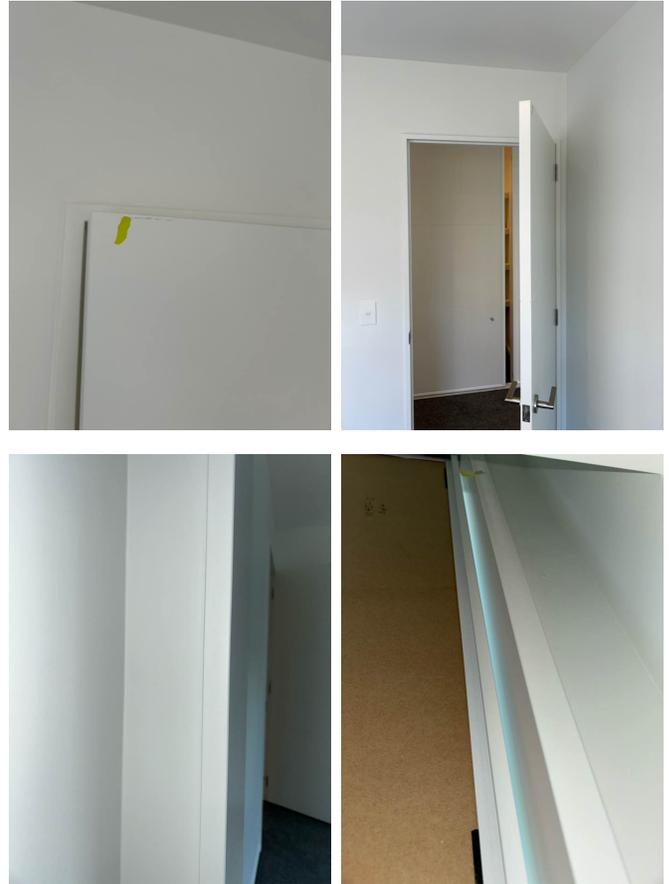
Minor mark on door. Incomplete painting on inside of wardrobe reveal, top coat not applied yet

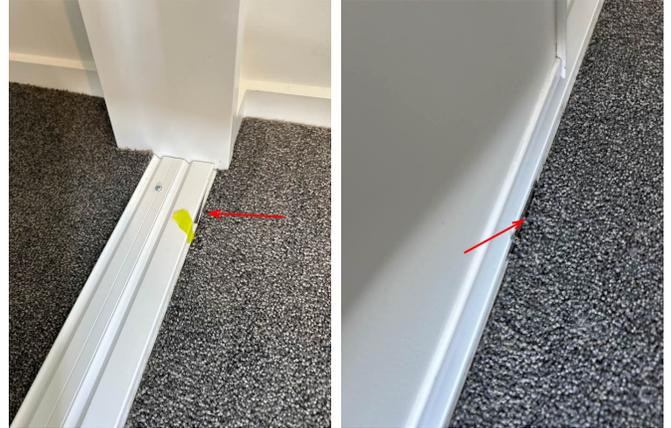
Small pieces of exposed malthoid packers

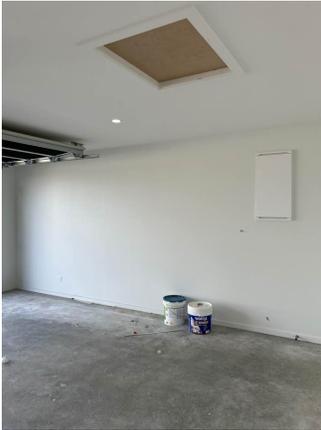
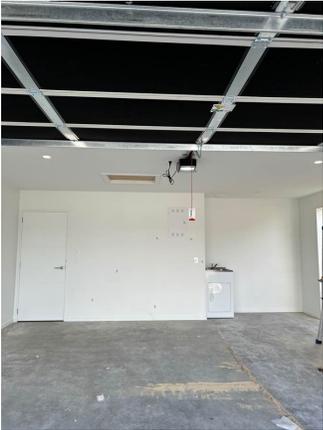
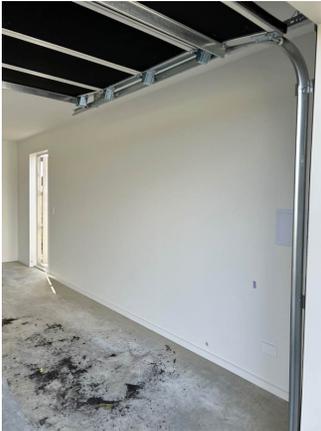
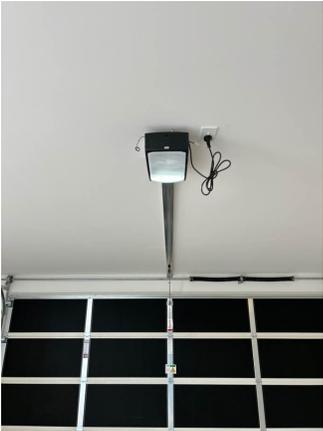
Gib walls and ceiling with paint finish - minor imperfections as marked with tape. Manhole cover to be painted

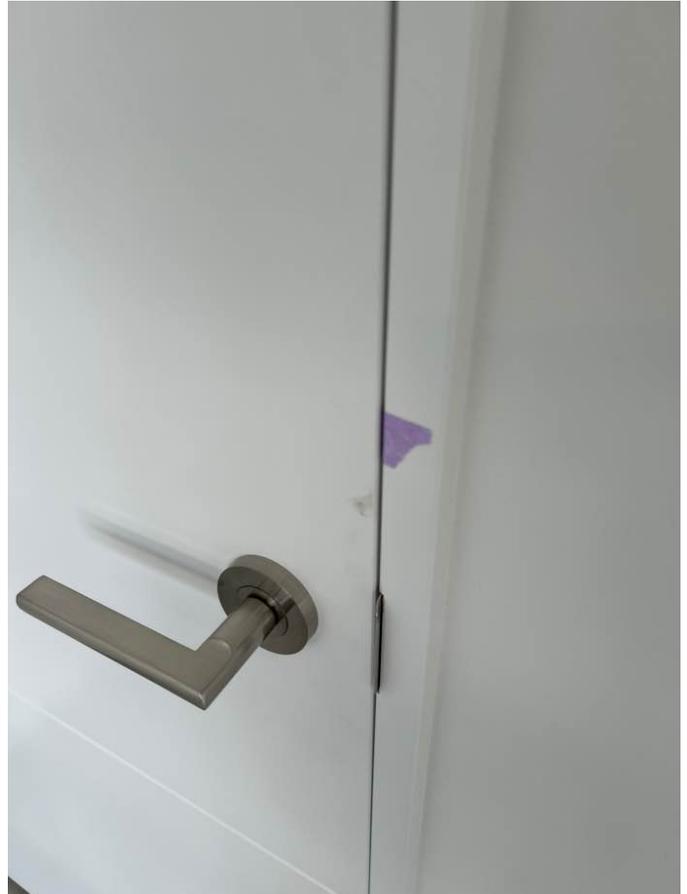
Minor marks
