# INFORMED PROPERTY INSPECTIONS

Name: Kyle Brookland  
Phone: 021 298 7395  
Email: [kyletheinspector@gmail.com](mailto:kyletheinspector@gmail.com)  
Date: 18/12/2025  
Time: 3:30 pm.  
Weather Conditions: Fine.  
Site Address: Christchurch  
Requested By: Sample Report.

## Summary

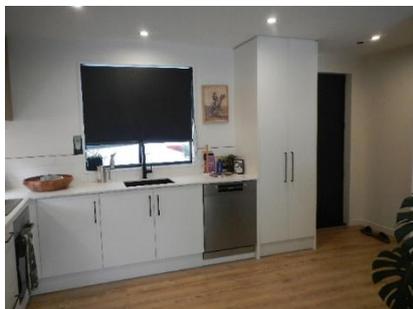
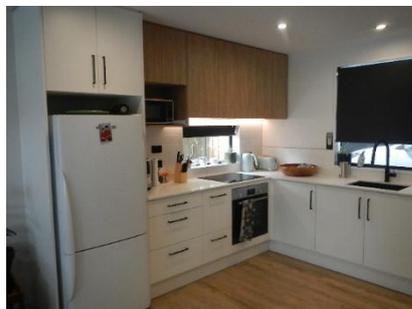
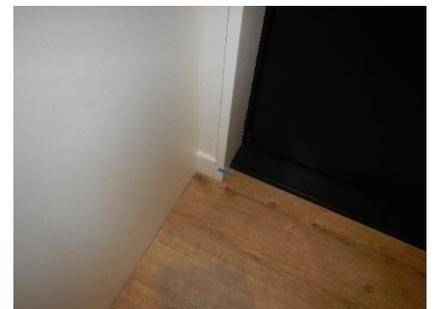
## Kitchen & Entry

Walls: Minor gaps are present at the trim at the left hand side of the door to the exterior.

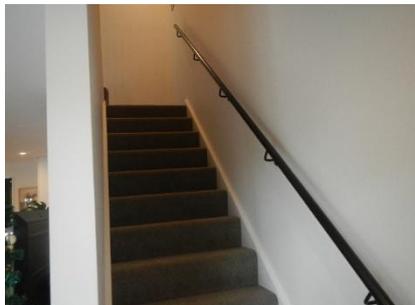
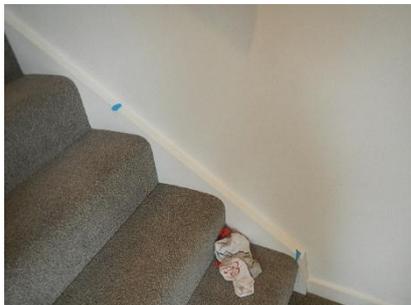
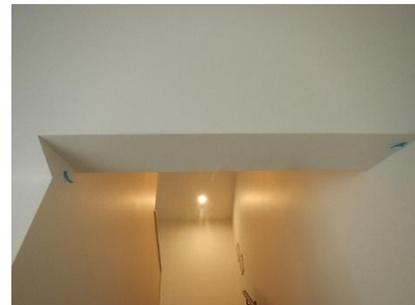
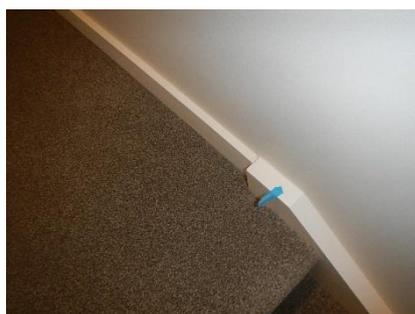
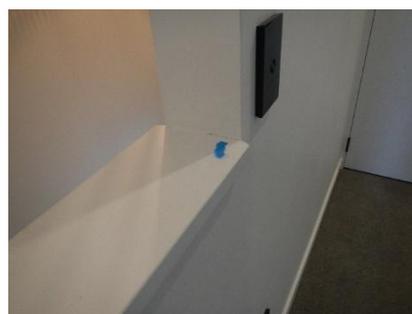
## Stairs & Hallway

Cracking is present at the wall to ceiling junction at the base of the stairs.  
Cracking is present at the end of the low height wall.  
Cracking is present at the ribbon board.

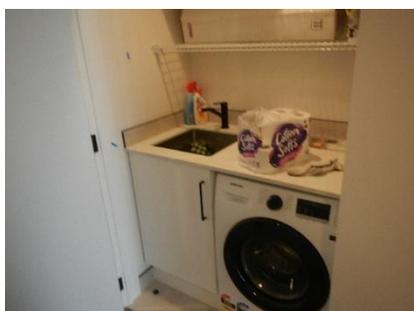
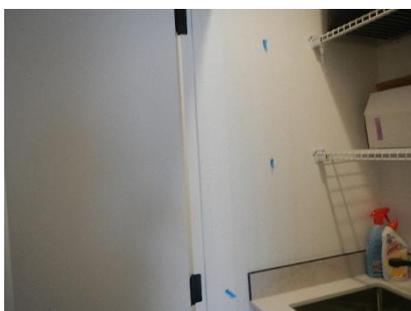
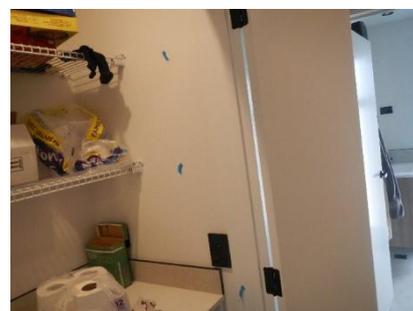
## Laundry

Raised fixings are present bordering on bedrooms one and two.

Raised fixings are present on the door frame.

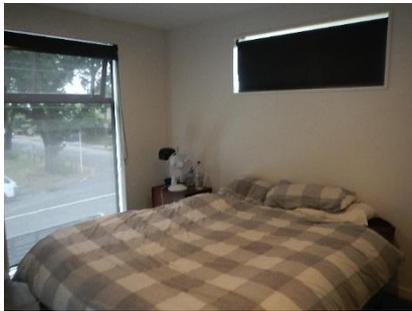
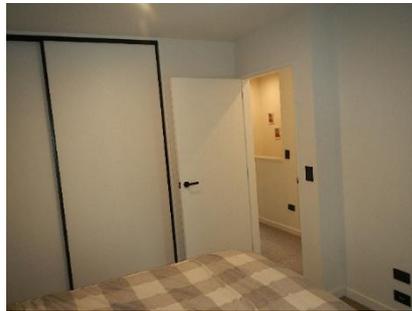
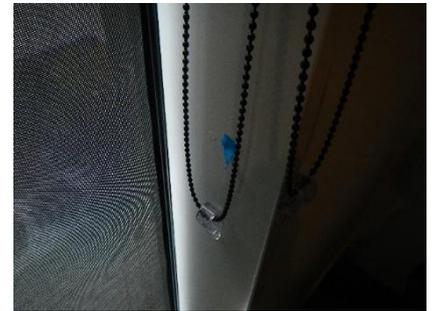
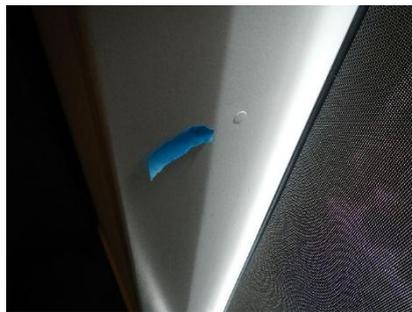
## Master Bedroom

Windows: Raised fixings are present on the window frame.

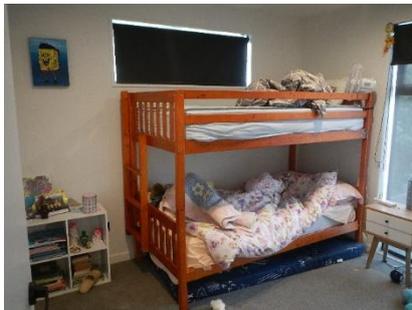
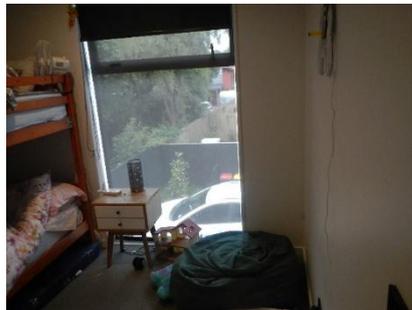
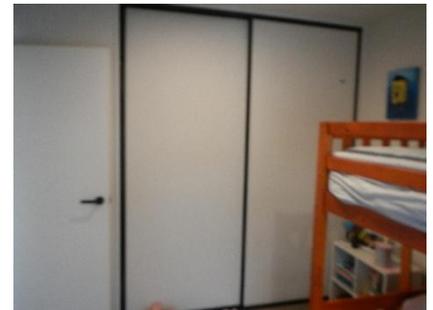
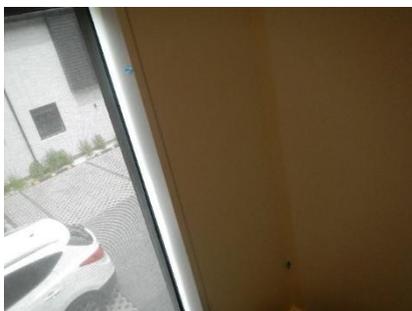
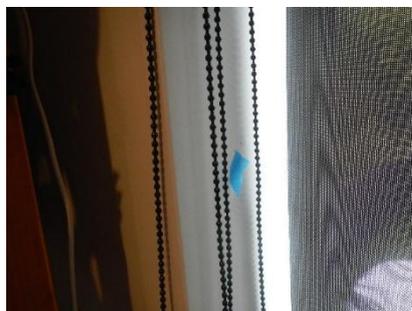
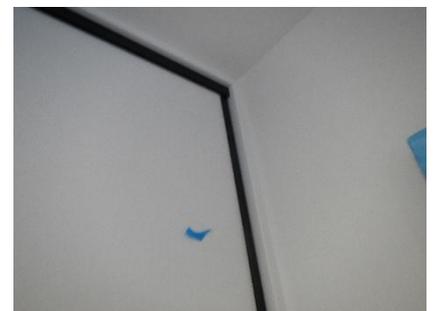
## Bedroom Two

Walls: Minor cracking is present at the corner to the right hand side of the window.

Doors: Minor cracking is present in the mitres of the door frame leading to the hallway and the wardrobe.

Windows: Minor raised fixings are present on the frame.

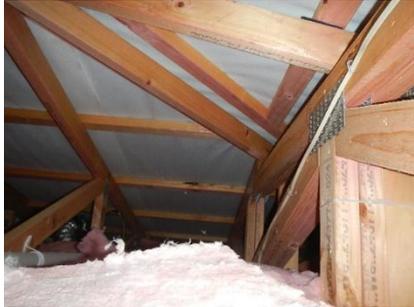
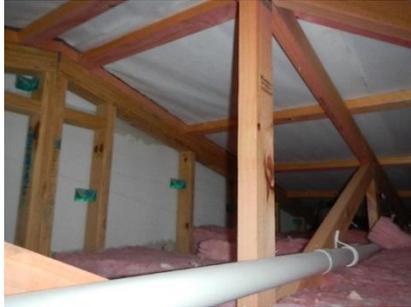
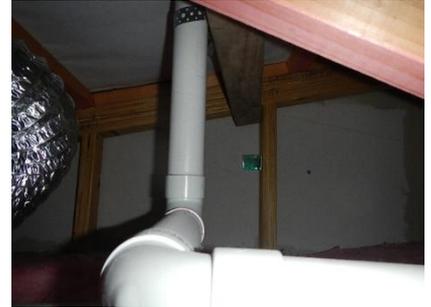
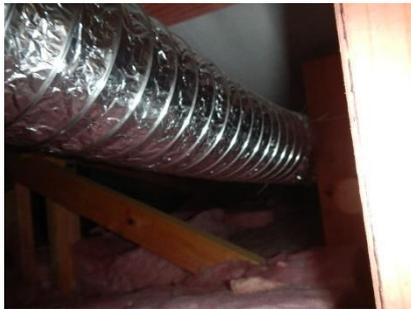
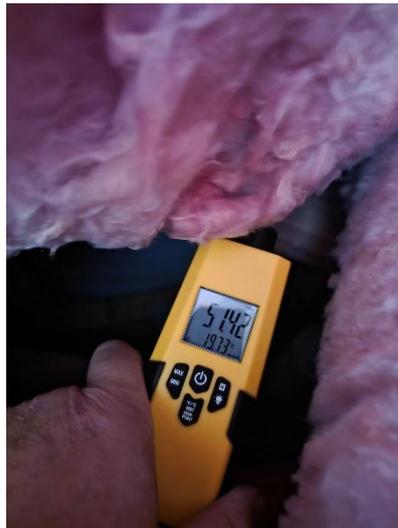
## Ceiling Cavity

Humidity: 51.42 Relative humidity.
