# Property Re-Inspection Report

**Property Address:**  
123 Sample St - Maintenance report

**Date:**  
October 16th 2025 12:00

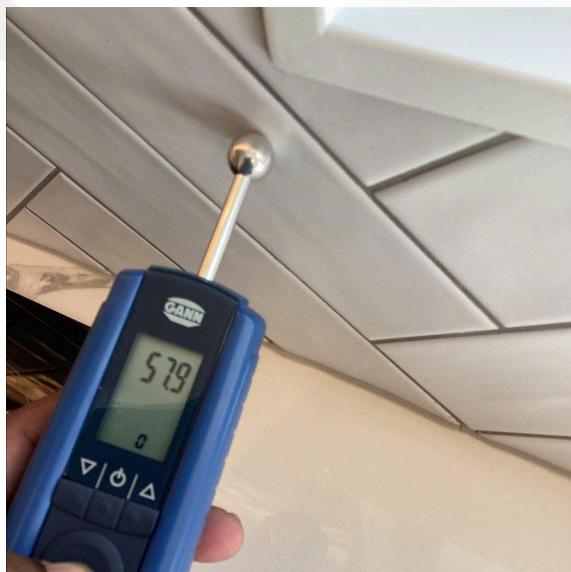
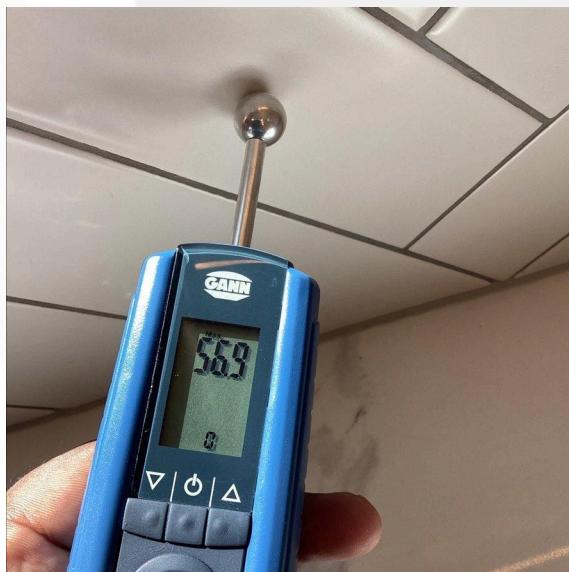
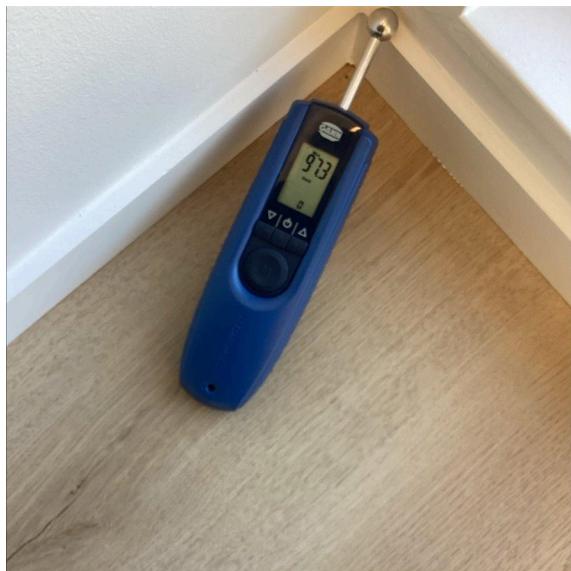
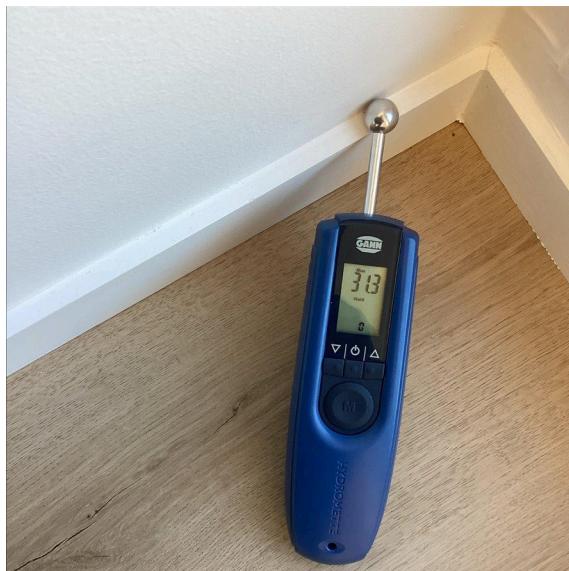
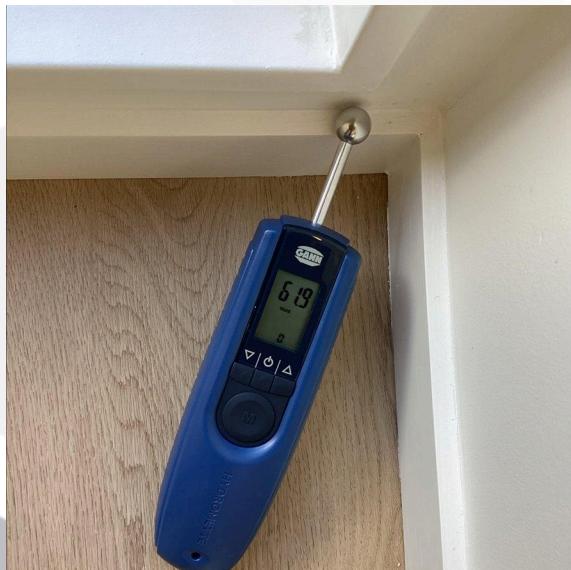
Moisture readings are still high on left side of the sliding door.

- 1) The light is still not functional.
- 2) The gaps on left side of the lounge door is sealed
- 3) Scratches are rubbed. Not visible
- 4) Re-grouting to achieve good finish not done. This was just a recommendation only.
- 5) The windows are sealed under.
- 6 ) Moisture readings have been taken too the the corners of kitchen window. Readings are not high. Reading show damp. This may be because of grout behind the tiles and still drying up.
- 7) Cleaning is done.
- 8) Moisture reading still high on left side of the lounge door.

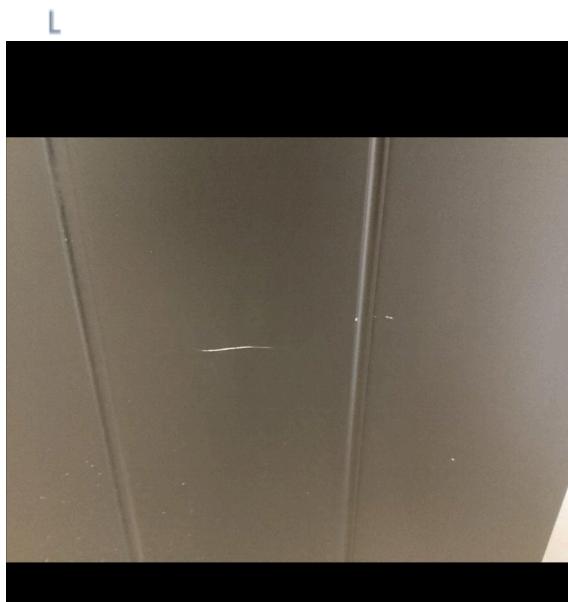
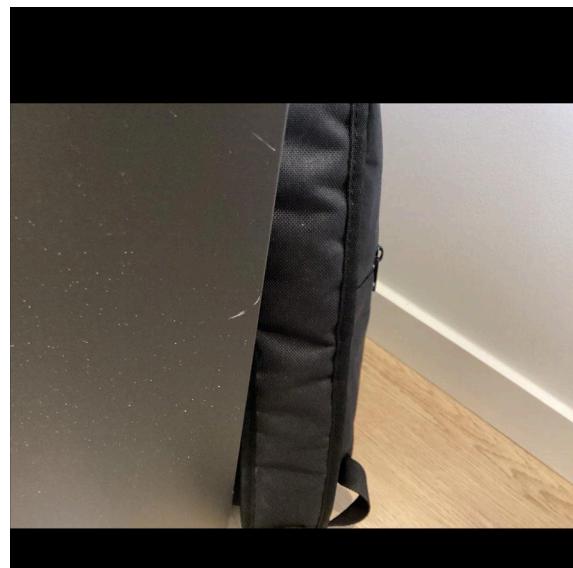
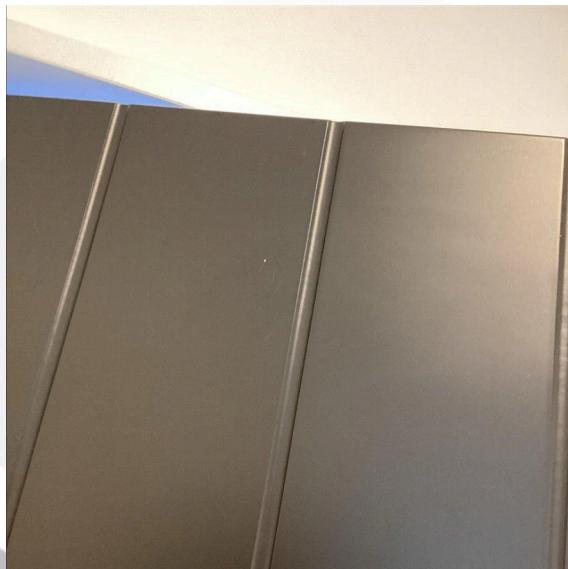
- 1) Scratches are still on the front door.

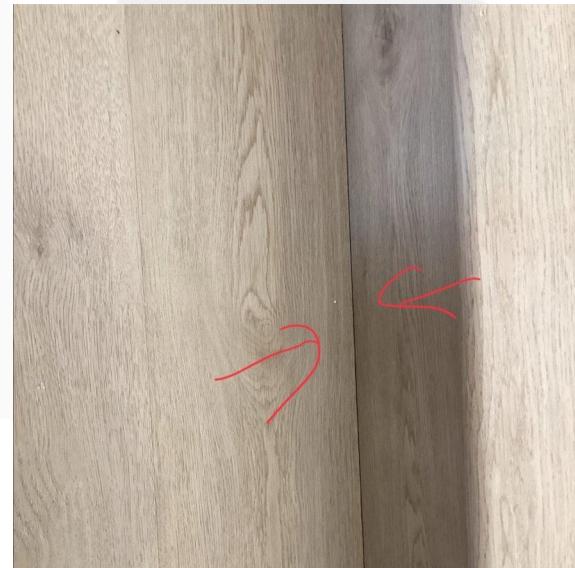
**Significance:** Minor

**Comment:** Seal the gap in between the steps.

- 1) The gaps have been sealed.

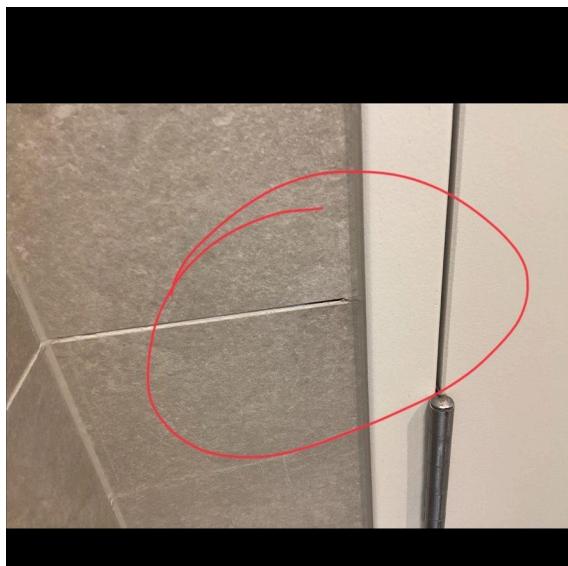
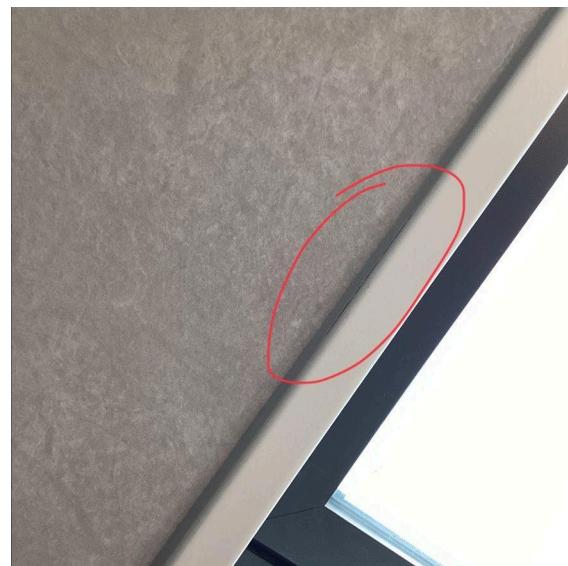
**Significance:** Minor

**Comment:** Grout gap noted.

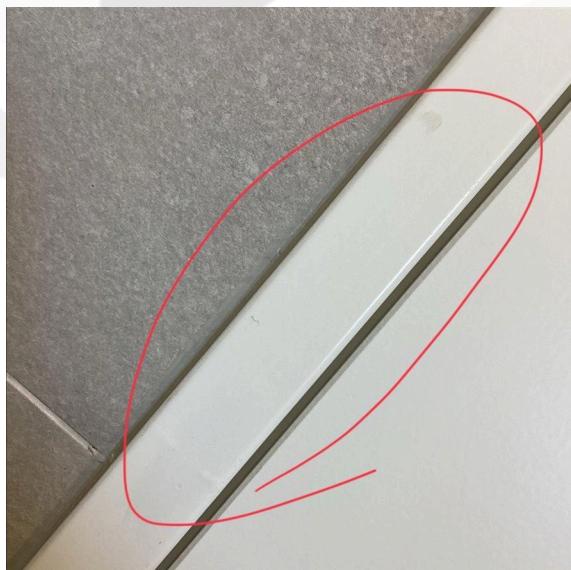
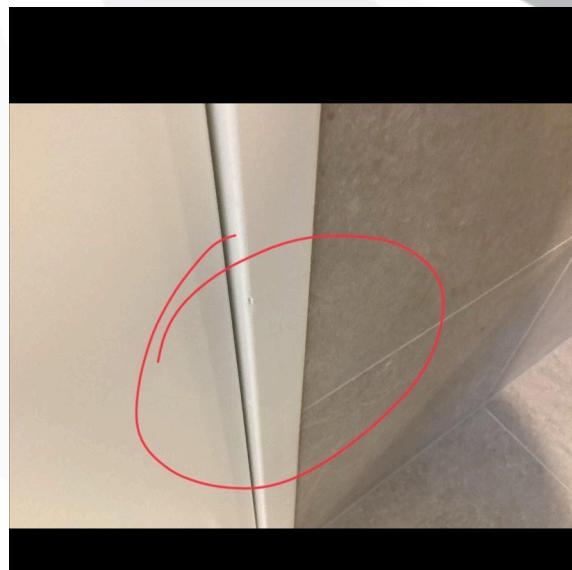
**Significance:** Minor

**Comment:** Paint touch-ups are required.

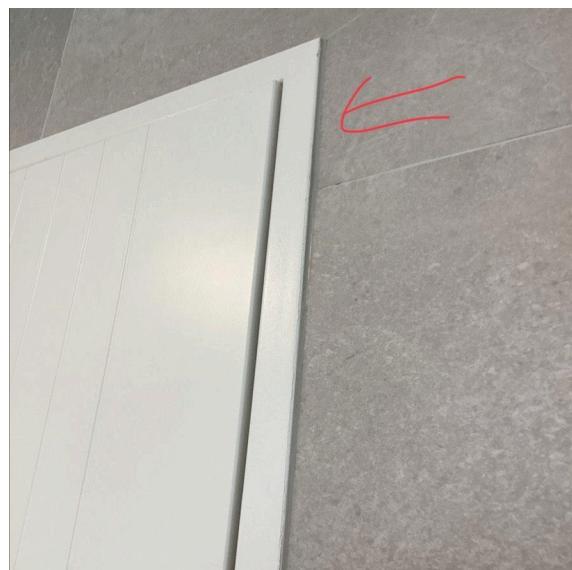
**Significance:** Further Investigation - Suitably qualified trades person

**Comment:** Door requires adjustment it is little outward from the top.

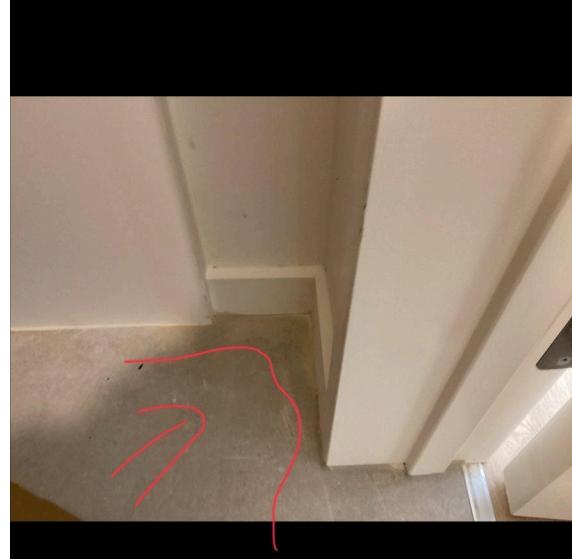
**Significance:** Minor

**Comment:** Clean the tiles.

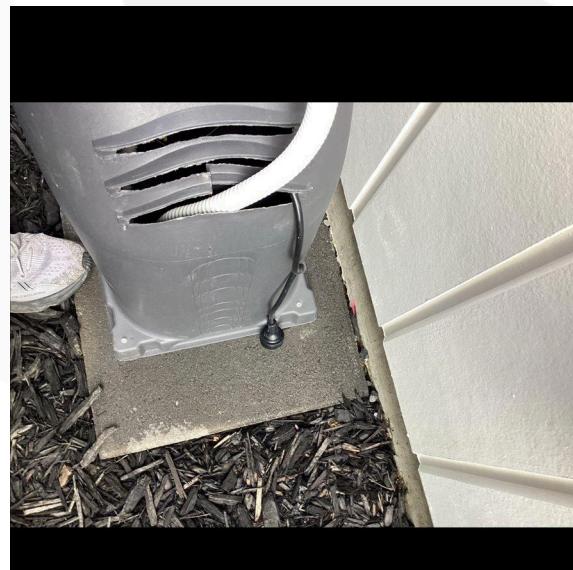
- 1) The strap is still loose on the HWC.
- 2) The heat pump is not connected to power.

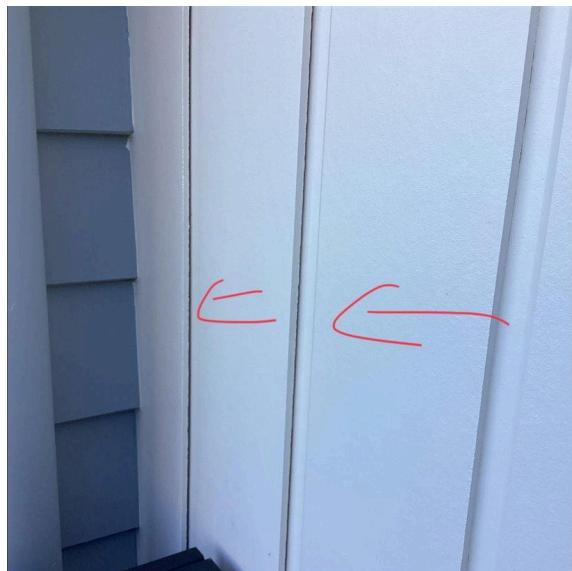
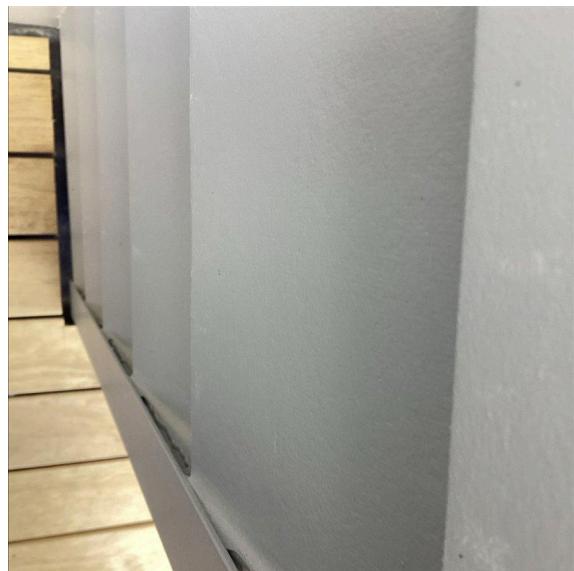
**Significance:** Minor

**Comment:** Paint touch ups

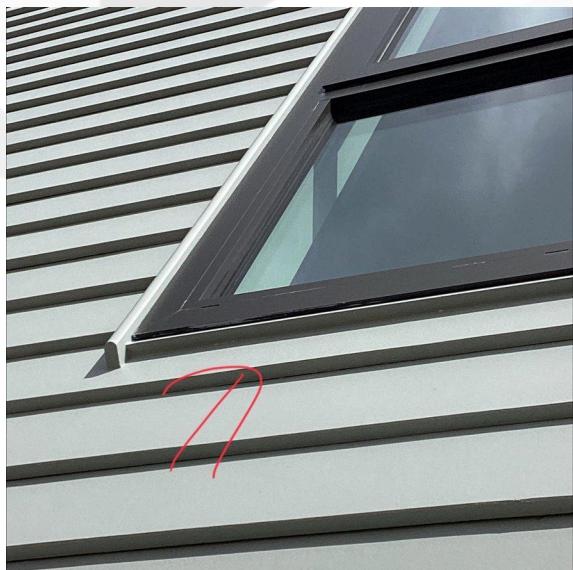
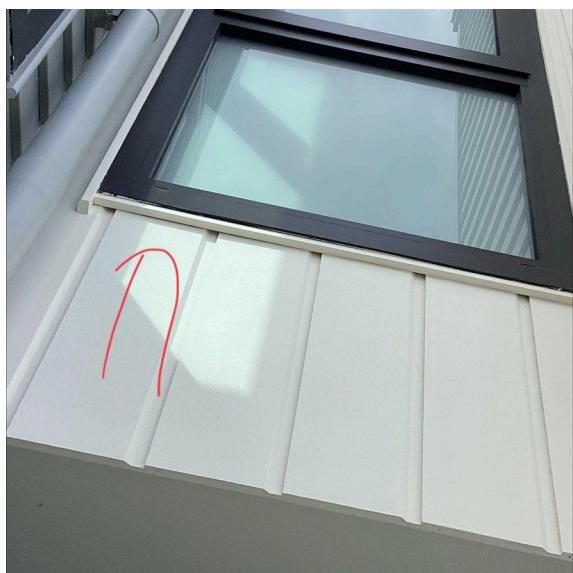
**Significance:** Further Investigation - Suitably qualified trades person

**Comment:** Paint gaps are still there on joinery.

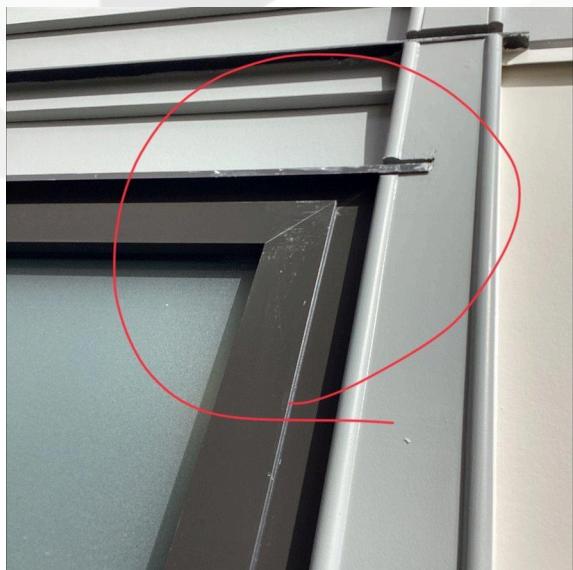
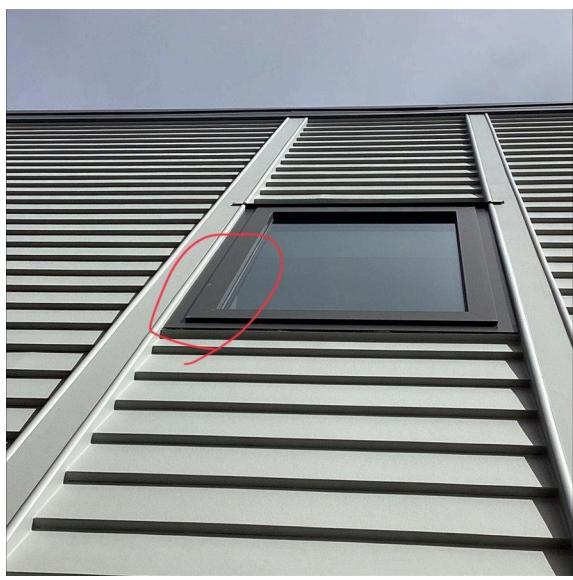
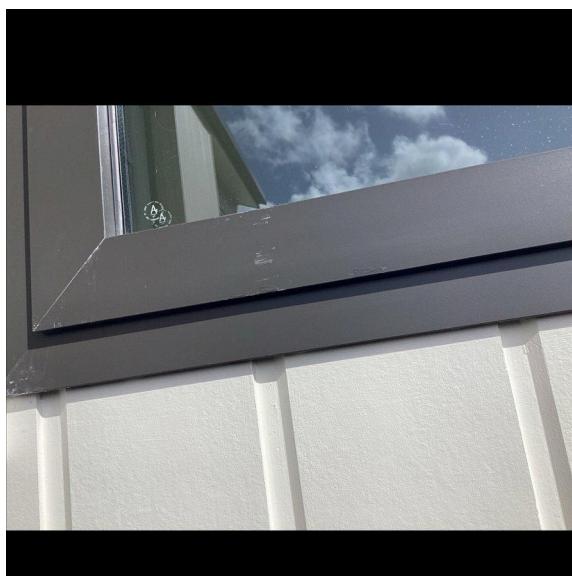
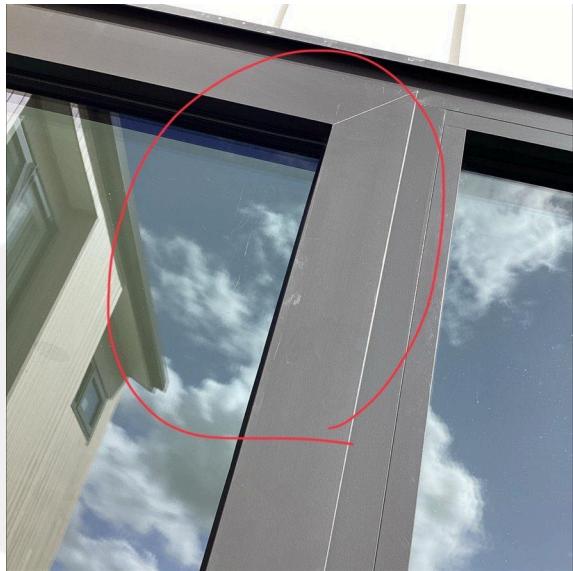
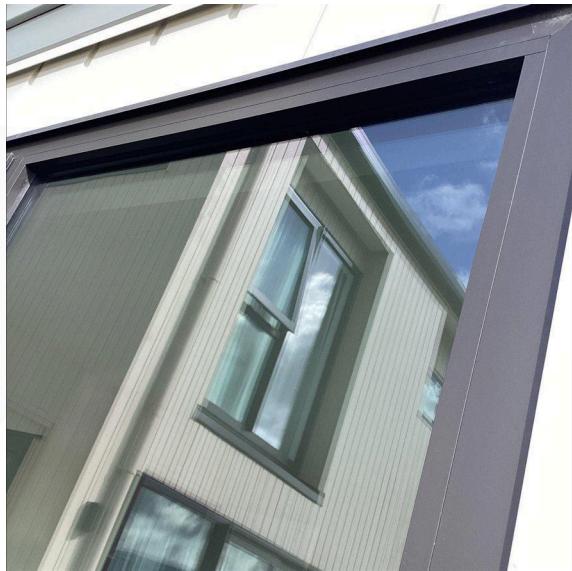
**Significance:** Further Investigation - Suitably qualified trades person

**Comment:** Paint mark are still there on joinery.

This is because painted not using marking tape while painting.

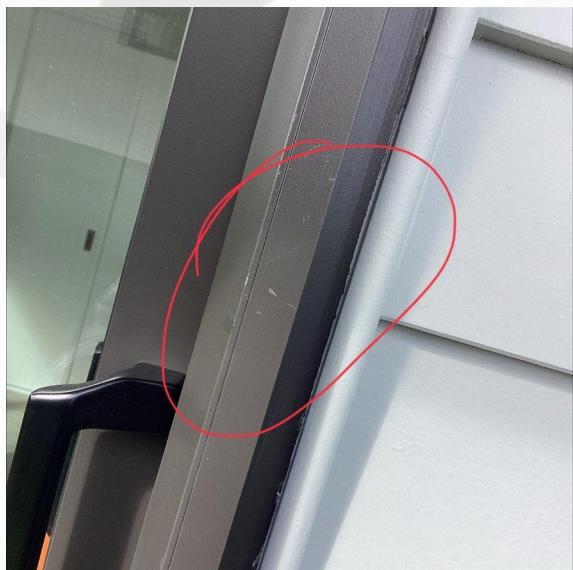
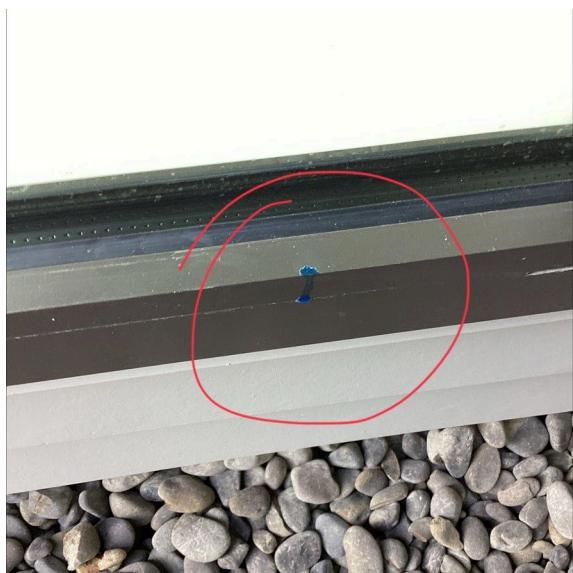
**Significance:** Further Investigation - Suitably qualified trades person

**Comment:** Photo 2 photos bathroom window requires cleaning.

Photo 3 red photo kitchen window requires cleaning.

Photos 4,5 & 6 scratches noted to glass and window frame of bedroom 2.

Photos 8 & 9 photo scratched noted to bed room 2 door

Clean bedroom 2 window.

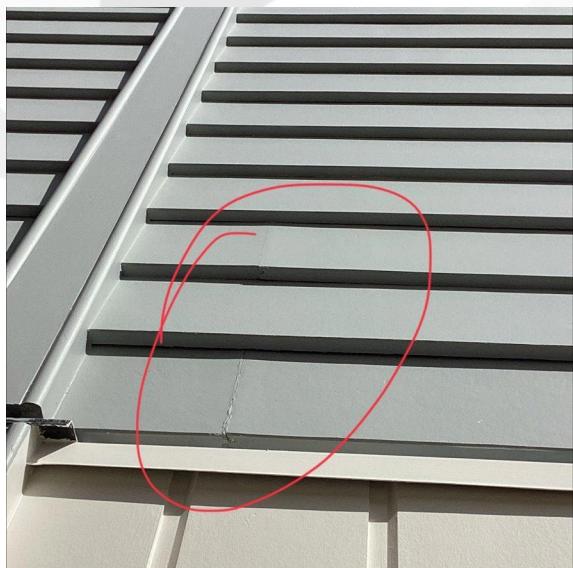
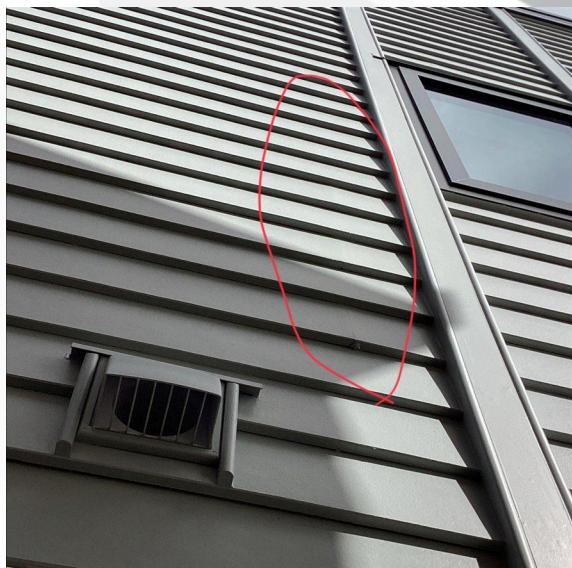
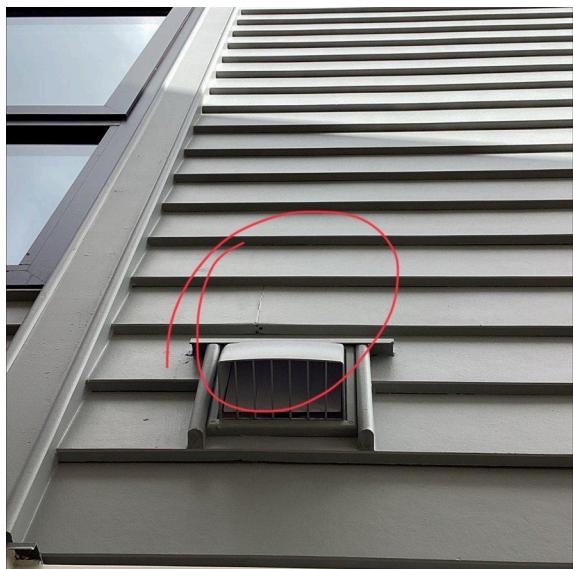
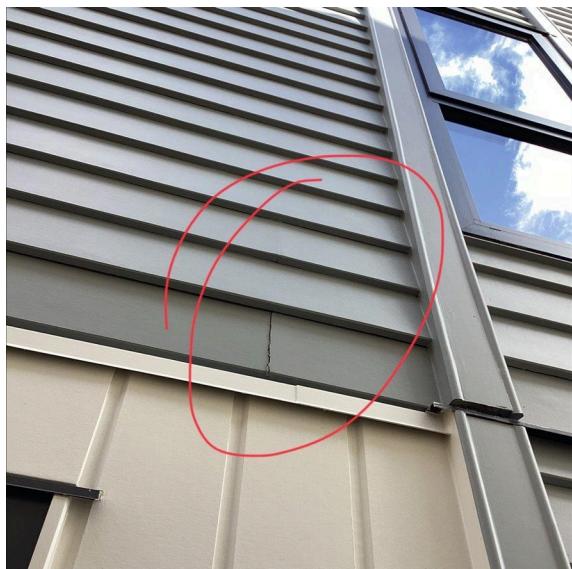
**Significance:** Further Investigation - Suitably qualified trades person

**Comment:** Marks still on the cladding.

Paint touchups not done to downpipes

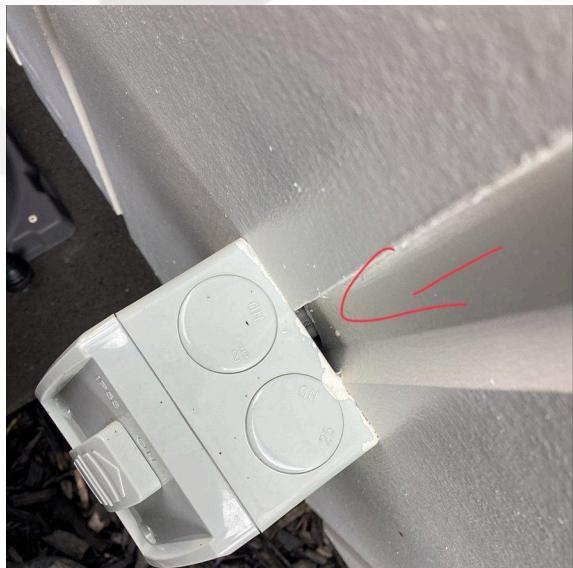
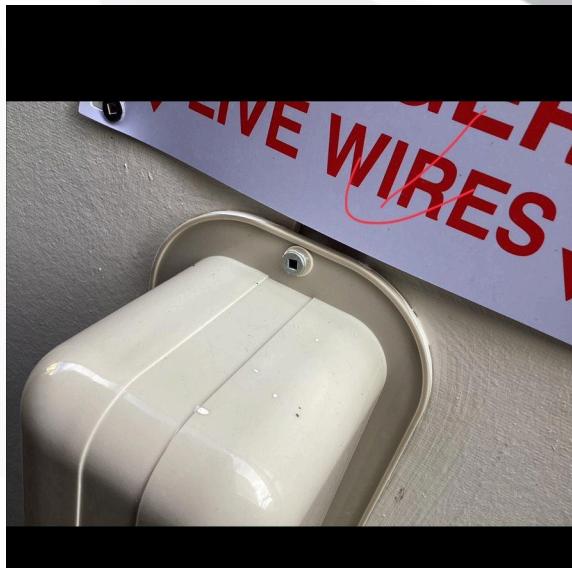
**Significance:** Further Investigation - Suitably qualified trades person

**Comment:** Crack are still there.

Photo 2 gaps have been sealed.

Photo 3 cracks are still there.

Photo 4 cracks are still there.

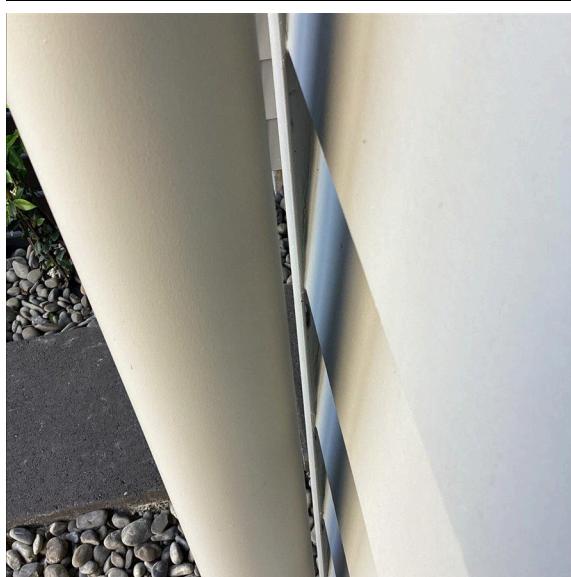
**Significance:** Minor

**Comment:** Seal the gap with silicon not done.

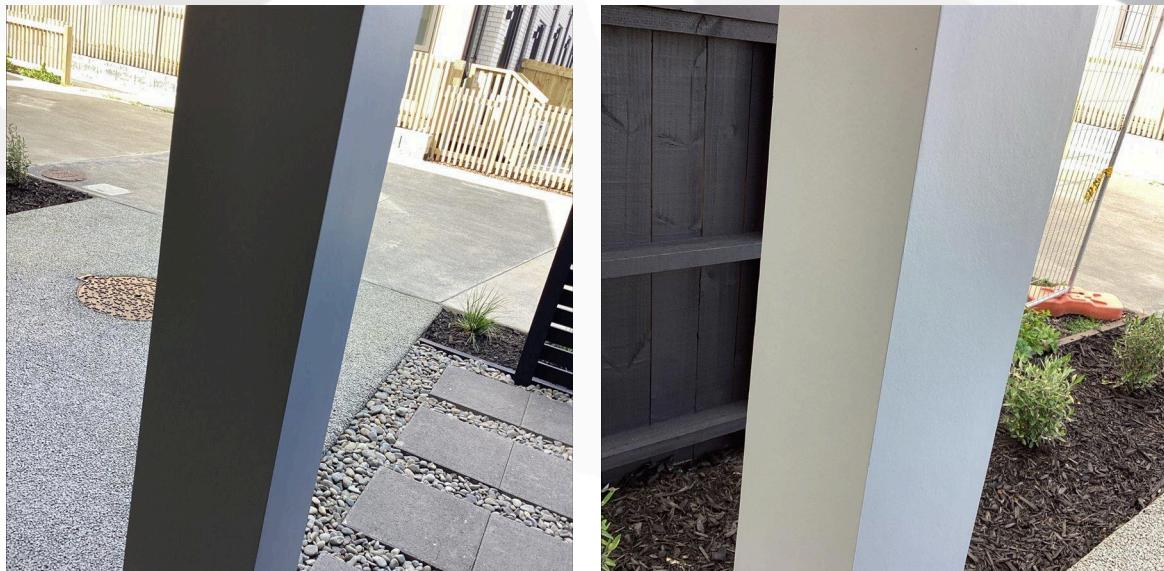
**Significance:** Minor

**Comment:** Most of the gaps sealed but some are still there.

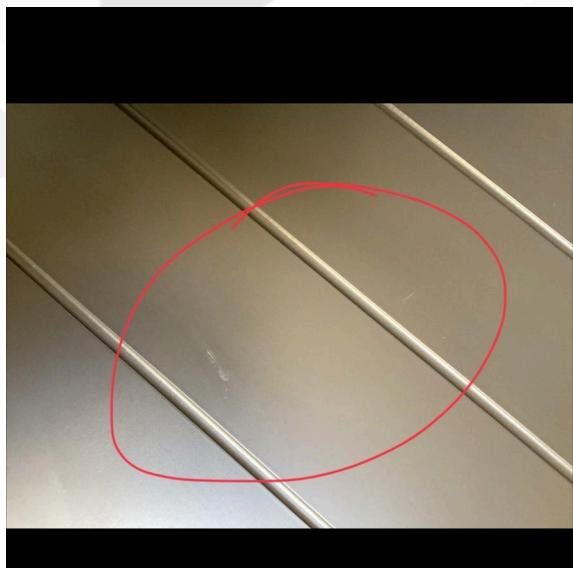
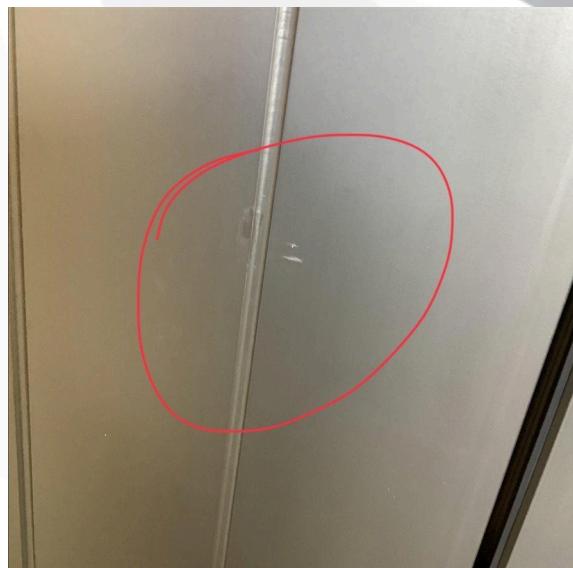
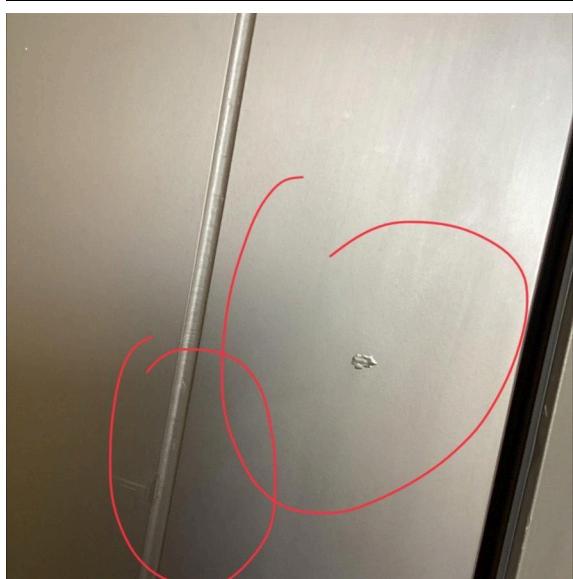
**Significance:** Minor

**Comment:** Gaps have been done

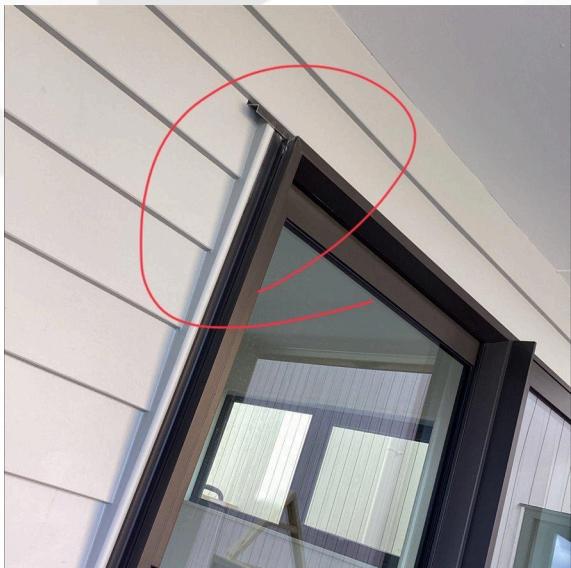
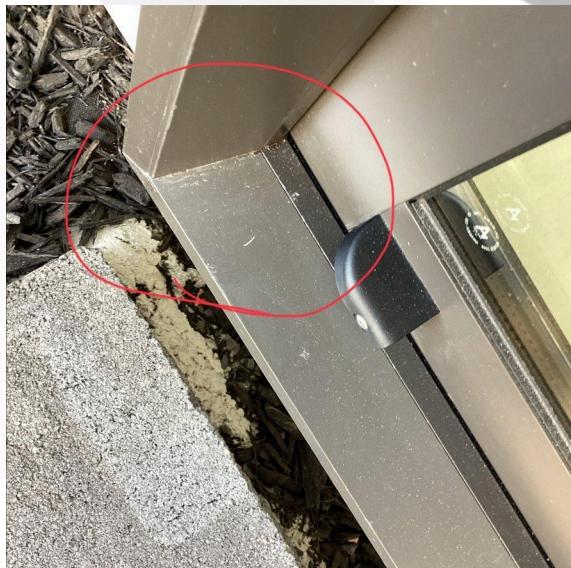
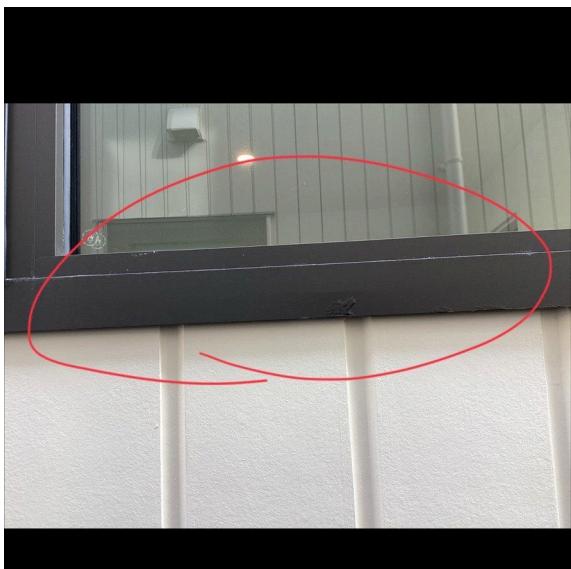
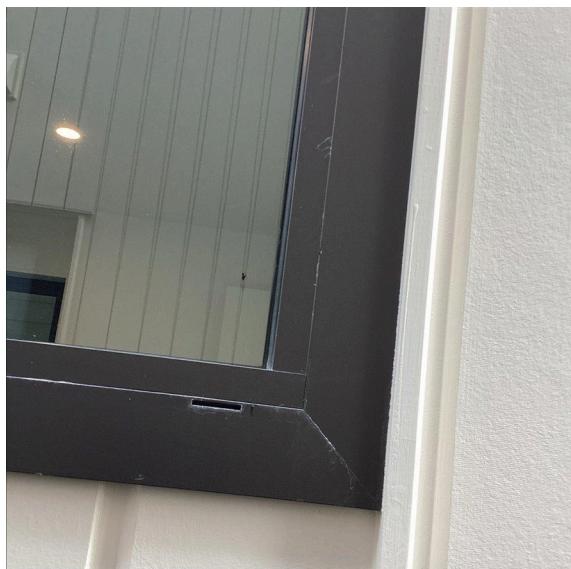
**Significance:** Minor

**Comment:** Scratches and marks noted to front door.

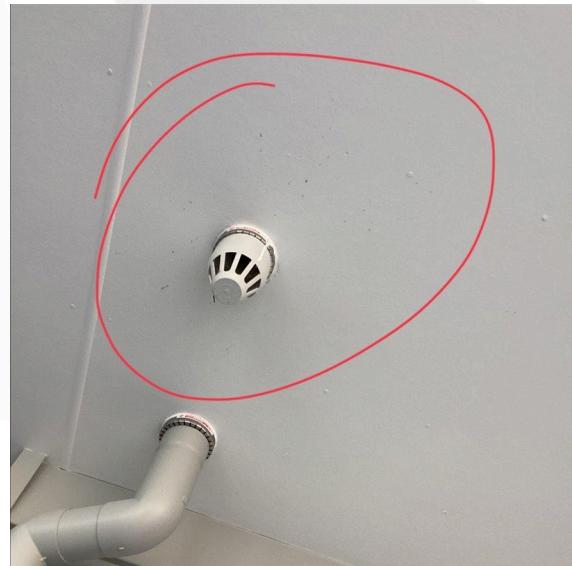
**Significance:** Minor

**Comment:** Paint touch-ups are required.
