RED LBP PRE-PURCHASE REPORT

PRE-PURCHASE

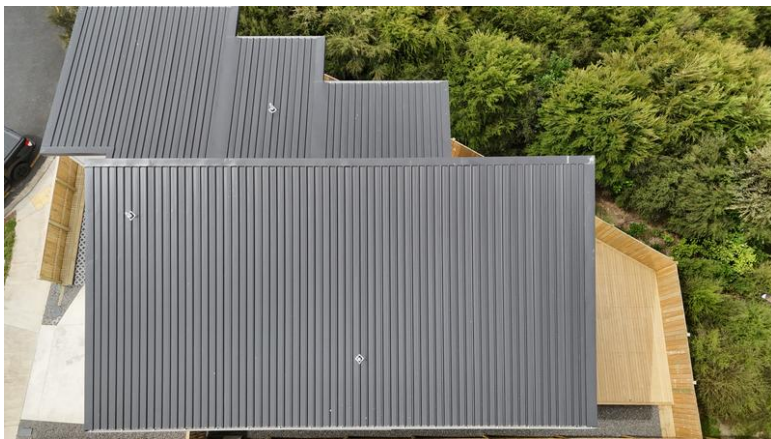
To maintain the weathertightness of the building, it is important to follow the manufacturer's guidelines for regular maintenance of the roofing system. This may include periodic inspections to identify any signs of damage, such as dents or missing fixings, surface deterioration or leaks. Promptly addressing these issues can prevent further damage and protect the building from the elements.

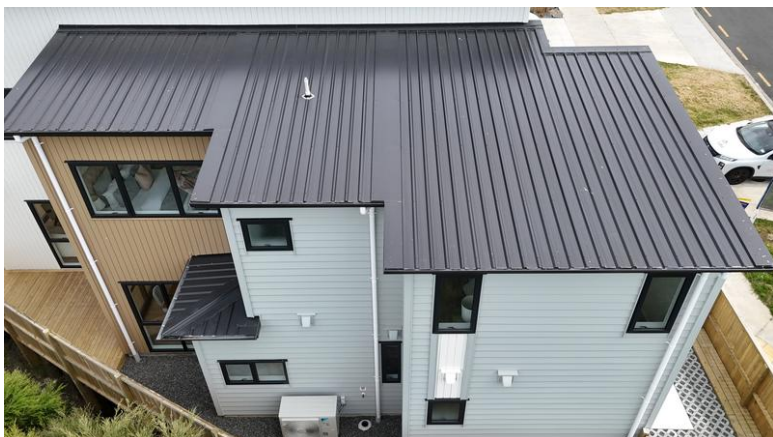
Photo 4
Profiled metal roof to the north side of the dwelling with a painted coating. No visible issues observed at the time of inspection.

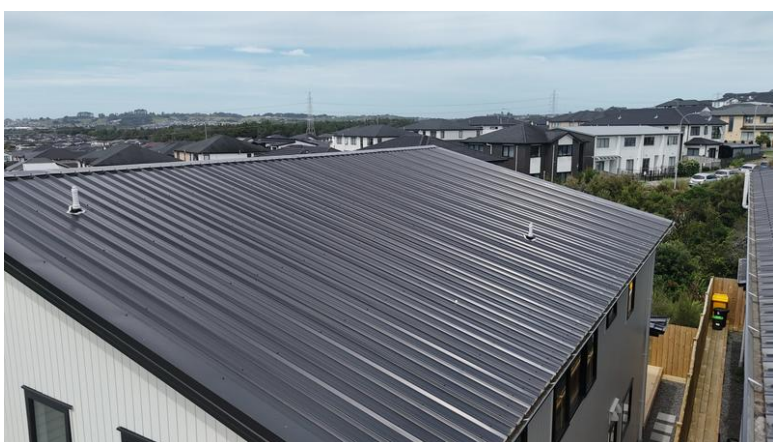
Photo 5
Profiled metal roof to the south side of the dwelling with a painted coating. No visible issues observed at the time of inspection.

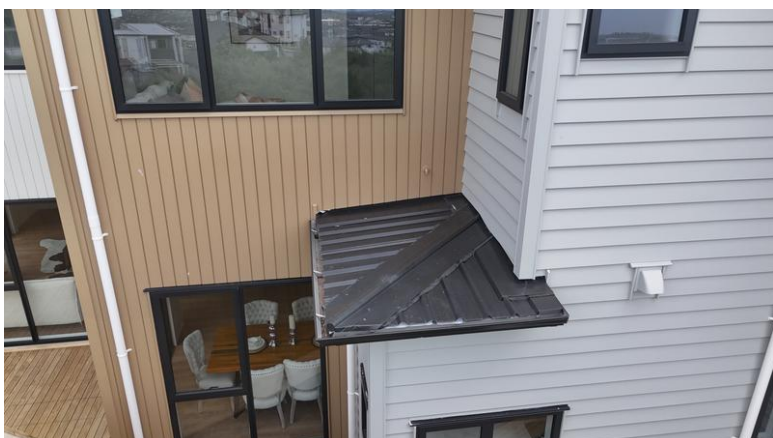
Photo 6
Profiled metal roof to the lower north side of the dwelling with a painted coating. No visible issues observed at the time of inspection.

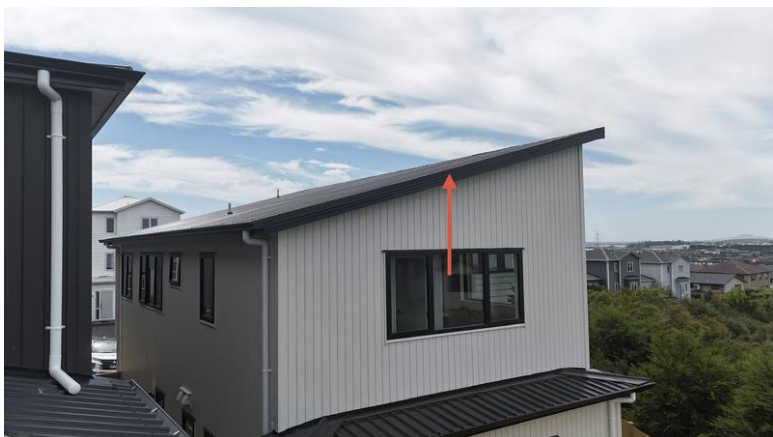
Signs of leaking - None visible at the time of the inspection.

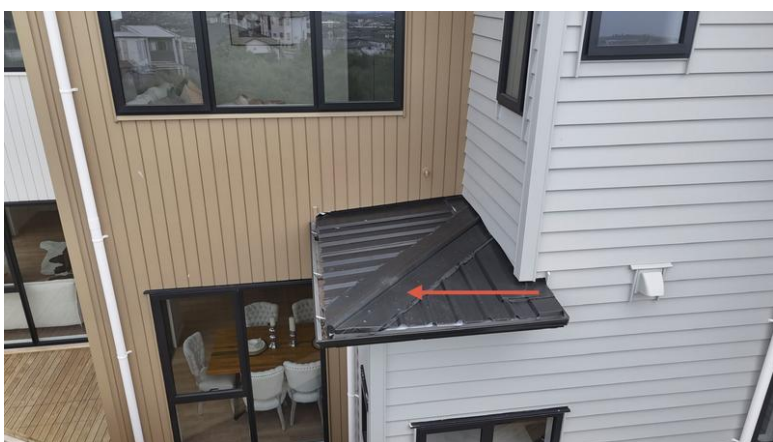
Barge flashings installed along the mono-pitch roof edges where the roof meets the vertical cladding, with no visible issues noted at the time of inspection.

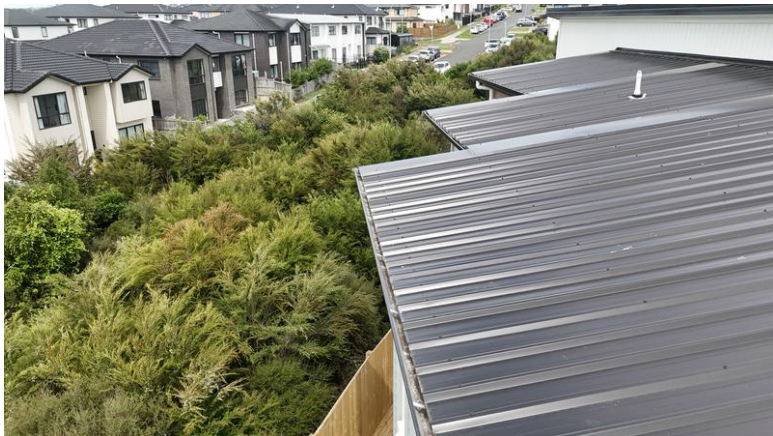
Photo 12
Gutters clear at the time of inspection.

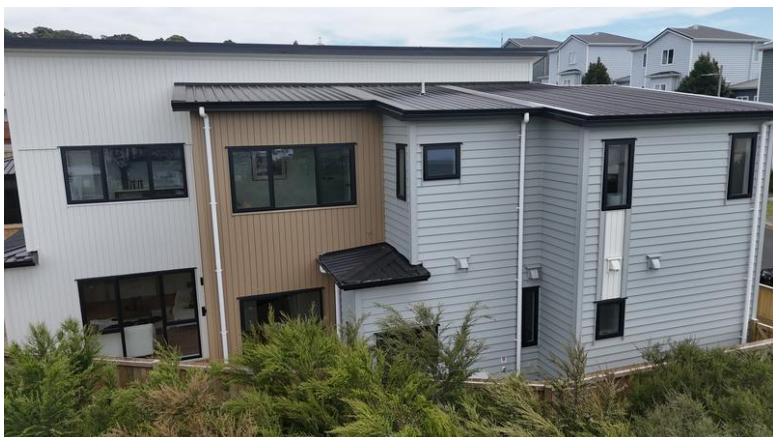
Regular maintenance is necessary to keep the exterior surfaces clean and free from grime and contaminants, especially in areas that are not typically washed by rain, such as below guttering and eaves. Failure to clean these surfaces can lead to accelerated deterioration of construction materials. It's important to schedule normal maintenance over the next few years.

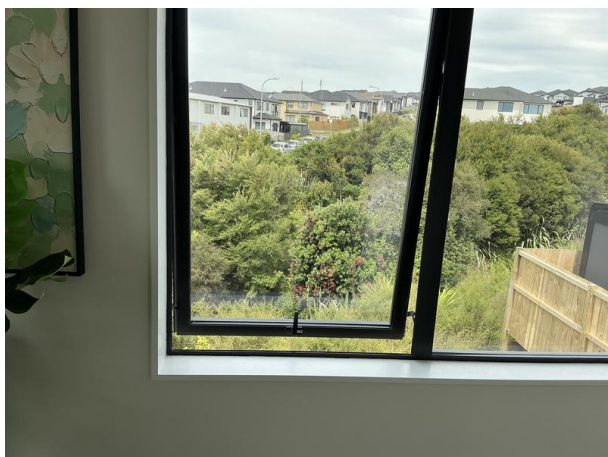
To maintain proper water flow and prevent blockages, it is essential to keep tracks, drainage channels, and weep holes clear of debris. Regular cleaning ensures these critical drainage systems function effectively, protecting the building from potential moisture-related damage.

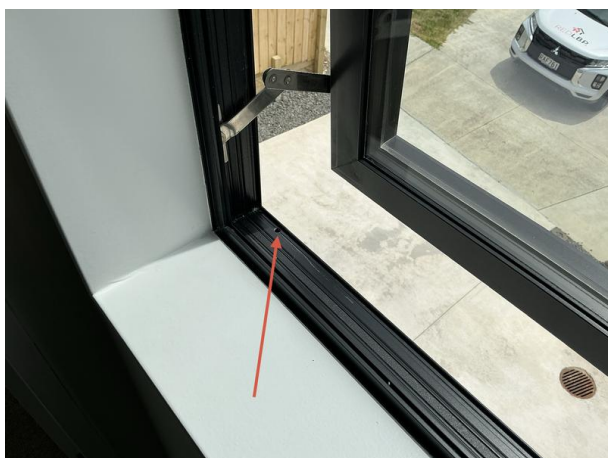
Double-glazed aluminium joinery with a powder-coated finish. Joinery rubbers and aluminium showed no visible defects, and all hardware was functional at the time of inspection.

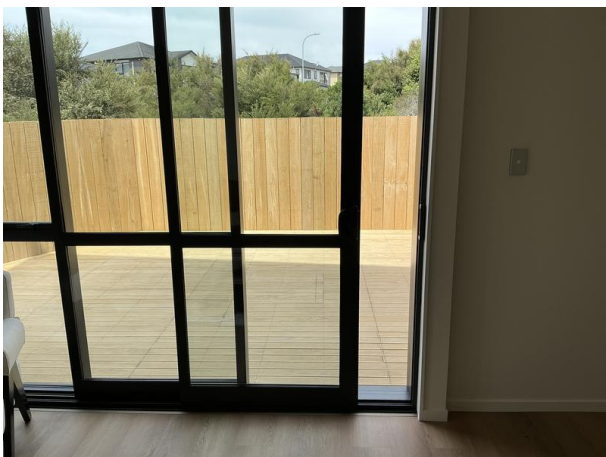
Double-glazed aluminium joinery with clear tracks, drainage channels, and weep holes. Timber reveals with a painted finish showing no visible issues or damage at the time of inspection.

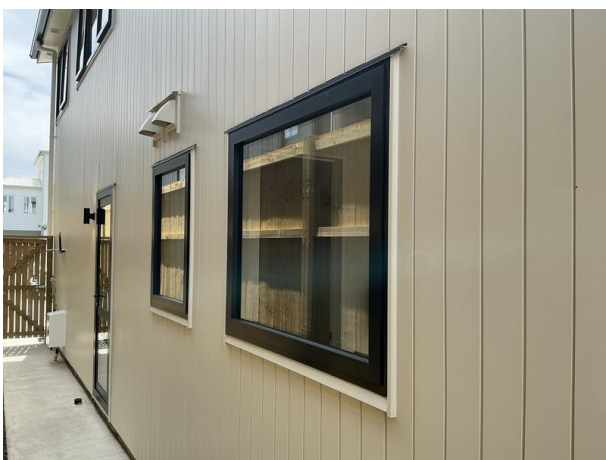
Double-glazed aluminium sliding doors to the dwelling were operating as intended with no visible defects or issues observed at the time of inspection.

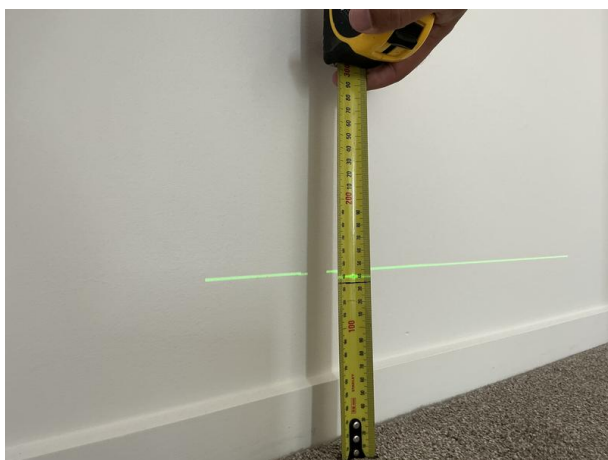
Concrete slab floor levels were spot-checked using a self-levelling laser. As a guide, particularly for new slabs within about the first six months, commonly accepted tolerances are: level within ± 10 mm in any one room or space, and surface deviation no more than ± 3 mm over any 3 m length. In the sampled areas, no significant faults or defects were identified. The overall level difference measured was approximately 4mm. This is a spot-check, not a full floor-level survey.

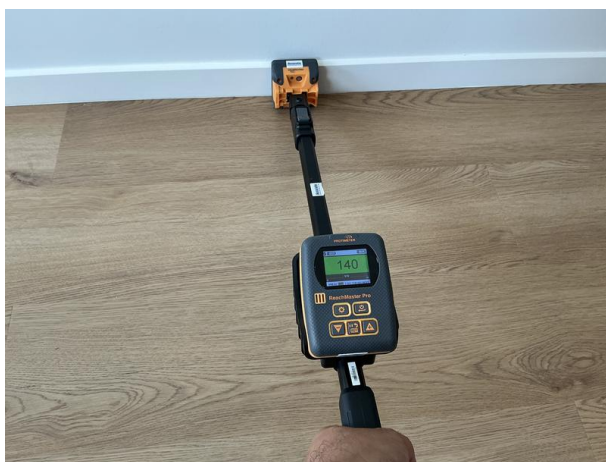
No indications of elevated moisture readings were detected. 'Supplementary' moisture testing photos are a representative sample of the comprehensive testing conducted.

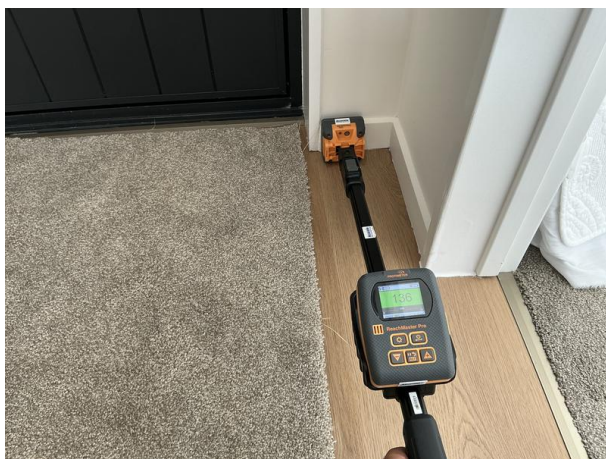
A base reading was taken to an interior wall using the non-invasive moisture metre - 140.

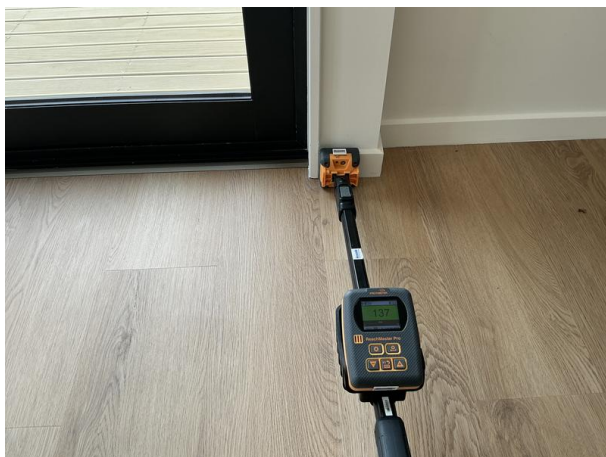
No indications of elevated moisture levels were detected to the bottom corners of the entrance - 136.

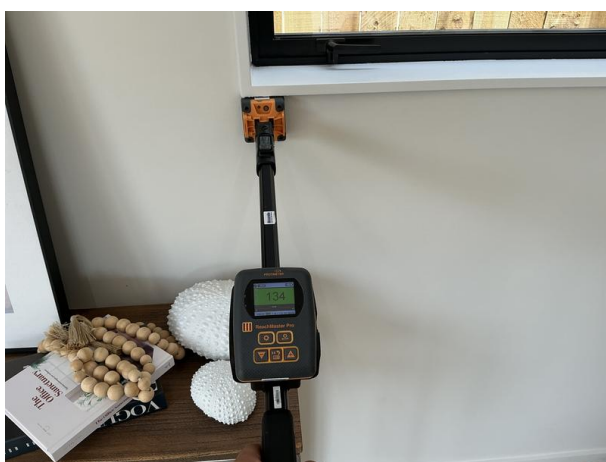
No indications of elevated moisture levels were detected to the bottom corners of the sliding doors - 137.

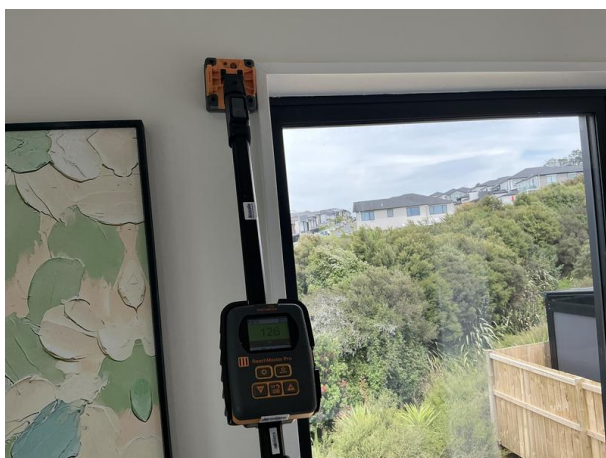
No indications of elevated moisture levels were detected to the bottom corners of the windows - 134.

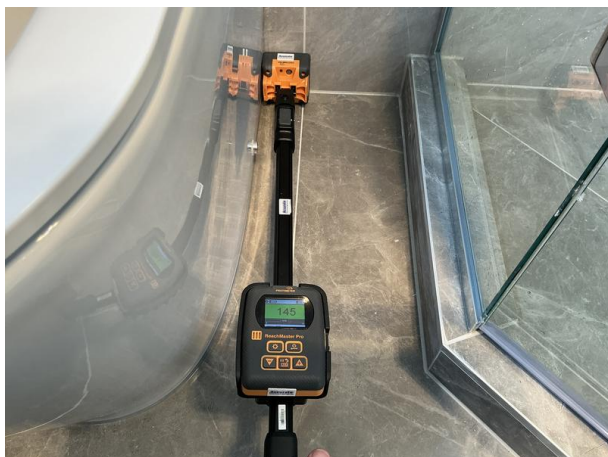
No indications of elevated moisture levels were detected to the top corners of the windows - 126.

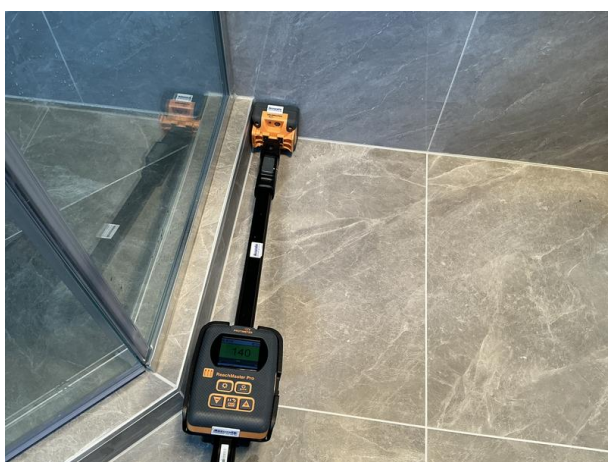
No indications of elevated moisture levels were detected to the bottom corners of the toilets - 145.

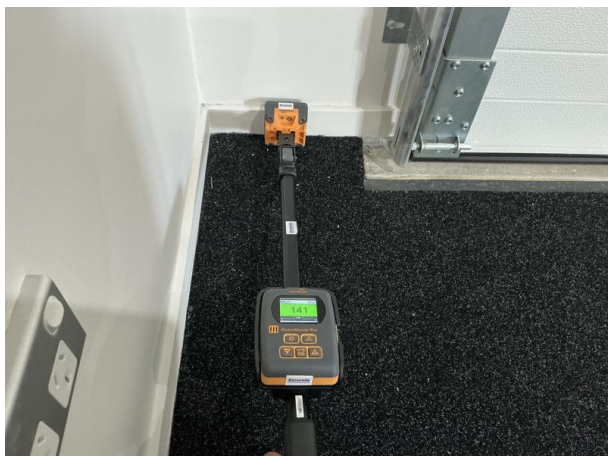
No indications of elevated moisture levels were detected to the bottom corners of the showers - 140.

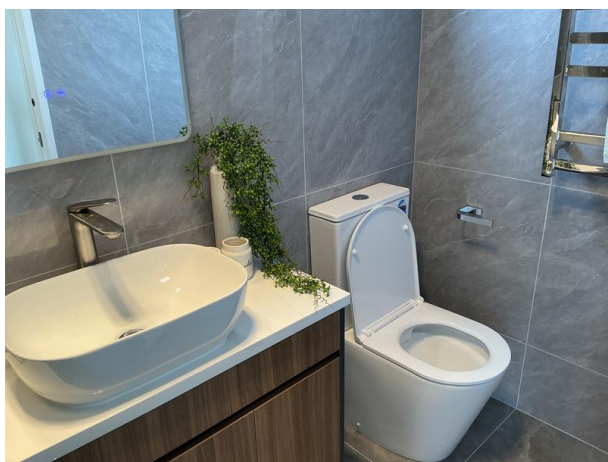
Photo 35
Ensuite off bedroom 1.

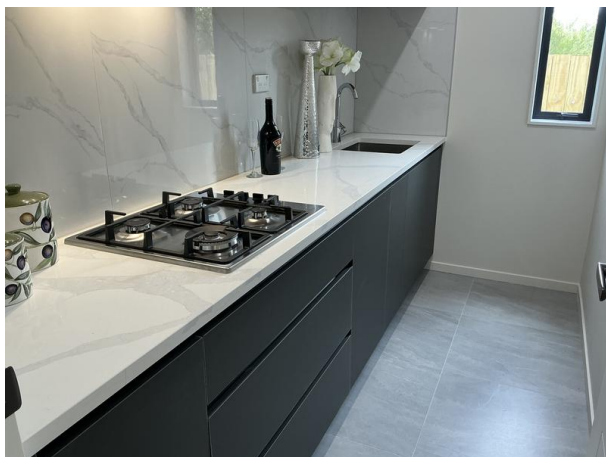
Photo 37
Kitchenette.

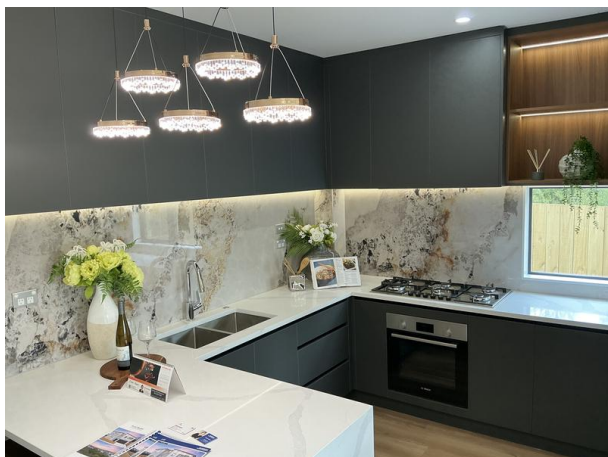
It is outside the scope of this report to check the operation and performance of the appliances, these are checked only for power connection. It is recommended that appliances are serviced regularly to ensure proper safe operation.

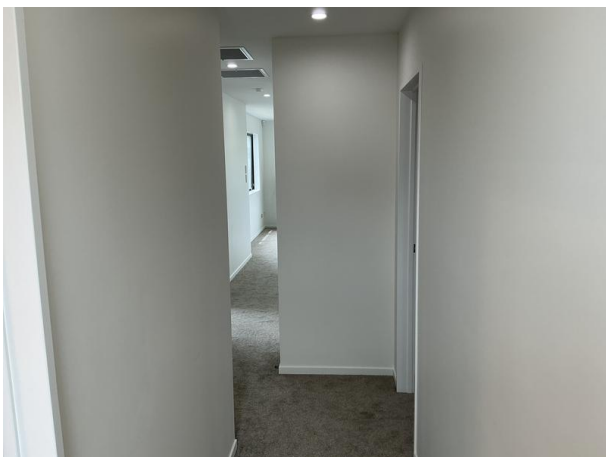
Ceiling linings - Plasterboard - Paint finished.
Ceiling wall junction - Square stopped.
Wall linings - Plasterboard - Paint finished.
Exterior joinery - Aluminium - Double-glazed - Standard glass - Painted timber reveals.
Internal doors - Hollow core.
Floor coverings - Carpet.
Benchtop - Sealed to cabinet/wall junction - Yes.
Benchtop material - Composite.
Benchtops level - Yes.
Damage - None visible at the time of the inspection.
Splashback - Tiled - Sealed edge.
Cabinetry - Functional - Yes. Material type - Laminate.
Cabinetry requires maintenance - No.
Water hammer - No noise or vibration noted.
Sink - Leaks or visible issues - No.
Faucet functional - Yes.
Type of plumbing - uPVC waste and braided wire.
Floor coverings for kitchette- Tiles.

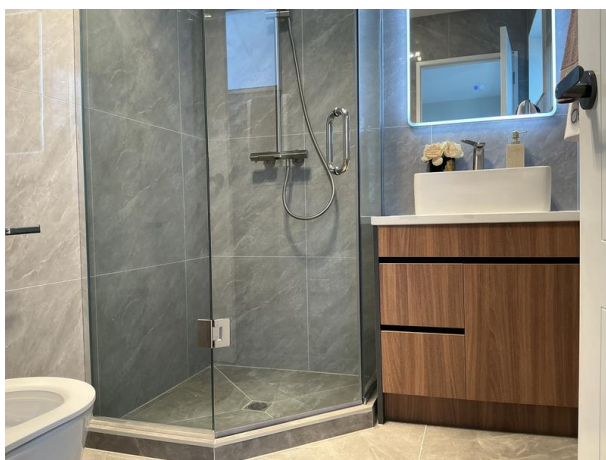
Photo 51
Ensuite off bedroom 4

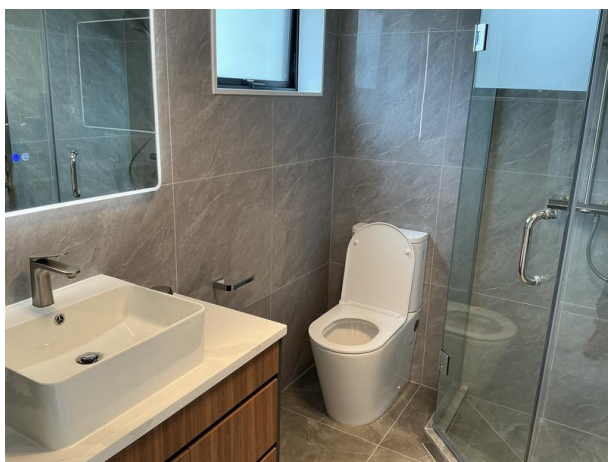
The statement regarding the shower pressure (adequate or inadequate) reflects the inspector's opinion based on the pressure observed during the inspection and is subjective to the inspector's judgment.

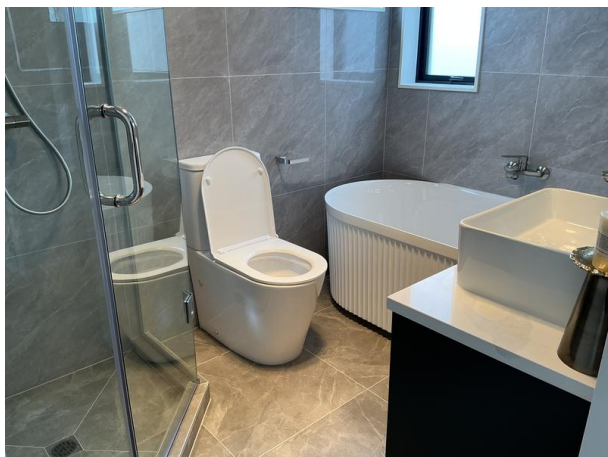
Photo 57
Ensuite off bedroom 6 with a bath.

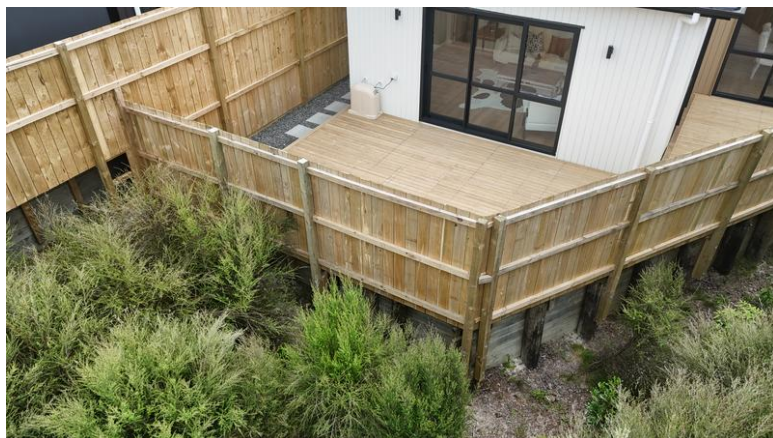
Photo 60
Retaining walls located around the perimeter of the dwelling. Inspection not possible due to limited access.

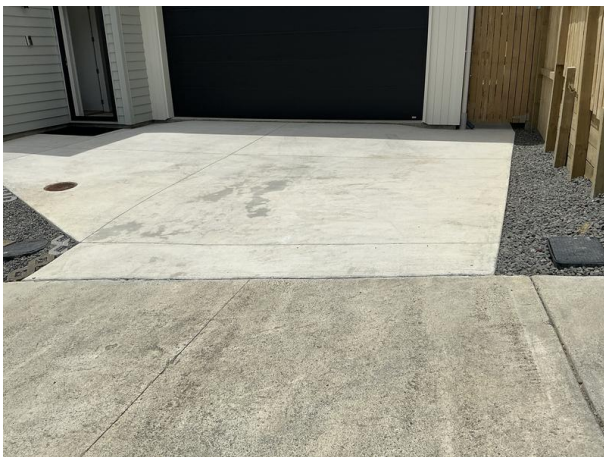
General upkeep and maintenance of driveway by cleaning and keeping free of debris.

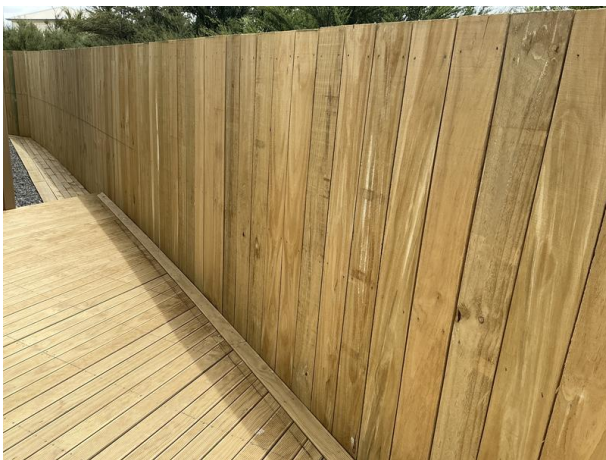
Ensure regular upkeep and maintenance by keeping vegetation and soil away from exterior timbers. These timbers are treated for external exposure but are not designed for prolonged contact with vegetation or soil, which can trap moisture and accelerate rot. Periodically inspect the area and clear any overgrowth or soil buildup.

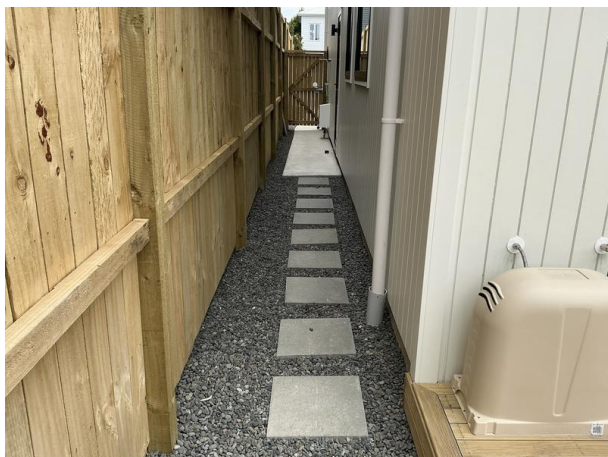
General upkeep and maintenance.

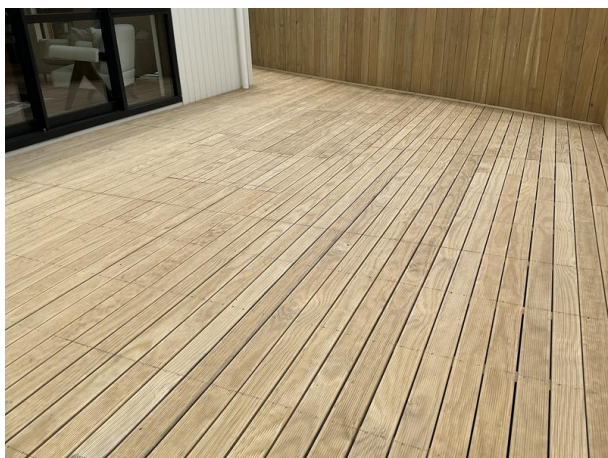
General upkeep and maintenance.

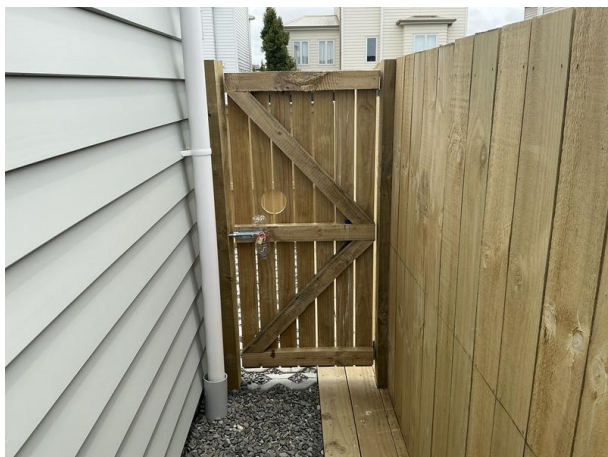
Recommend regular lubrication of the hinges and latch to maintain full function.

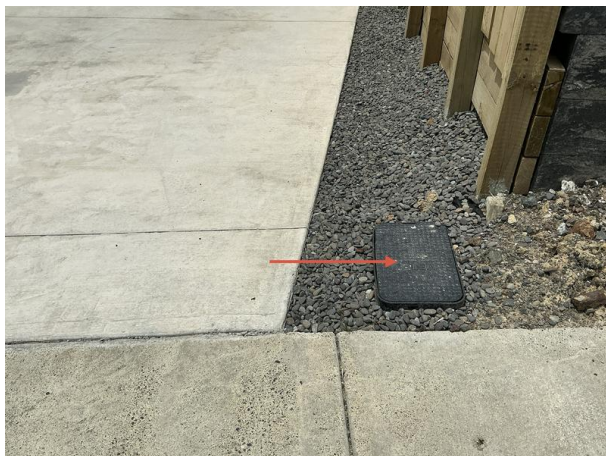
Photo 70
Water toby located on the west side of the dwelling.

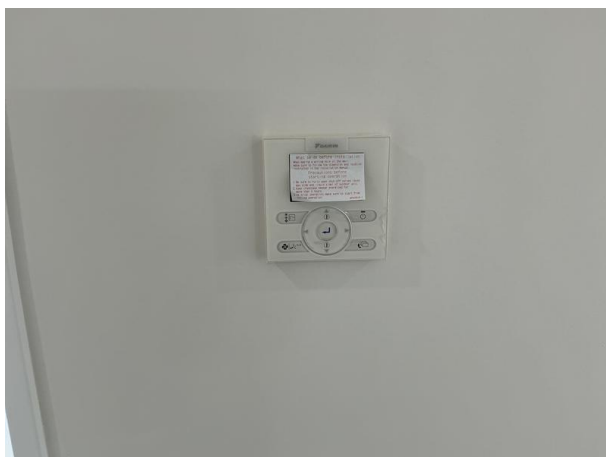
Photo 79
Fully ducted heat pump system control pad located in the hallway.

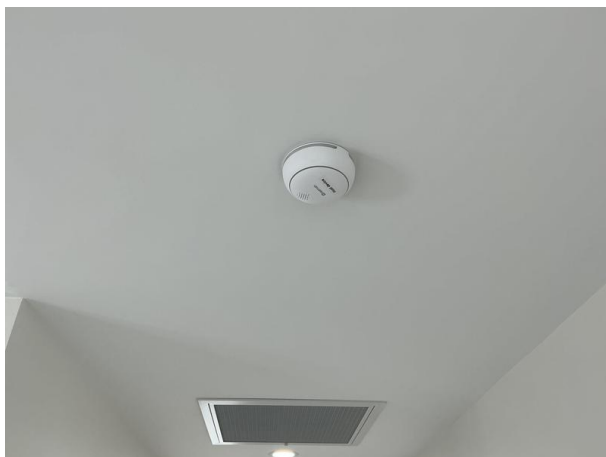
To ensure that your alarm system is functioning optimally, it is recommended to follow the manufacturer's maintenance advice. Additionally, on a monthly basis, you should check the alarm still works by pressing the test facility located on the outside of the device. Replace dead batteries immediately and gently vacuum the dust that gathers on the device. Do not take the alarm apart or off its mount to do this.
