123 Sample St - Multi storey

20/01/2026

Inspector Name: Sam Taylor

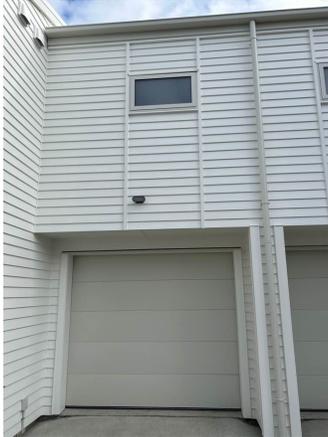
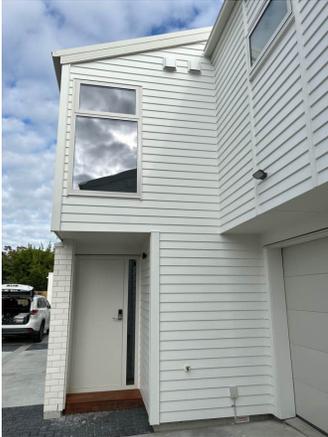
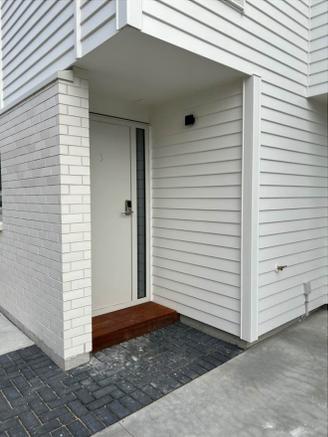
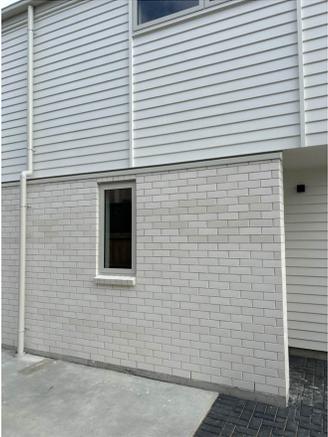
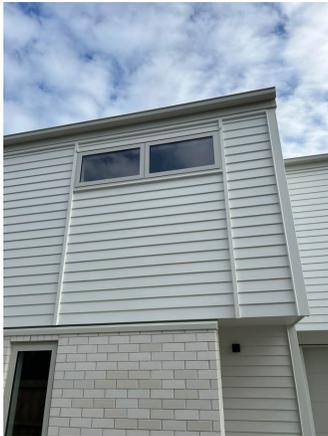
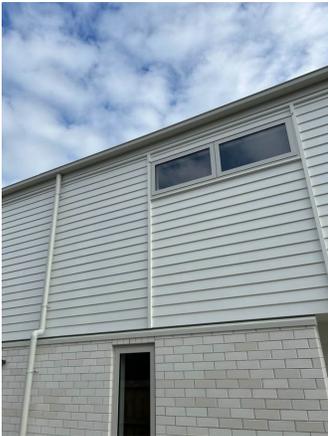
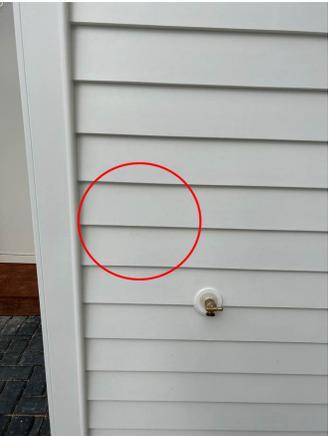
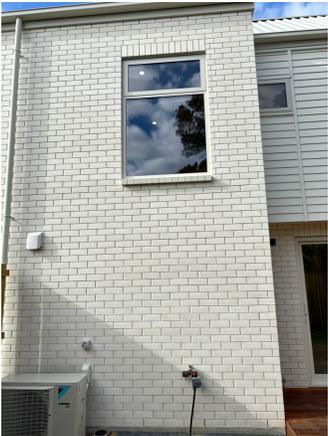
Small amount of glue on board

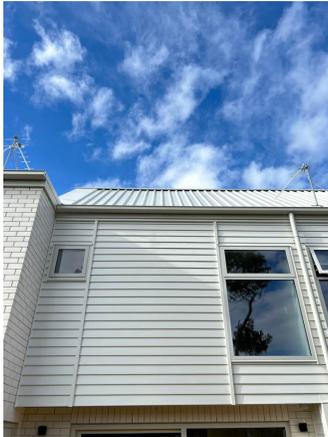
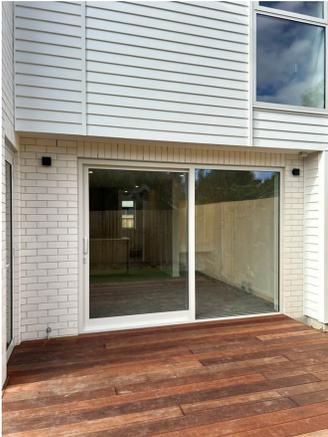
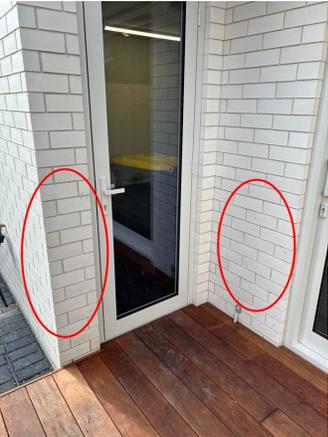
Minor marks on brickwork

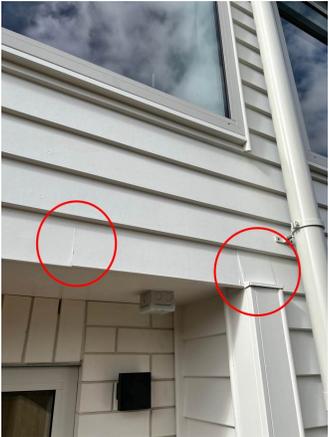
Finishing imperfections

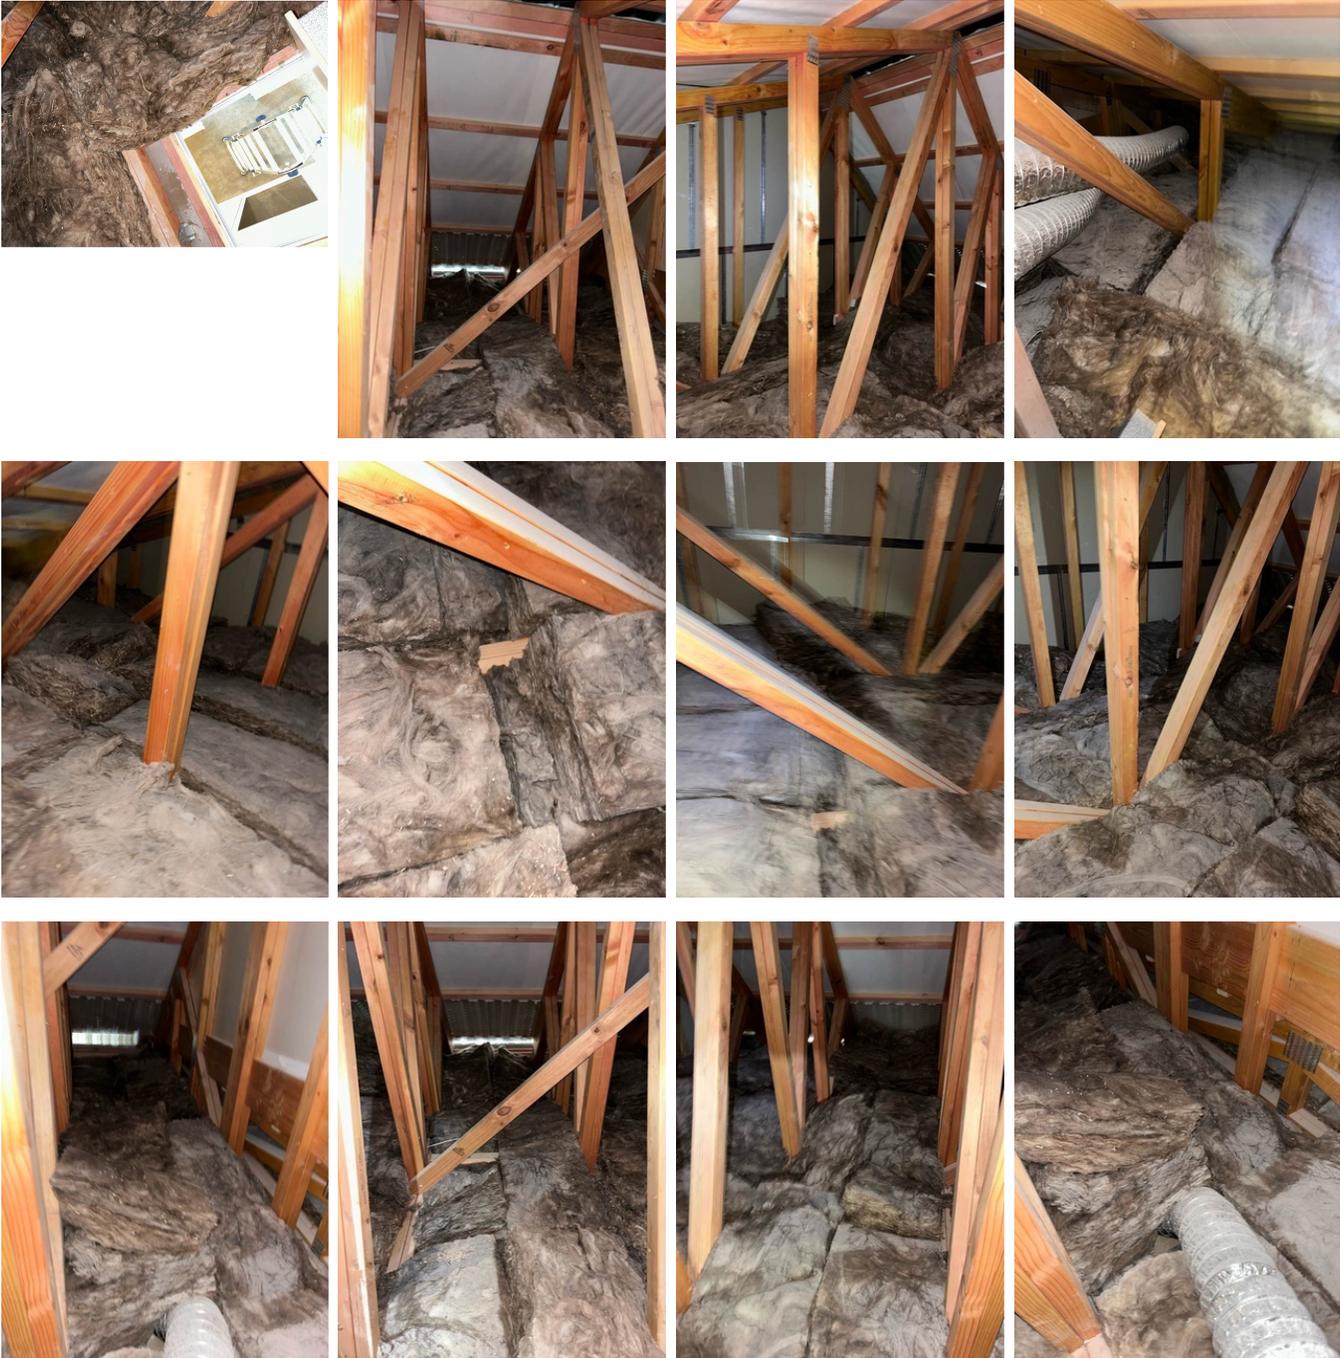
Insulation has not been adequately installed in all areas and requires tidying to meet NZS4246 insulation standard. A small amount is missing next to manhole

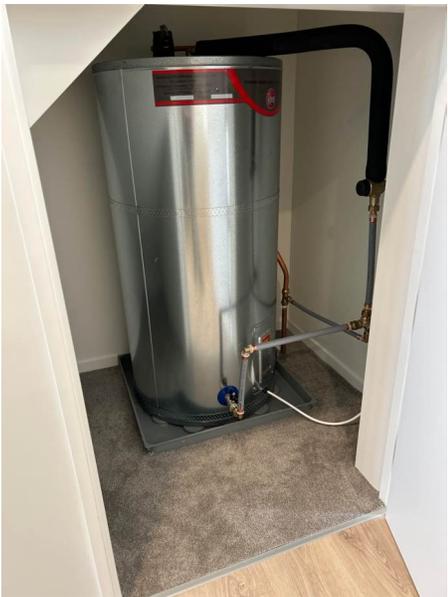
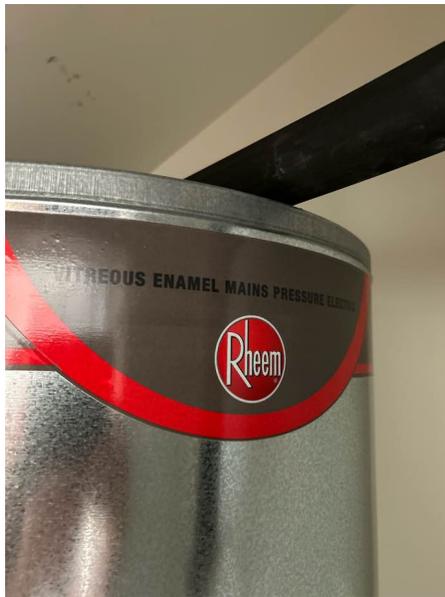
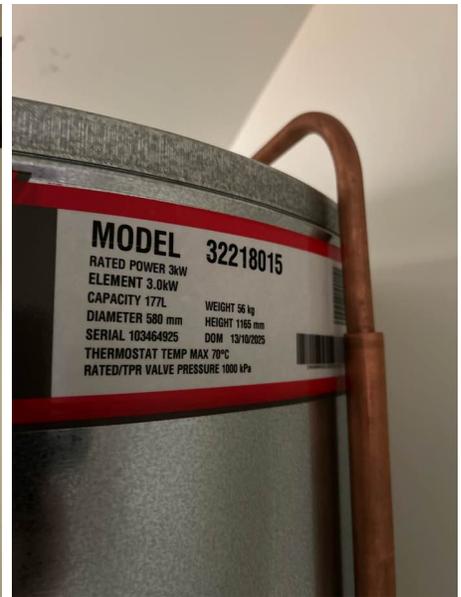
Condition of Water Heating System:

Good

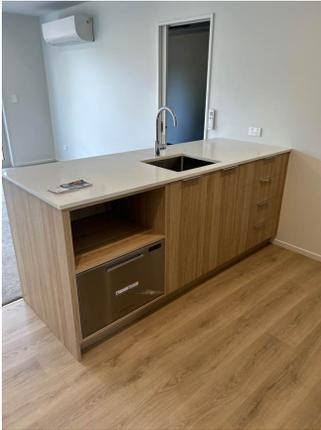
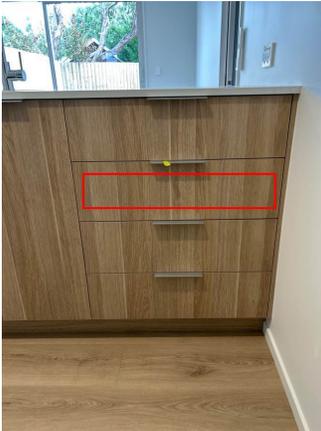
Drawer catching on drawer above

Maintenance Recommended

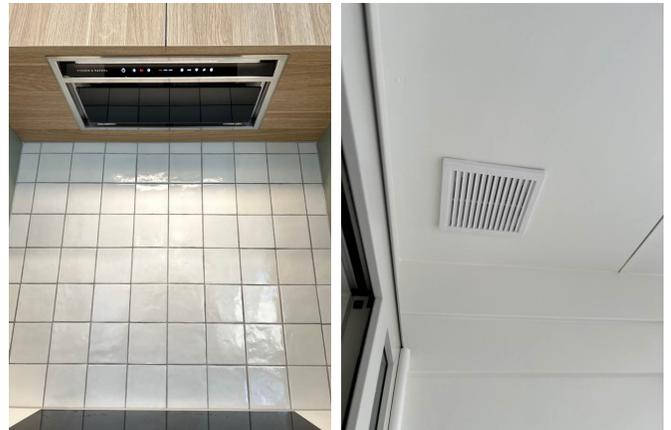
Rangehood
