123 Sample St

26/01/2026

This is a new build property in good condition with just a small few minor finishing imperfections in the process of being completed

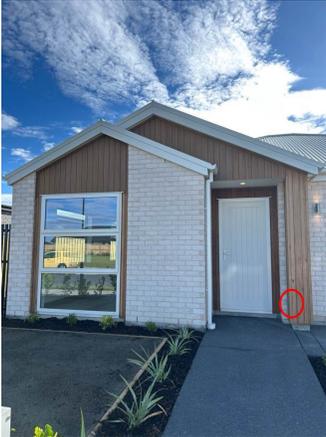
Small pencil mark on cedar

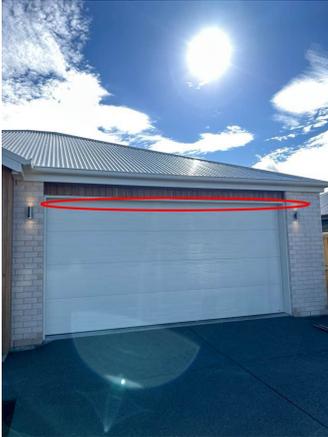
Hand marks on reveal

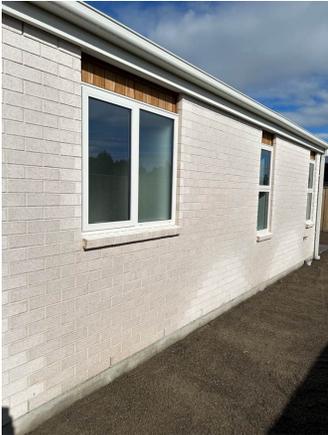
Minor marks on soffit outside lounge

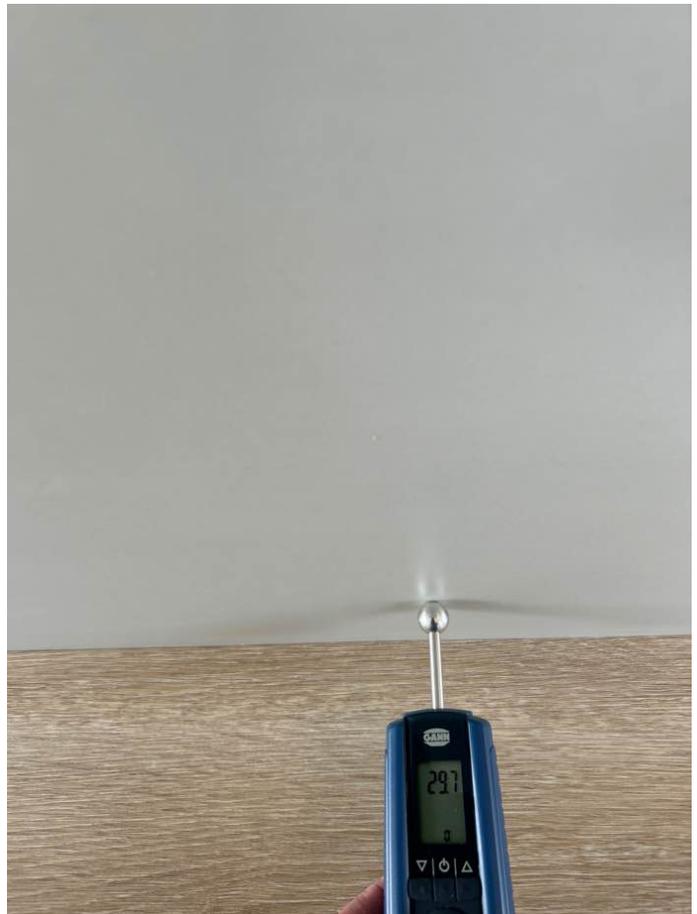
Moisture Reading
20-40 digits - Dry

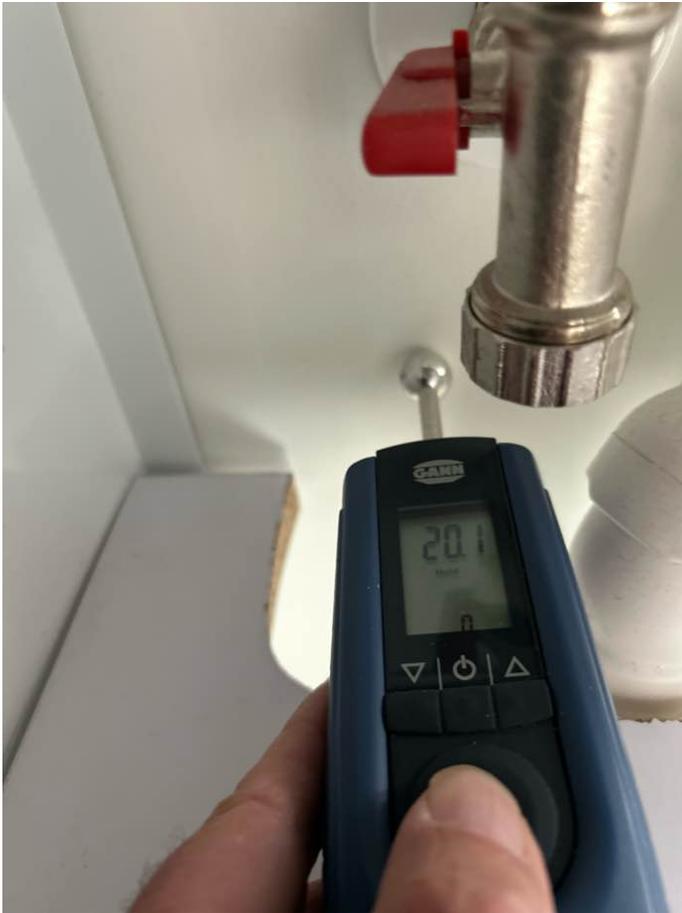
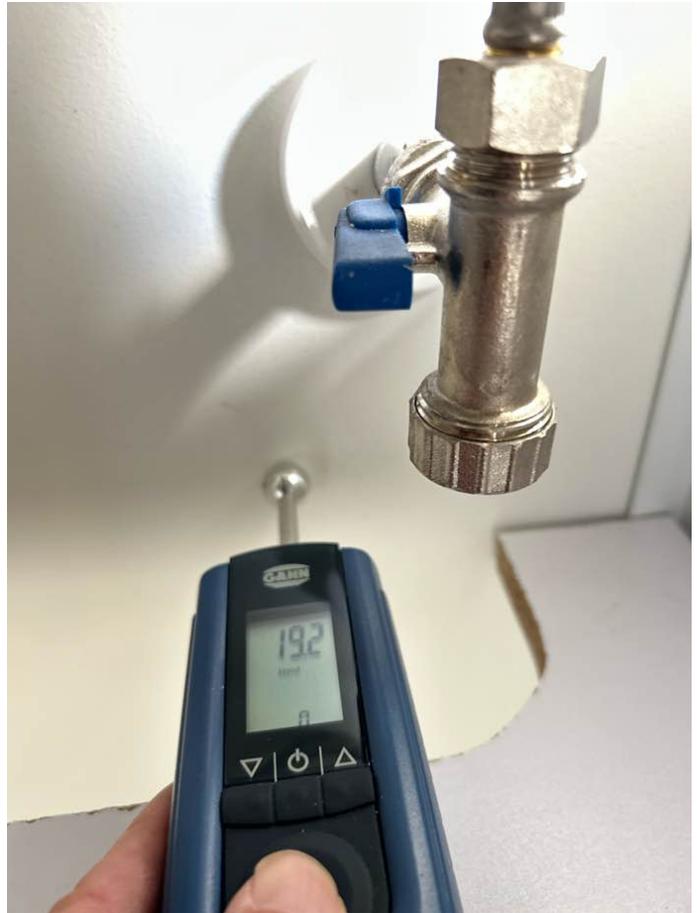
Room:
Laundry

Moisture Reading
20-40 digits - Dry

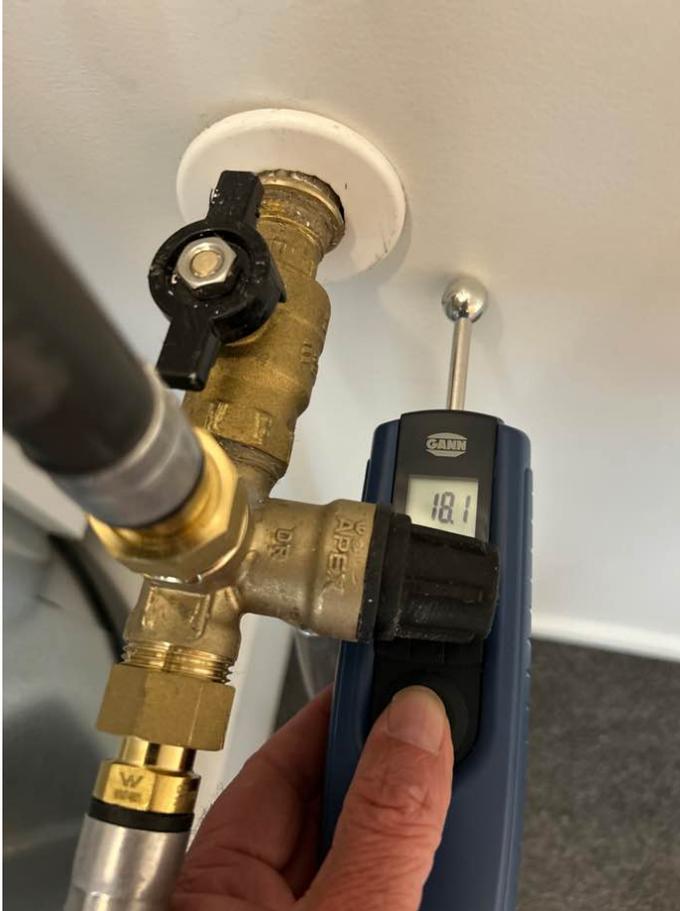
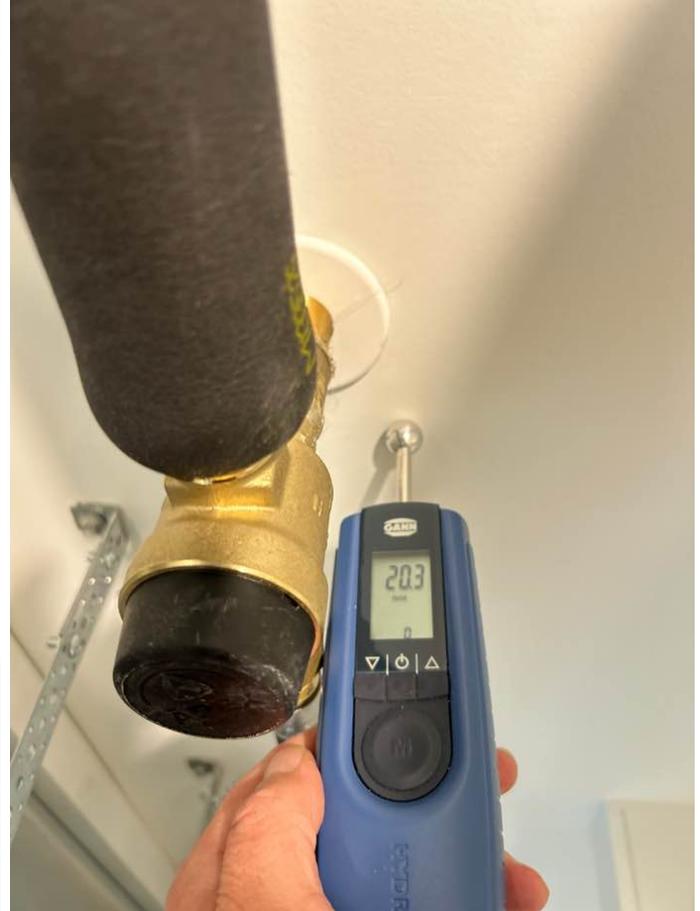
Moisture Reading
20-40 digits - Dry

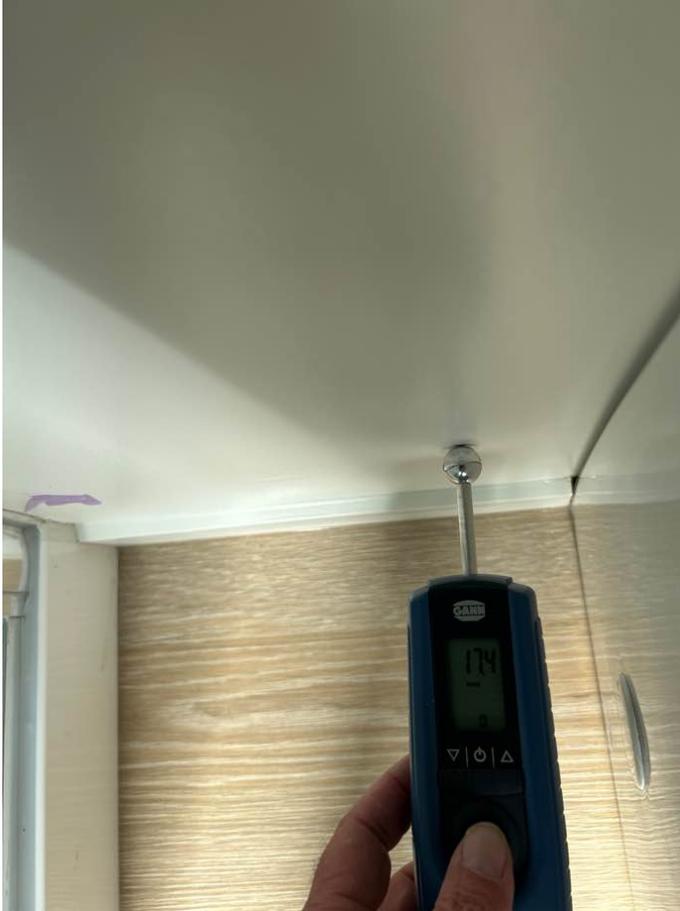
Room:
Ensuite 1

Moisture Reading
20-40 digits - Dry

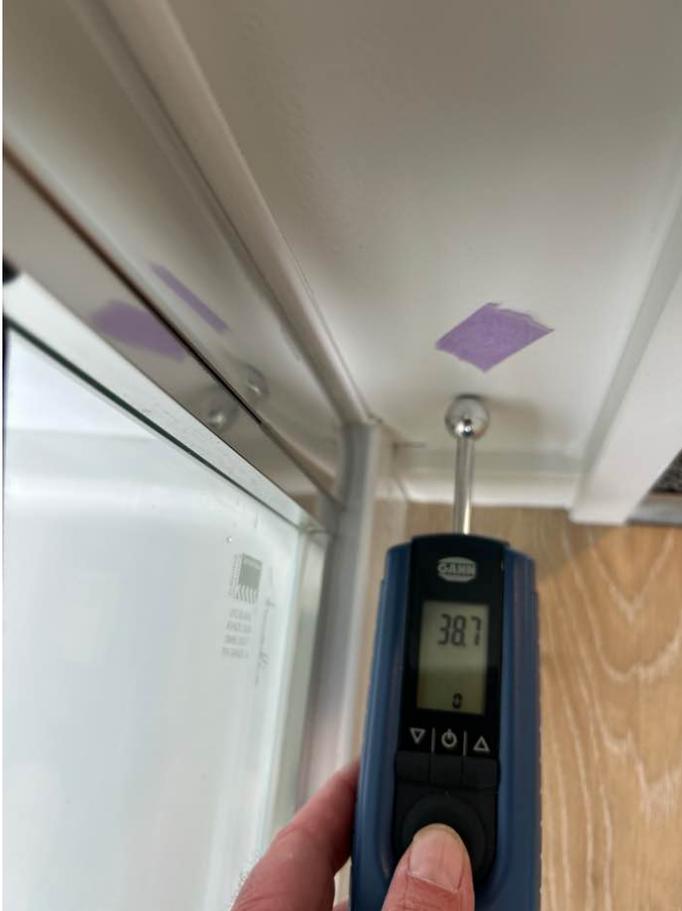
Room:
Bathroom 1

Moisture Reading
20-40 digits - Dry
