# Property Re-Inspection Report

**Property Address:**  
123 Sample St - Maintenance report

**Date:**  
October 16th 2025 12:00

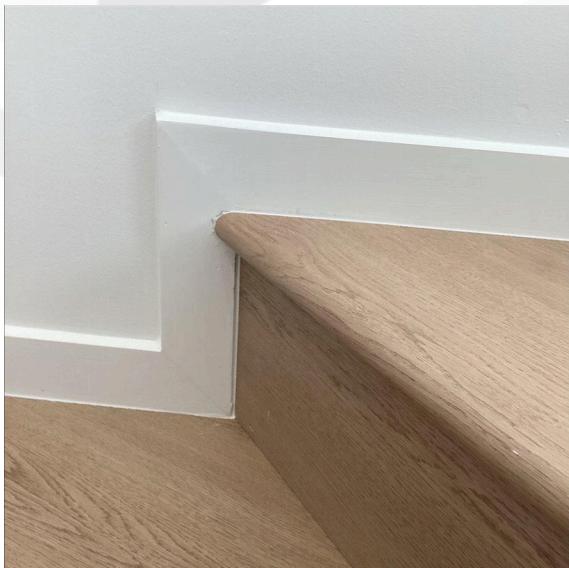
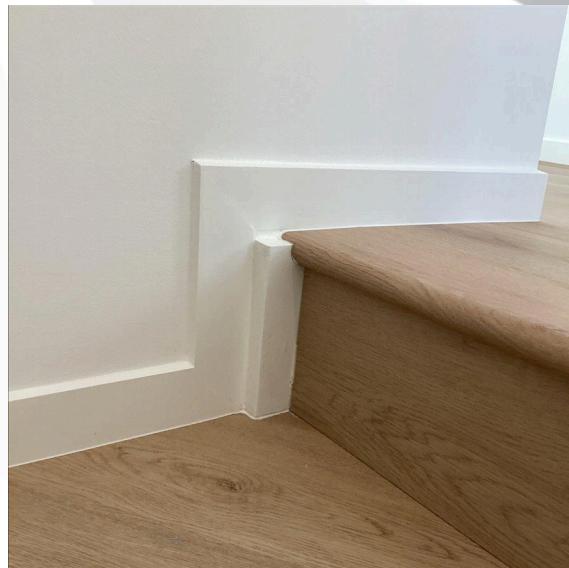
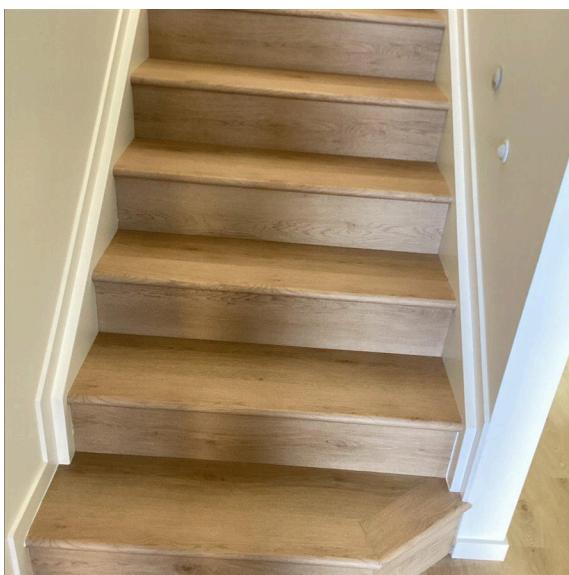
- 1) The gaps have been sealed.

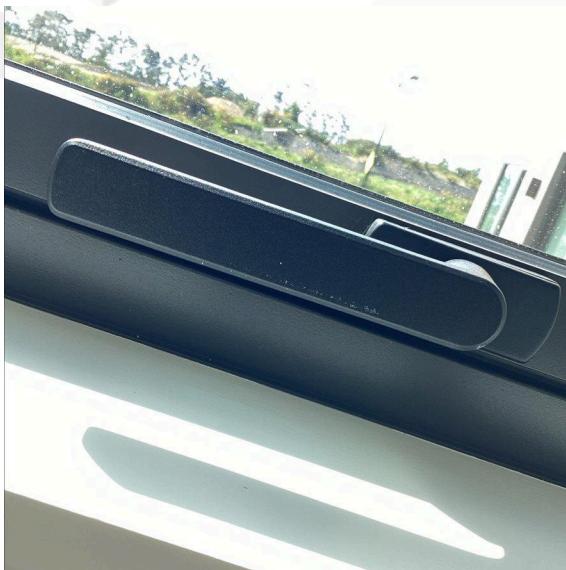
- 1) White paint still there on window handle.
- 2) Door rubbing with carpet.
- 3) The window is sealed under the sill.
- 4) The door is sealed.

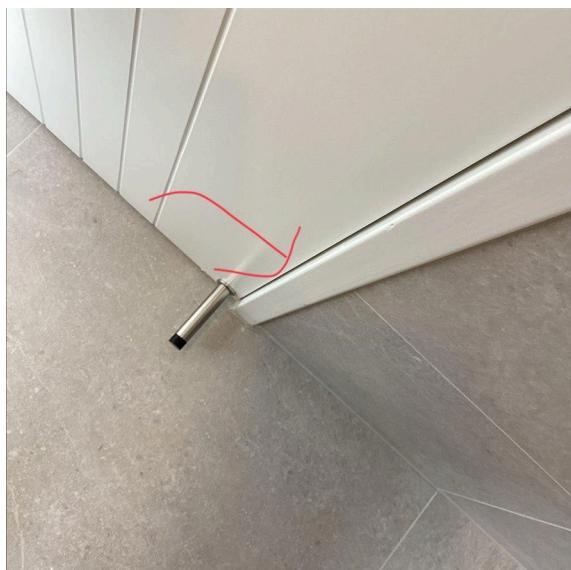
**Significance:** Further Investigation - Suitably qualified trades person

**Comment:** Door requires adjustment it is little outward from the top.

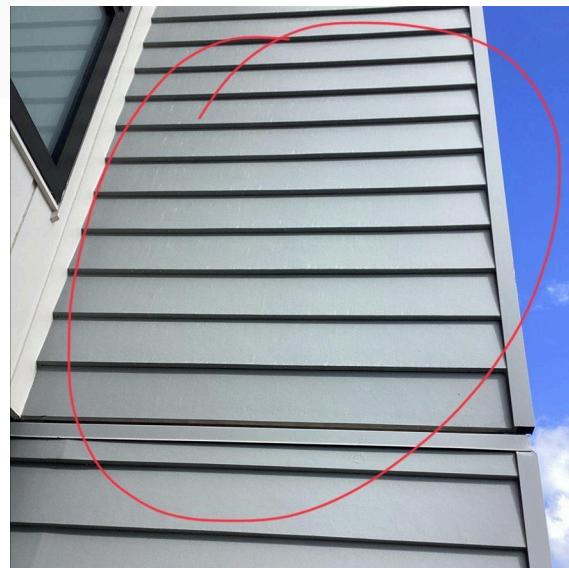
**Significance:** Minor

**Comment:** Paint drops seen

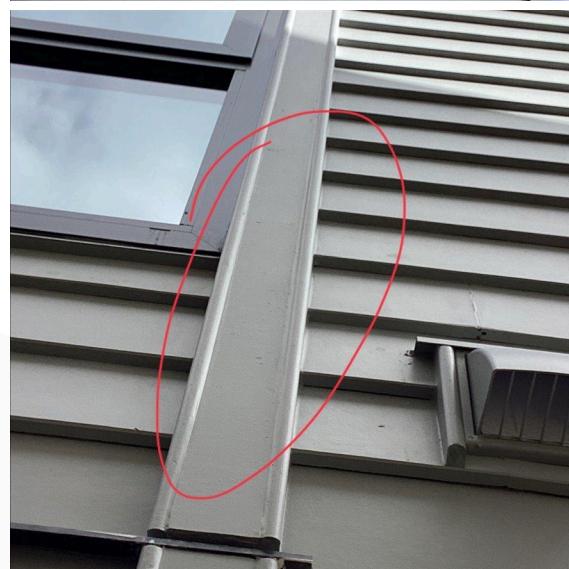
**Significance:** Minor

**Comment:** Paint touch ups

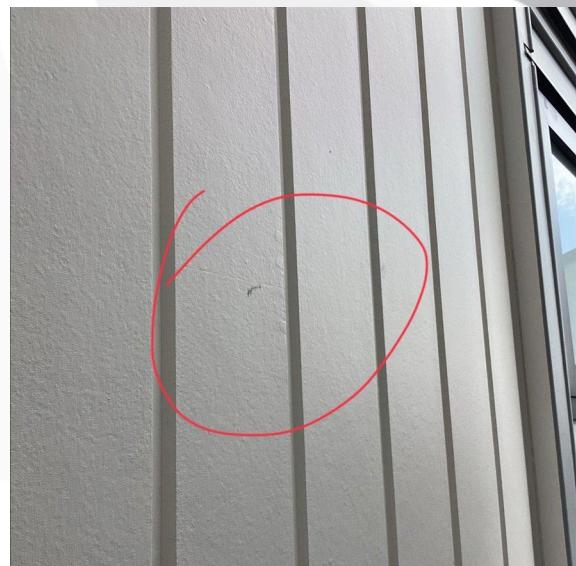
**Significance:** Further Investigation - Suitably qualified trades person

**Comment:** Paint gaps are still there on joinery.

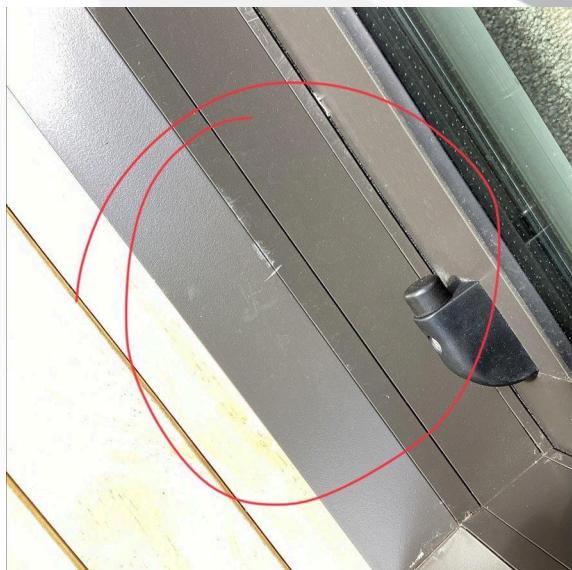
**Significance:** Further Investigation - Suitably qualified trades person

**Comment:** Photo 2 photos bathroom window requires cleaning.

Photos 4,5 & 6 scratches noted to glass and window frame of bedroom 2.

Photos 8 & 9 photo scratched noted to bed room 2 door

Clean bedroom 2 window.

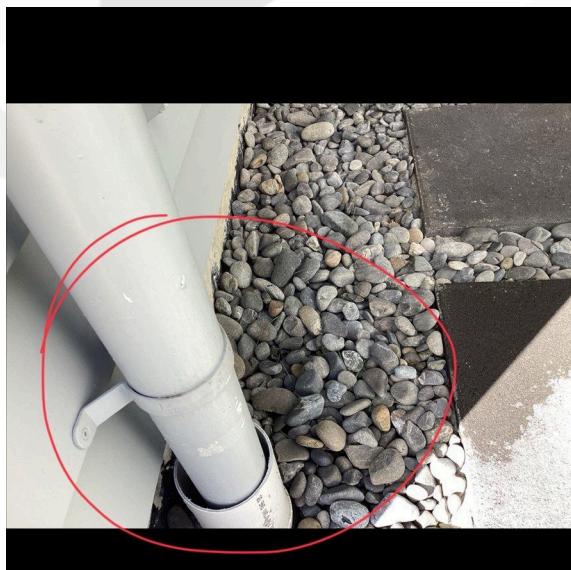
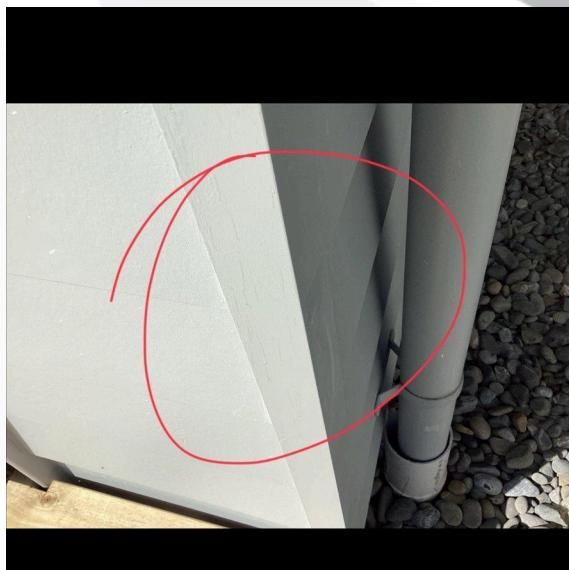
**Significance:** Further Investigation - Suitably qualified trades person

**Comment:** Marks still on the cladding.

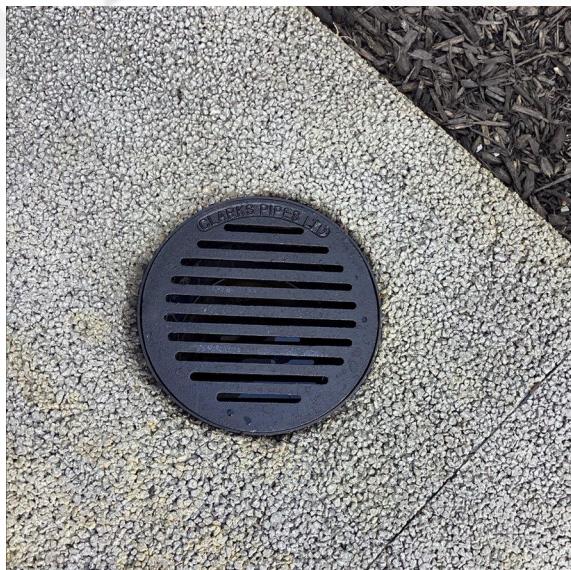
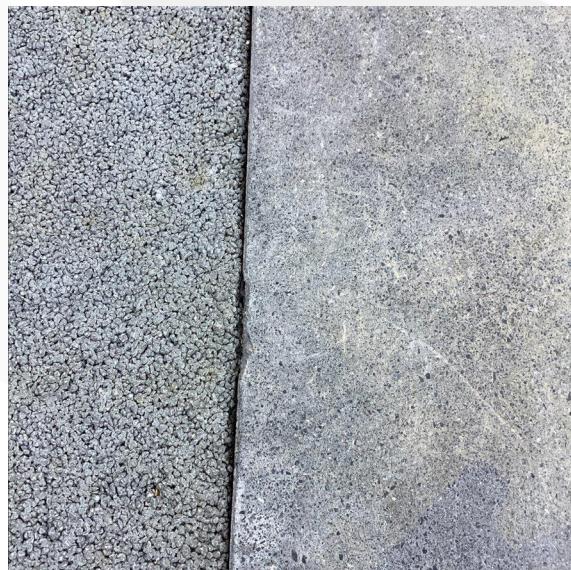
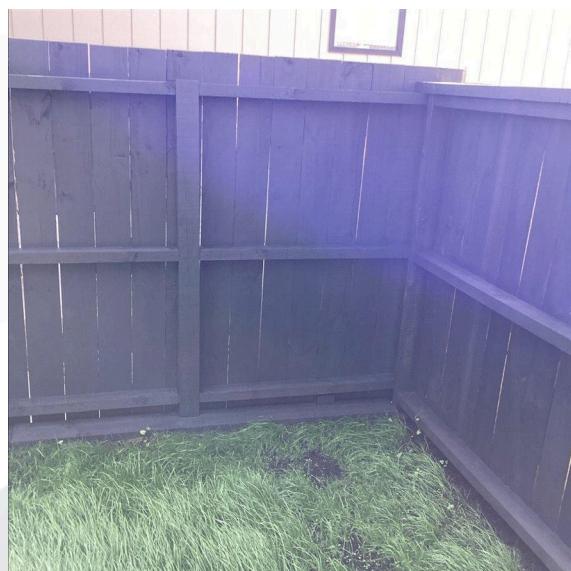
- 1) The drain is painted.
- 2) The fence is painted.
- 3) Small dents still noted.
